Docket No. 272 – Development and Management Plan Inspection

Segment 2a Inspection

Date: May 13, 2008

Location: Segment 2a – Beseck Switching Station to Cheshire/Hamden Town Line

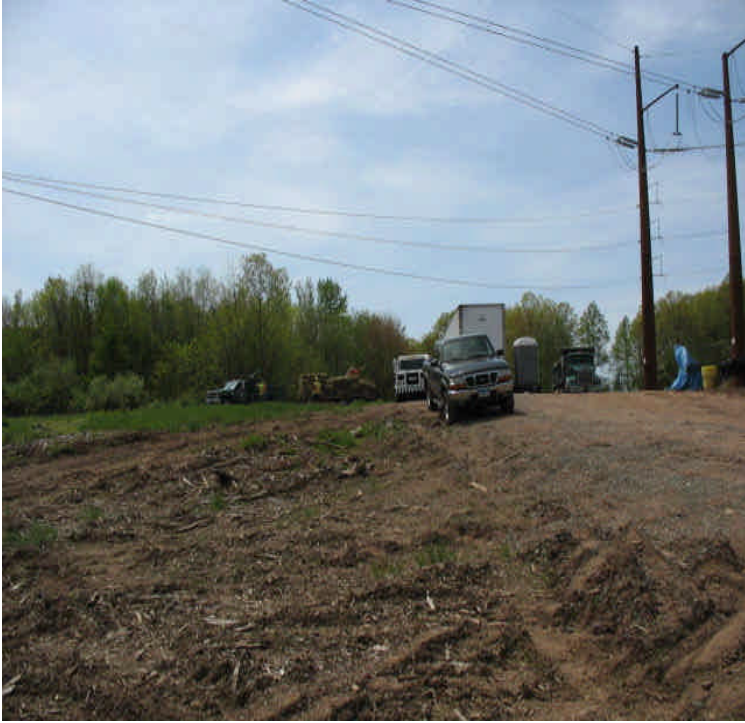
Carpenter Ln: Large area disturbed/exposed from line work. Crews were starting to bring equipment to the site for reclamation activities.

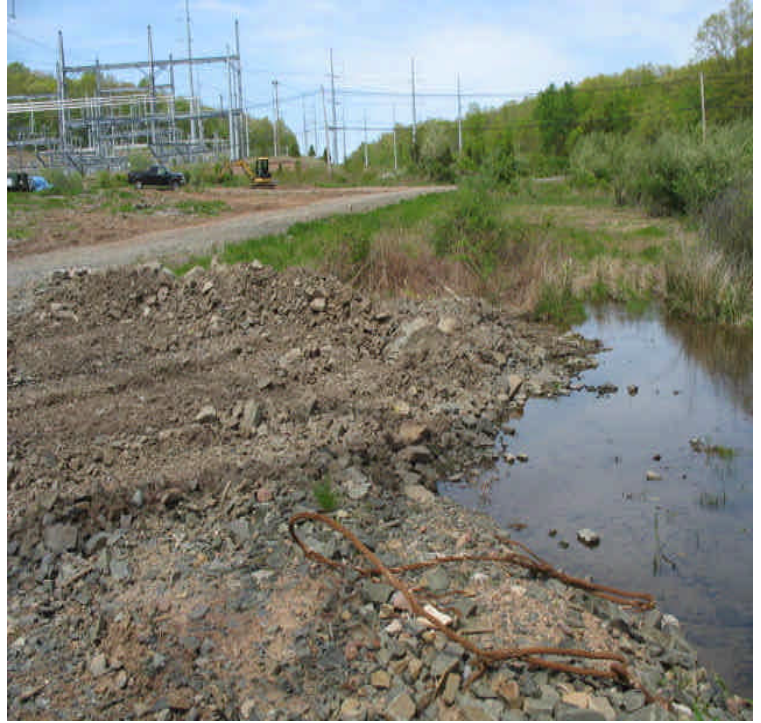
Carpenter Ln: The stone/sediment stockpile from pad work that was left in/adjacent to wetlands has been pushed further into wetlands to extend the pad.

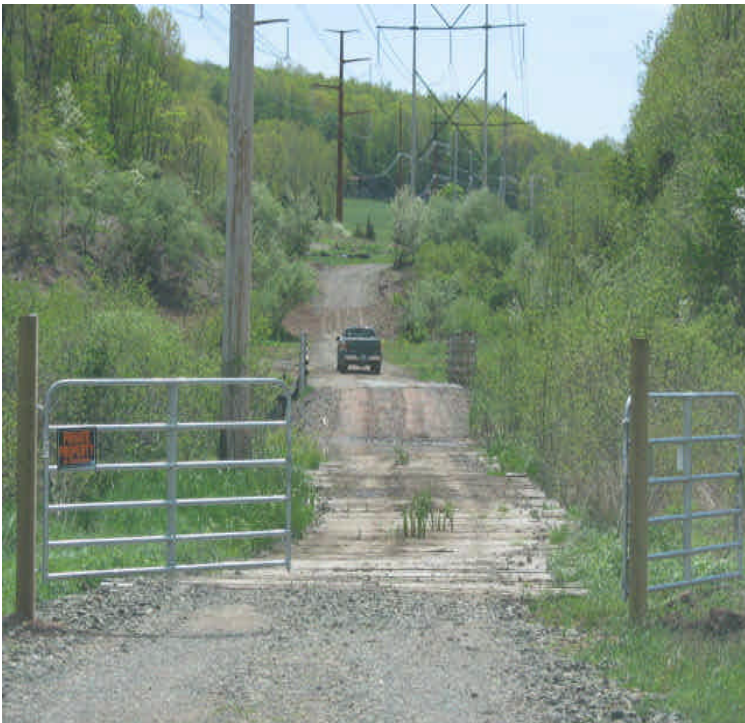
Durham Rd: Contractor measuring the length of the access road has driven through the flooded timber mats. Keep off mats when flooded if feasible.

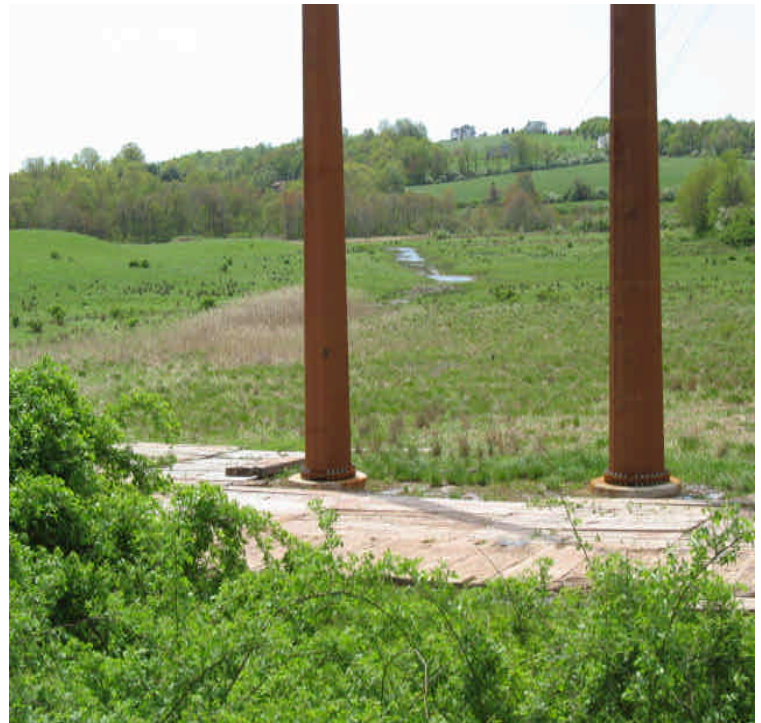
Tamarack Swamp Rd: View of timber mat staging area within wetland

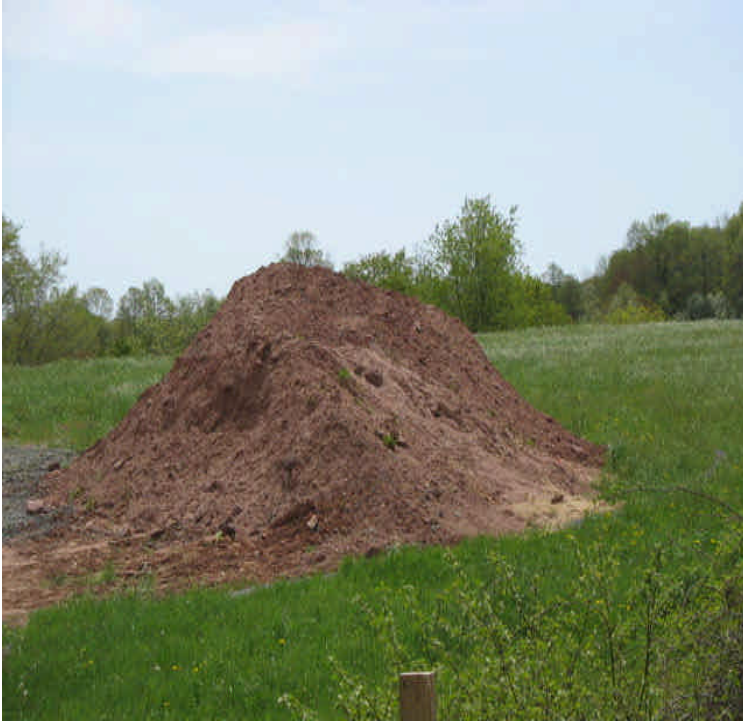
Tamarack Swamp: Stockpile located in the uplands. Stabilize or remove as soon as possible.

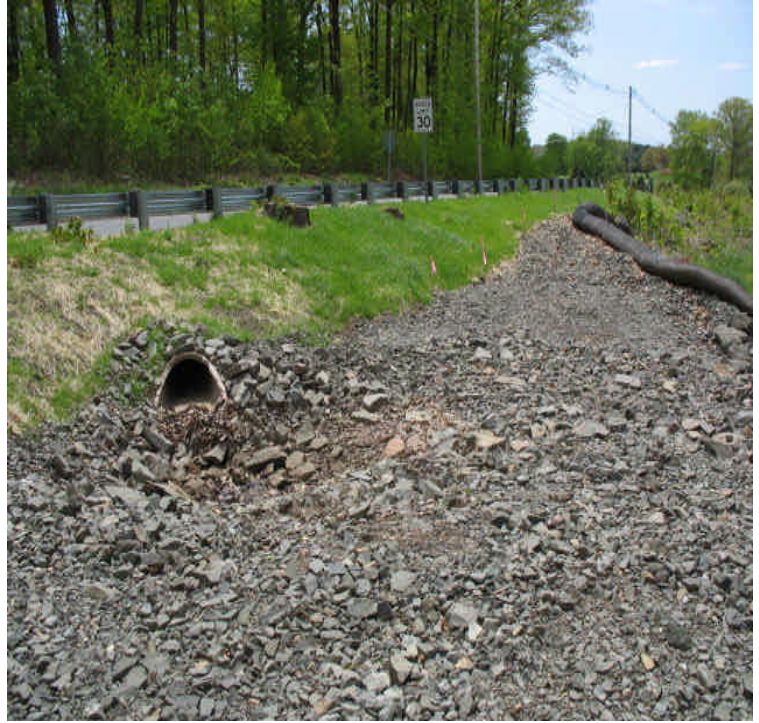
Harrison Rd: View of the recently installed stormwater solution for run-off from the roadway. Stormwater has been percolating through the stone during heavy rain. Continue to evaluate.

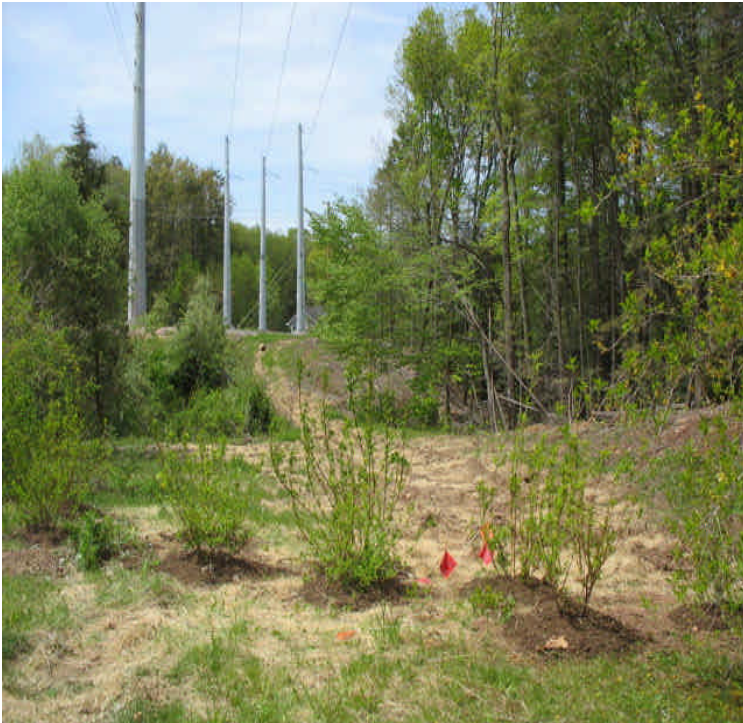
Old Farms Rd: Landscaped plants were placed at the access to the wetland crossing.

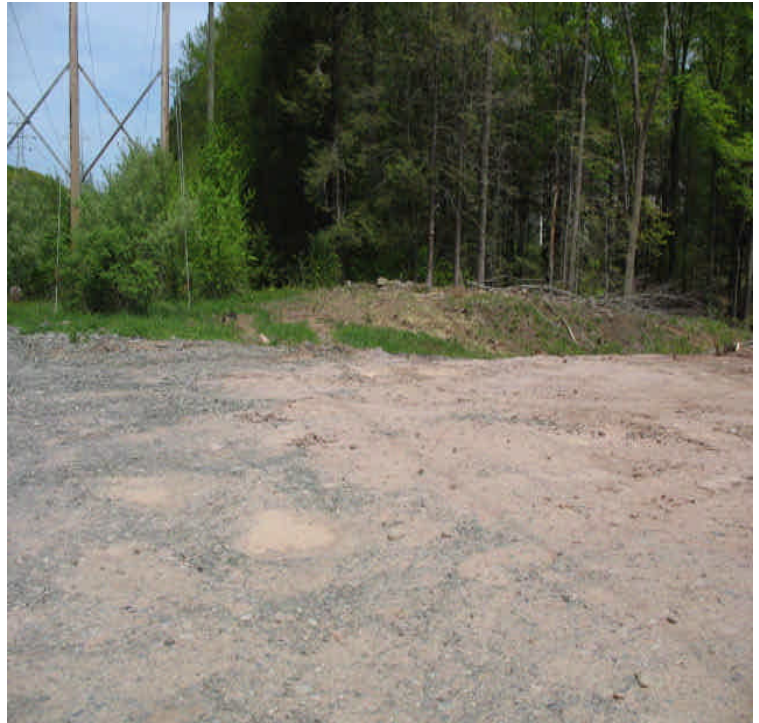
Old Farms Rd: Stockpile upgradient from wetlands has been fully removed.
