**Docket No. 272 – Development and Management Plan Inspection**

**The Connecticut Light and Power Company Certificate of Environmental Compatibility and Public Need for the construction of a new 345-kV electric transmission line and associated facilities between Scovill Rock Switching Station in Middletown and Norwalk Substation in Norwalk, Connecticut, including reconstruction of portions of existing 115-kV and 345-kV electric transmission line, the construction of Beseck Switching Station in Wallingford, East Devon Substation in Milford, (and Singer Substation in Bridgeport), modifications at Scovill Rock Switching Station and Norwalk Substation, and the reconfiguration of certain interconnections.**

**Segment 2a Inspection**

**Date:** May 20, 2008

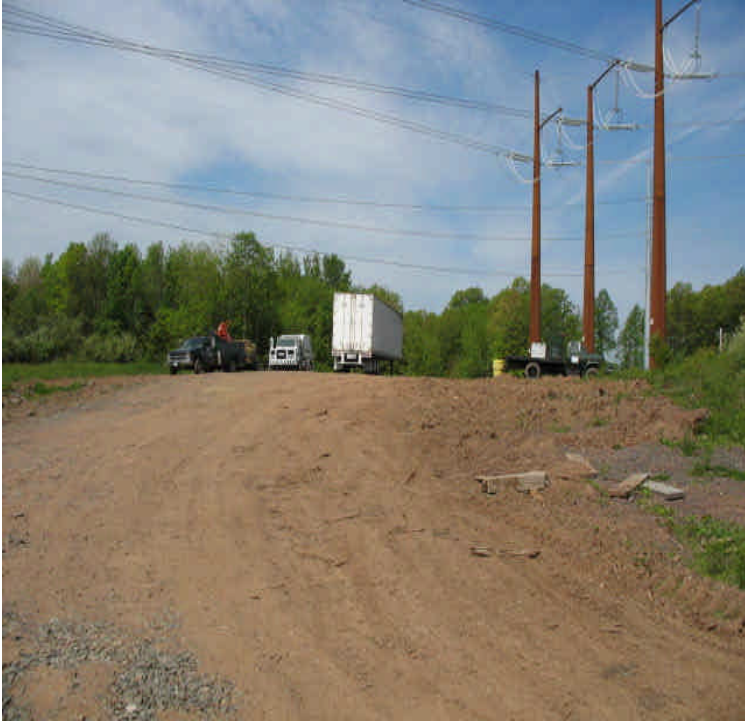
**Carpenter Ln: Large area disturbed/exposed from line work. Crews continue to mobilize onsite for reclamation activities. Spill kits were also observed (proactively).**

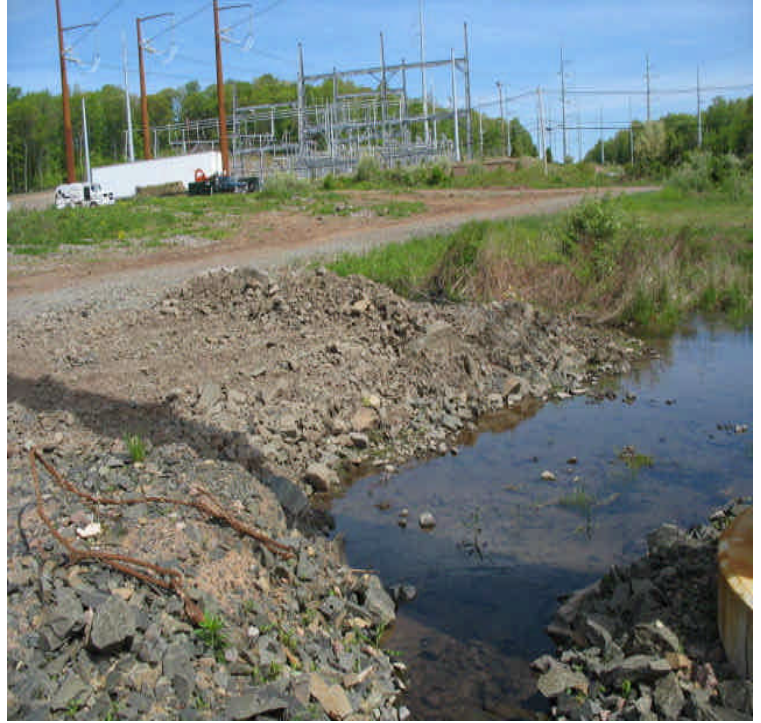
**Carpenter Ln: The stone/sediment stockpile from pad work that was left in/adjacent to wetlands has been pushed further into wetlands to extend the pad.**

<p>Foundation and site construction</p>	<p>Stone stockpiled at Carpenter was pushed</p>	<p>Ensure location of stone is correct and replace</p>	<p>Controls need attention</p>

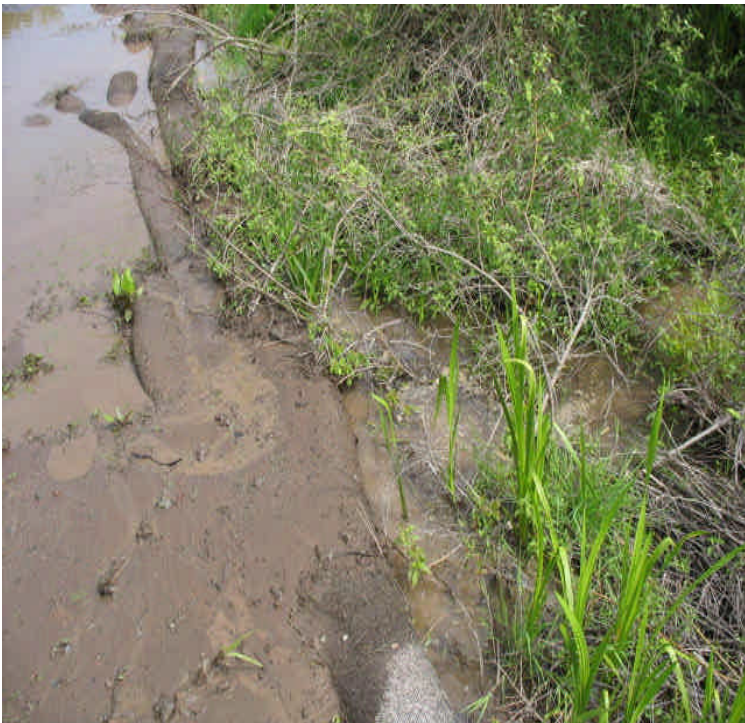
**Durham Rd: Mud and turbid water noted spilling over the controls at the timber mat wetland crossing. Additional controls and possible sediment removal needed.**

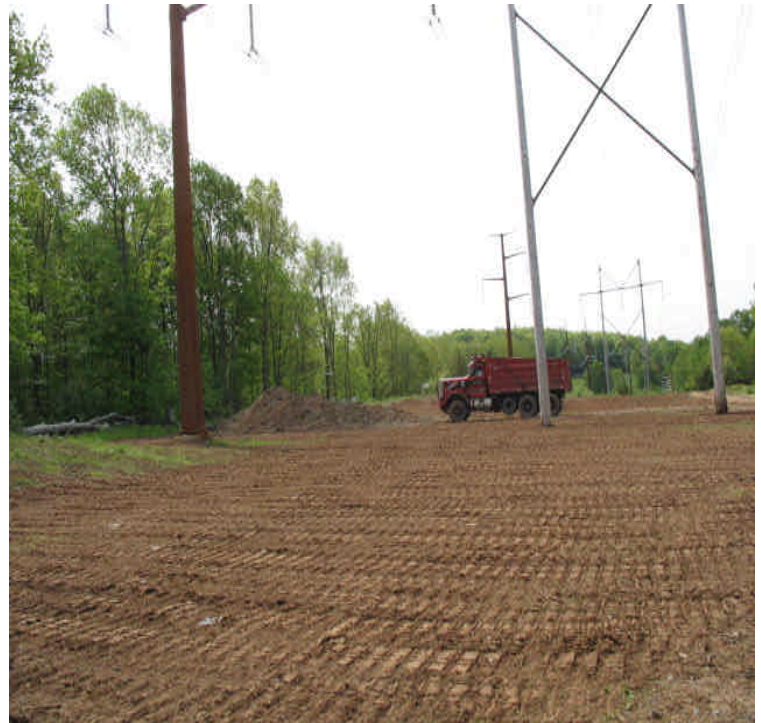
**Durham Rd: Final grading/restoration was underway.**

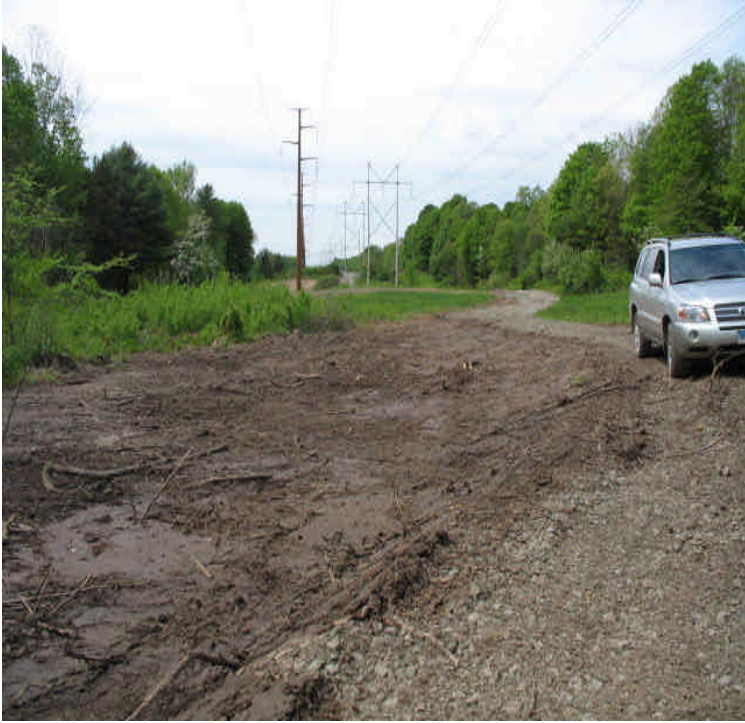
**Liney Hall Ln: Timber mats removed from the wetlands. Minor amounts of stone remain in the wetlands and should be removed by hand.**

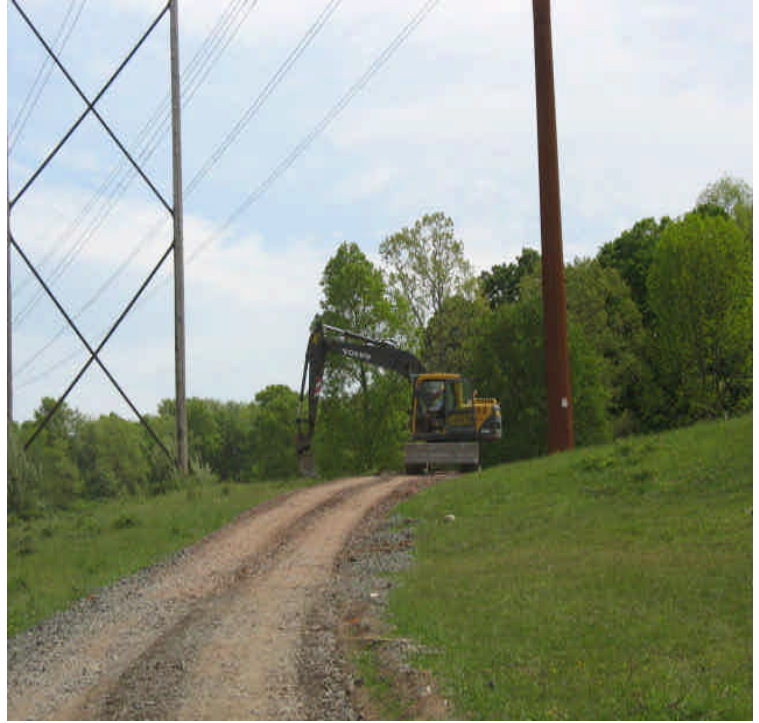
**Liney Hall Ln: Final restoration of pads and access road narrowing were underway.**

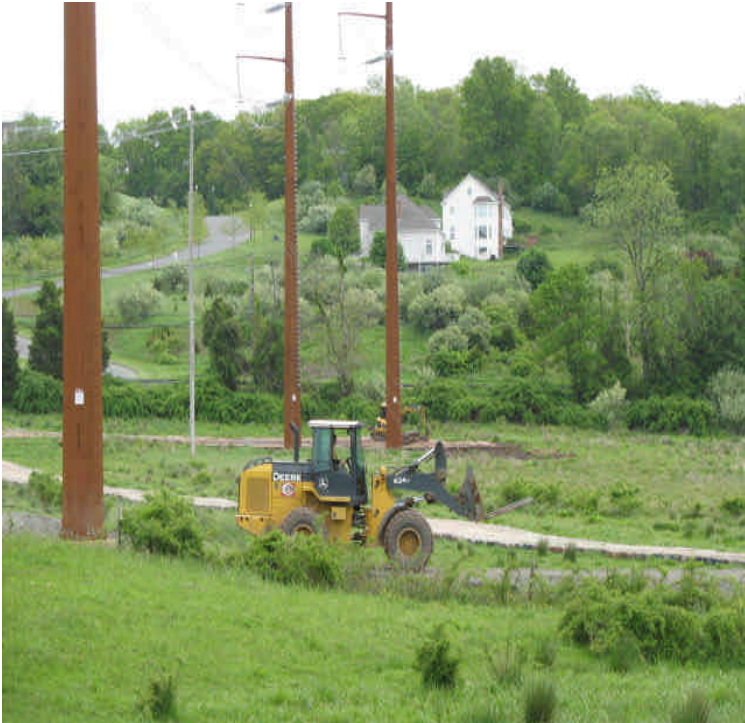
**Tamarack Swamp Rd: Timber mat removal underway within wetlands.**

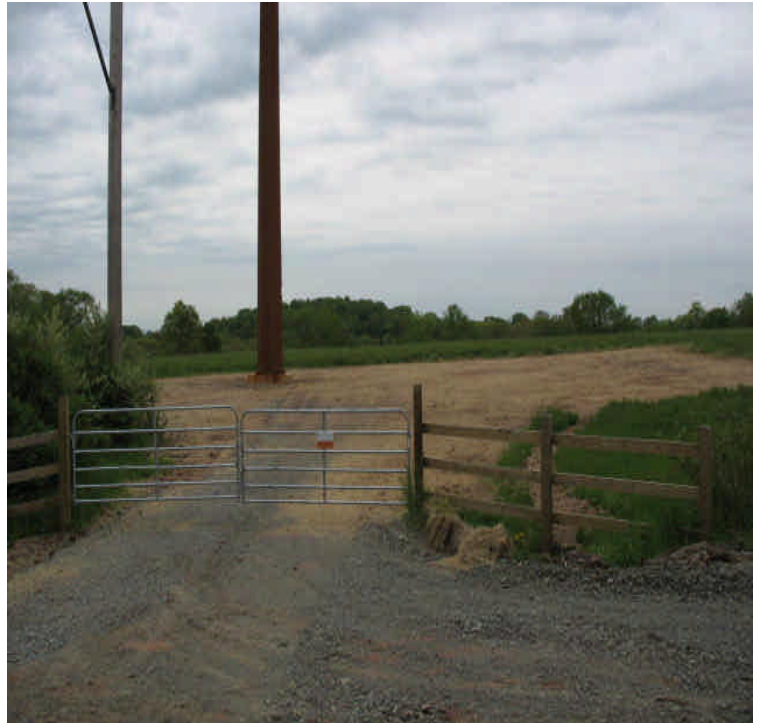
**Tamarack Swamp Rd: Stockpile has been removed and crews had just completed application of mulch and seed.**
