Docket No. 272 – Development and Management Plan Inspection

Segment 2a Inspection

Date: May 28, 2008

Location: Segment 2a – Beseck Switching Station to Cheshire/Hamden Town Line

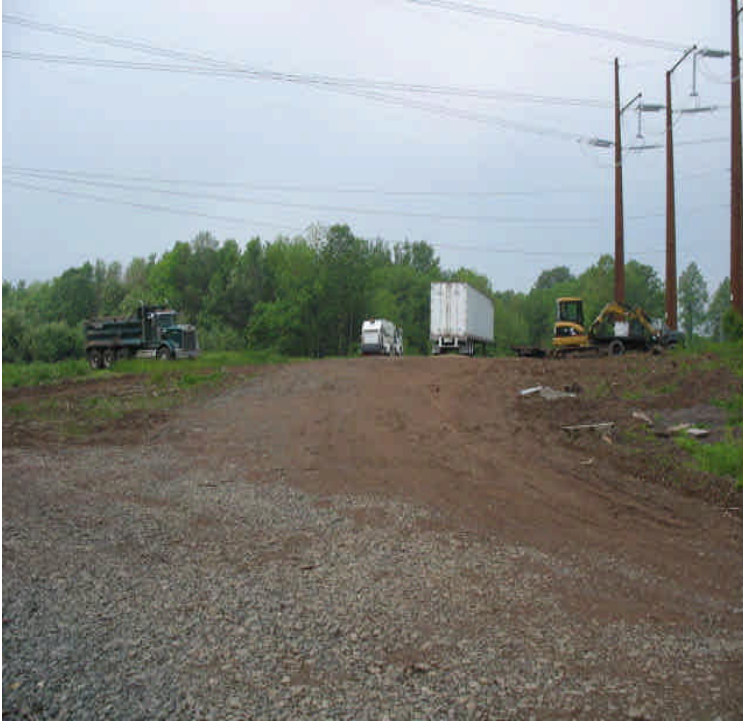
Carpenter Ln: Large area disturbed/exposed from line work. Crews continue to mobilize onsite for reclamation activities. Spill kits were also observed (proactively).

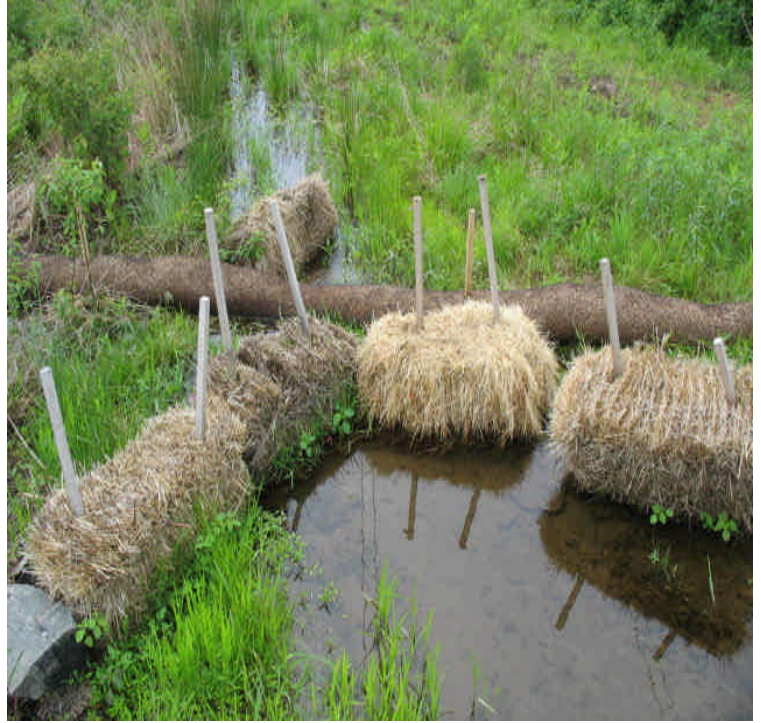
Carpenter Ln: New haybales and silt sock have been installed at the drainage outlet.

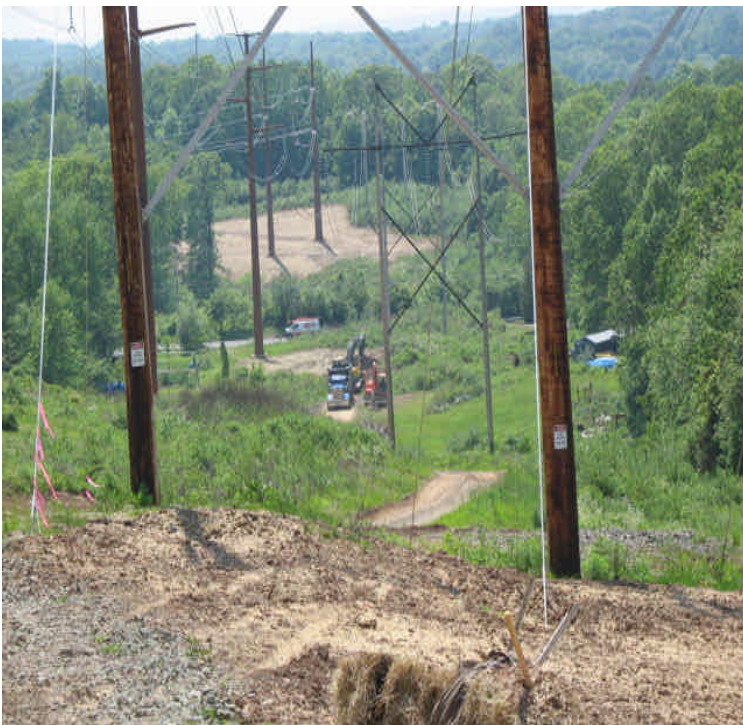
High Hill Rd: Final restoration underway. Removing stone/soils and applying hay and seed. Note the slope north of Durham Rd at final grade and seeded.

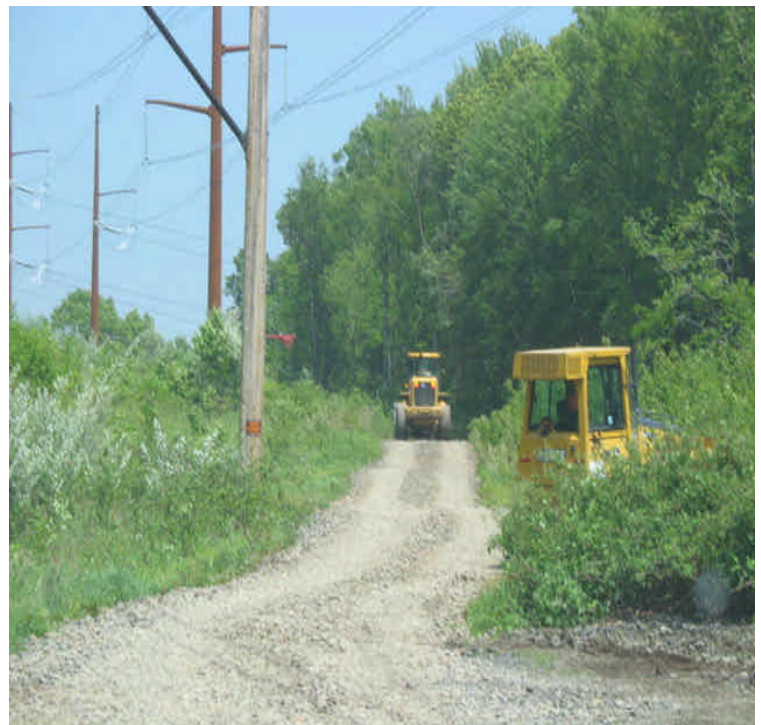
Durham Rd (north): Final grading/restoration was underway.

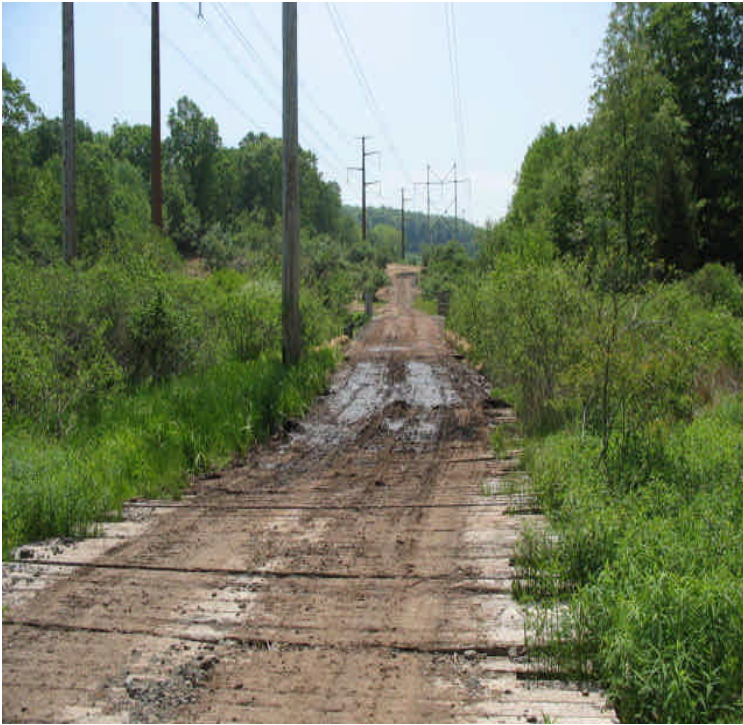
Durham (south): Timber mats and haybales added at flooded crossing. Additional mats and/or controls are needed when active. Sediment needs to be evaluated and removed by hand from the wetlands.

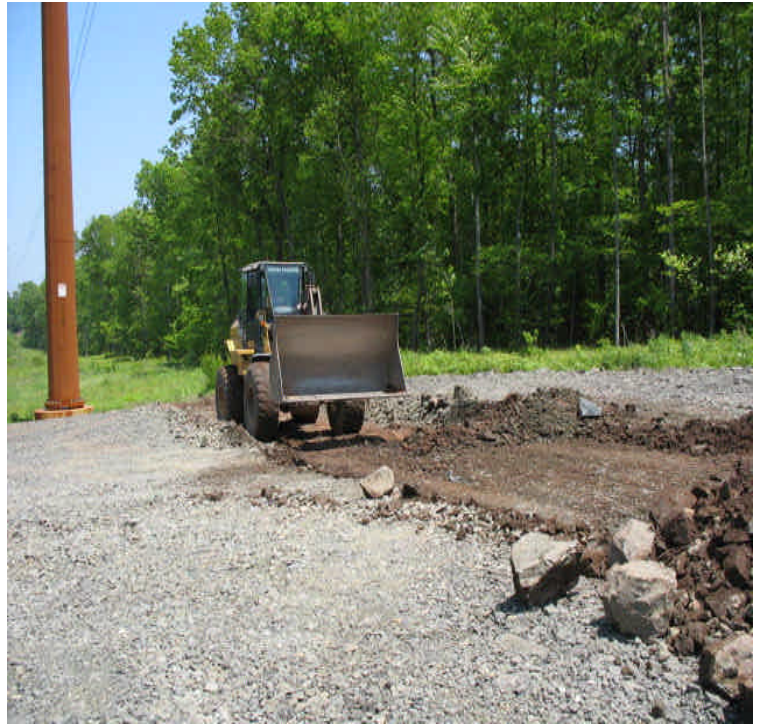
Stony Brook Rd: Final restoration of pads and access road narrowing were underway.

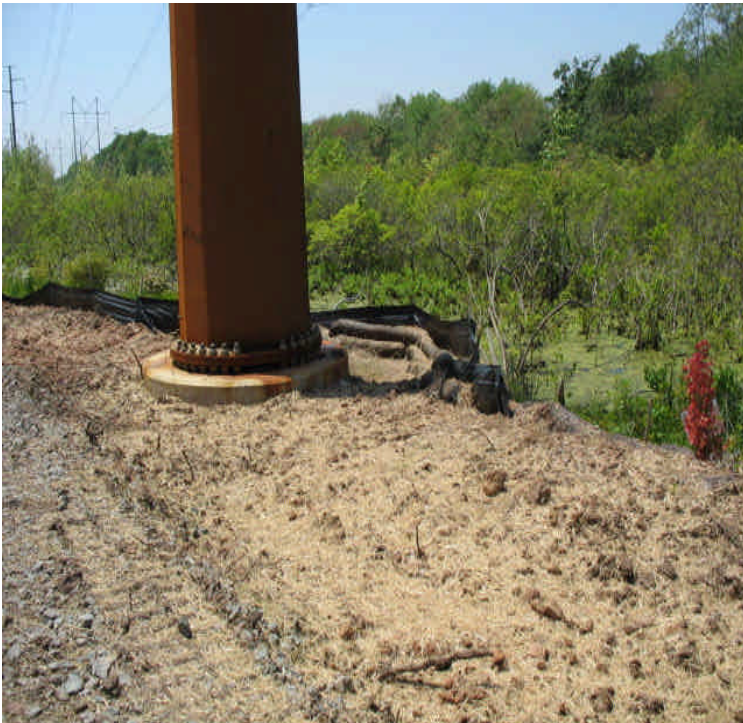
Tamarack Swamp Rd (southwestern side): Final grading is complete. Some sediment removed from the wetlands, hay and seed applied. Silt fence can be removed when vegetative cover has established.

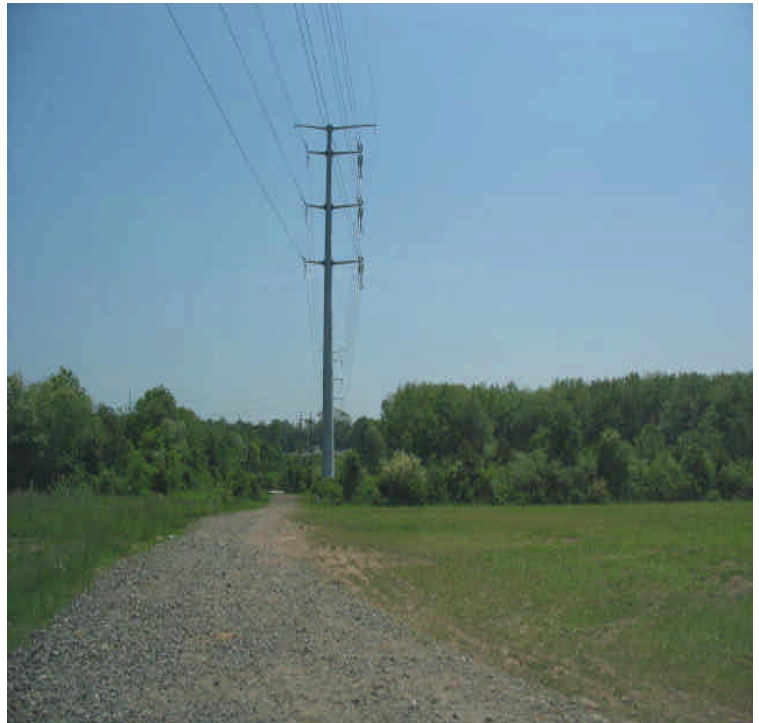
Pond Hill (east): Seed germination noted following final stabilization efforts. The field has returned to its original condition.
