Docket No. 272 – Development and Management Plan Inspection

Segment 2a Inspection

Date: June 3, 2008

Location: Segment 2a – Beseck Switching Station to Cheshire/Hamden Town Line

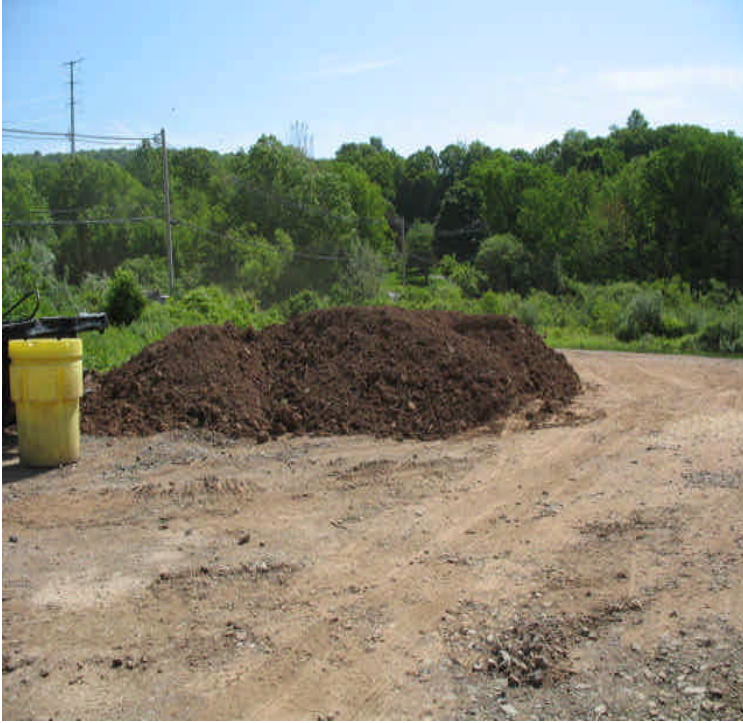
Carpenter Ln: Soil stockpile on site resulting from work within wetlands. Note that a spill control container has been left onsite proactively during restoration activities.

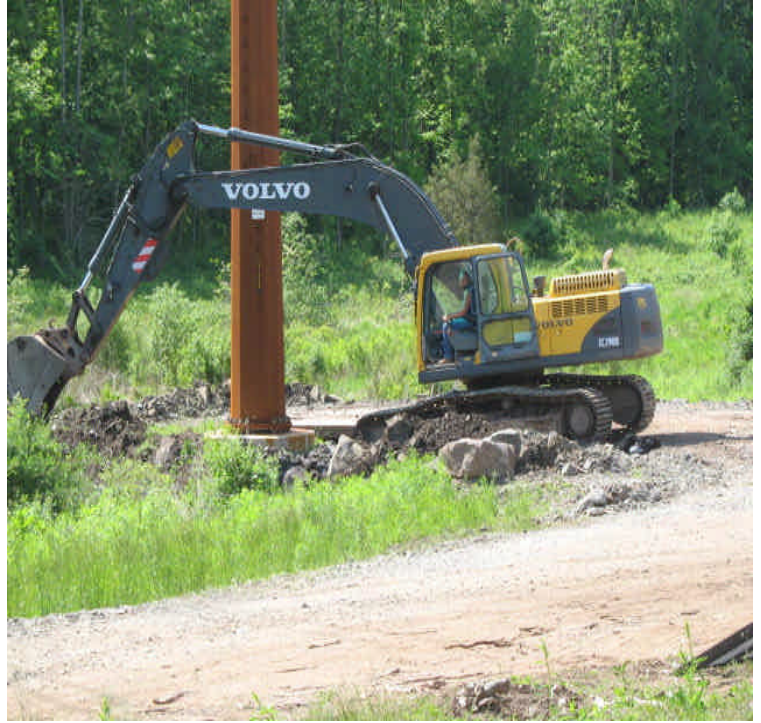
Carpenter Ln: Restoration work is underway within the wetlands. Monitor controls and equipment closely during work.

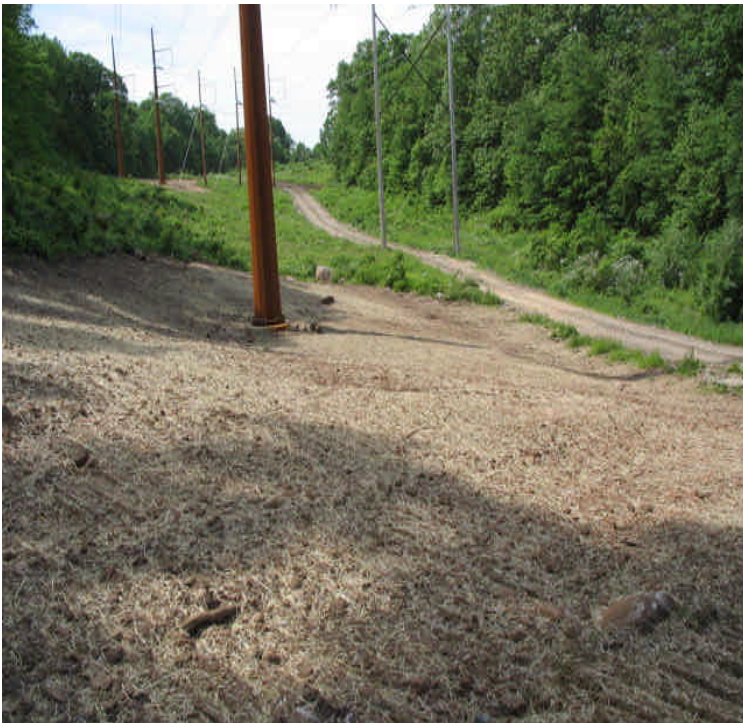
High Hill Rd: Final restoration continues. Crews were removing soils and applying hay and seed.

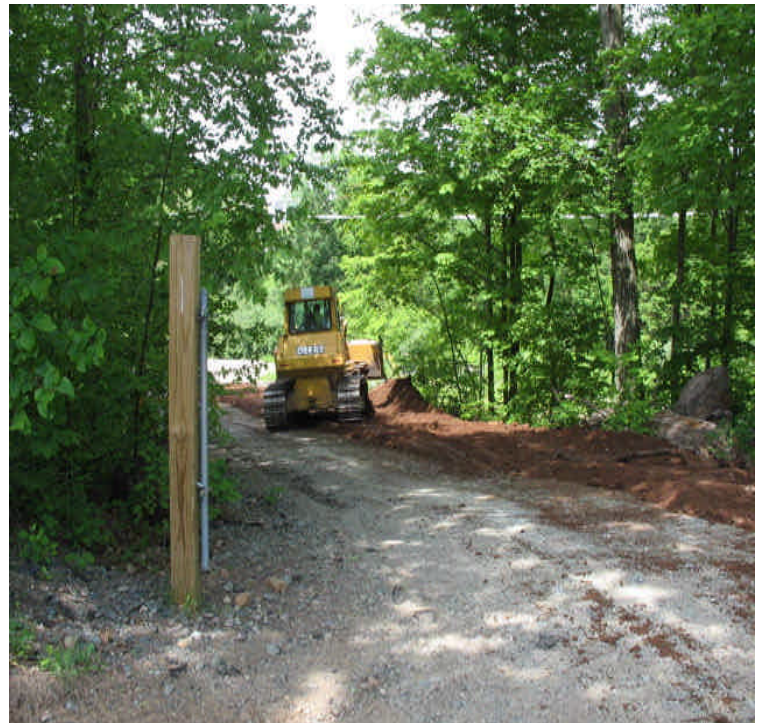
High Hill Rd: Final grading/restoration was underway. Crews were spreading topsoil at the site entrance.

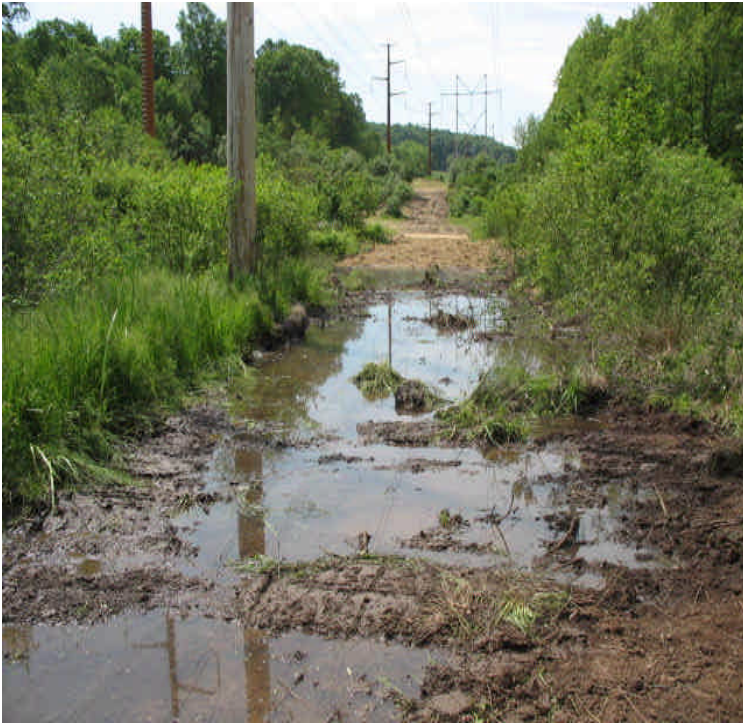
Durham (south): Timber mats and bridge have been removed from the flooded crossing. Monitor and stabilize exposed soils.

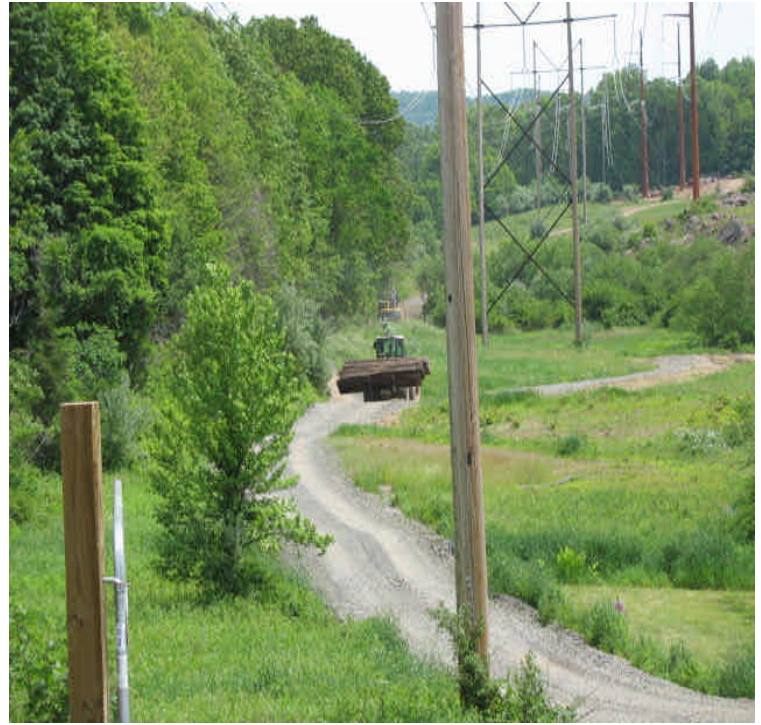
Liney Hall: Timber mat and bridge removal is underway. Restore exposed areas upon completion of work.

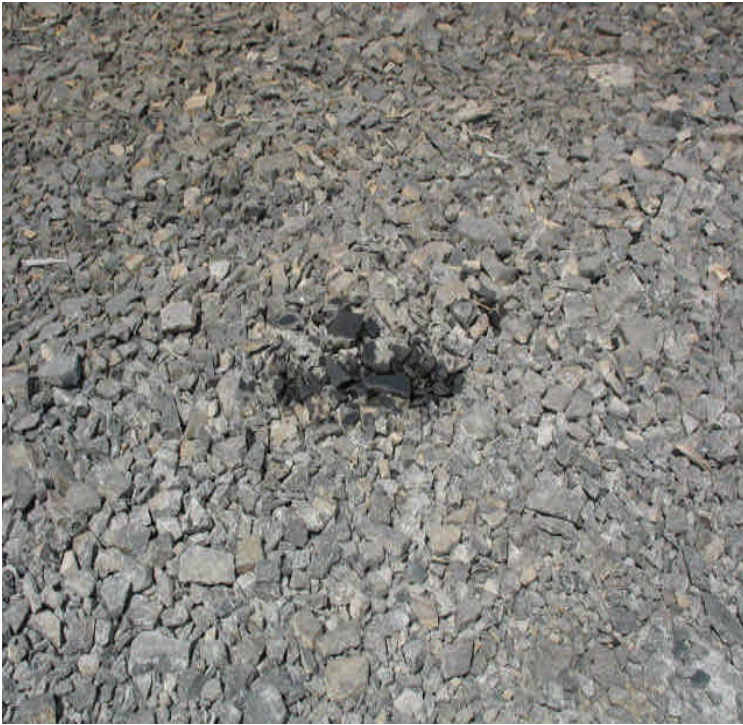
Stony Brook Rd: Hydraulic fluid drips noted at the site entrance. Crews were working to check and repair the leaking equipment.

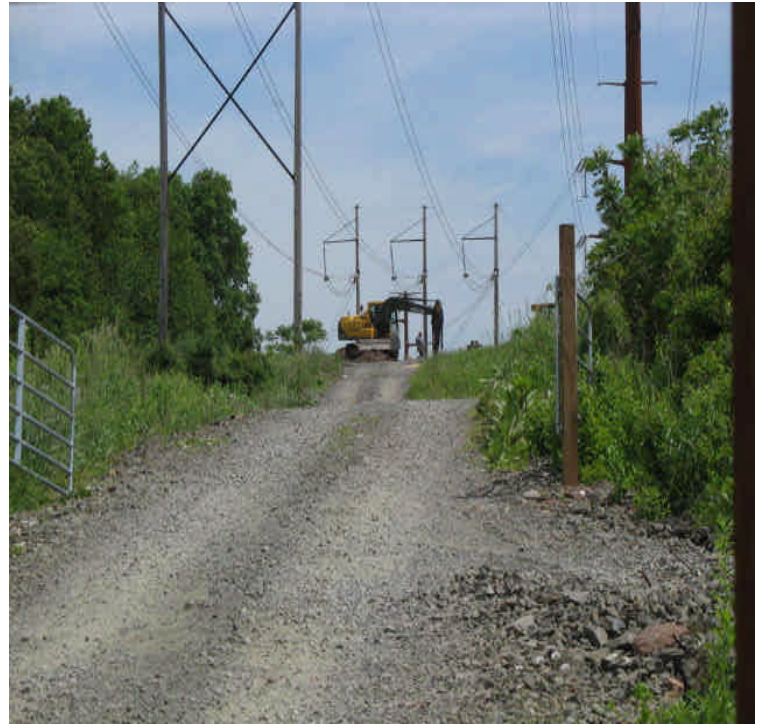
Stony Brook Rd: Final restoration continues.
