Docket No. 272 – Development and Management Plan Inspection

Segment 2a Inspection

Date: July 1, 2008

Location: Segment 2a – Beseck Switching Station to Cheshire/Hamden Town Line

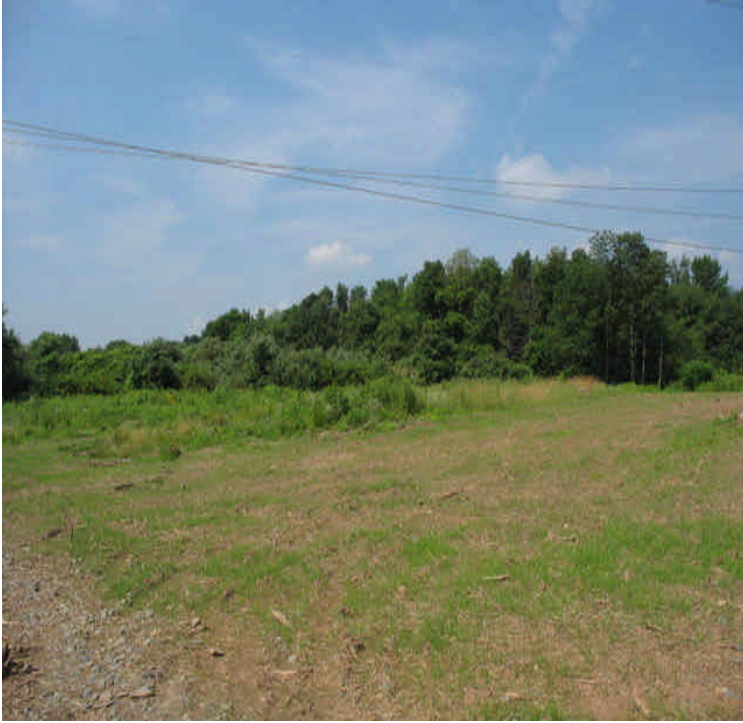
Carpenter Ln: Soil stockpiles were removed and the disturbed area has been graded and seeded. Some grass growth was noted.

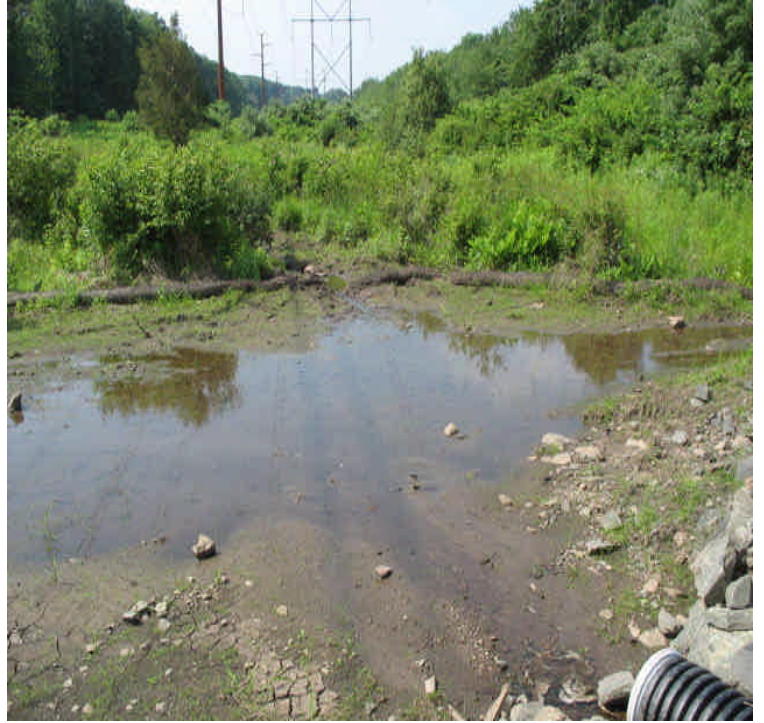
Carpenter Ln: Restoration work is complete within the wetlands. Minor seeding will be done when water subsides. Impacts were reduced from original permitted numbers and narrowed to a spur road.

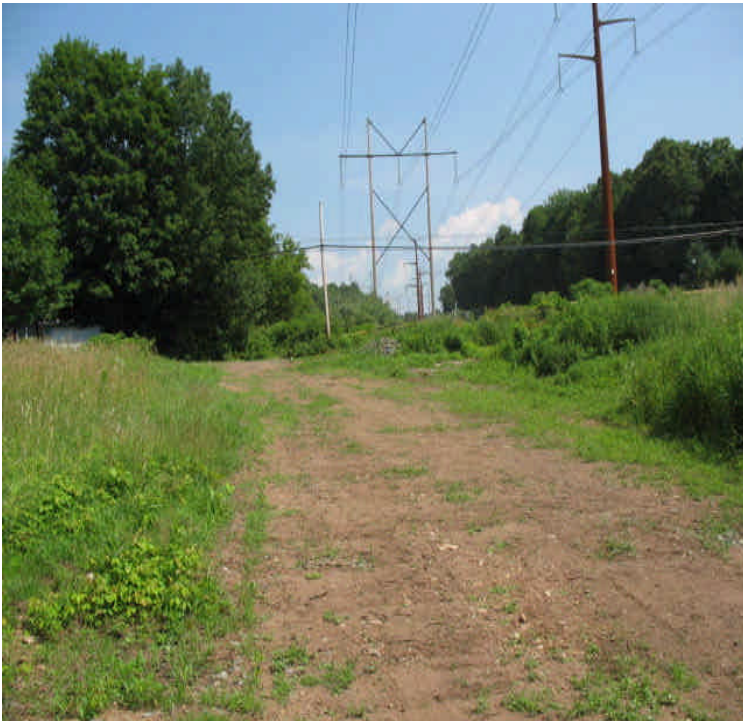
Durham Rd (South): Exposed access road sloping toward the wetlands. Needs minor controls to prevent run-off from entering the wetlands.

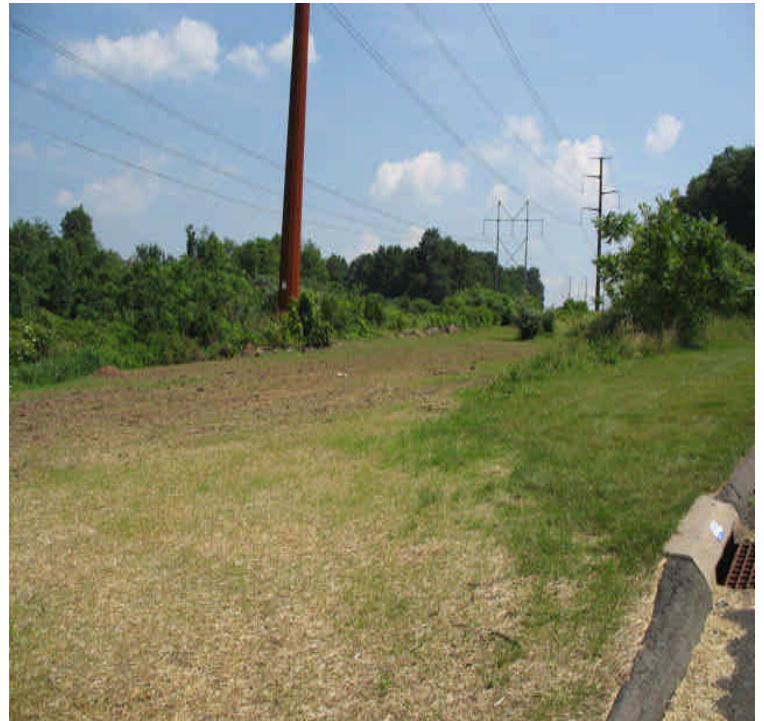
Stony Brook: Final grading/restoration complete. Topsoil, hay and seed have been spread.

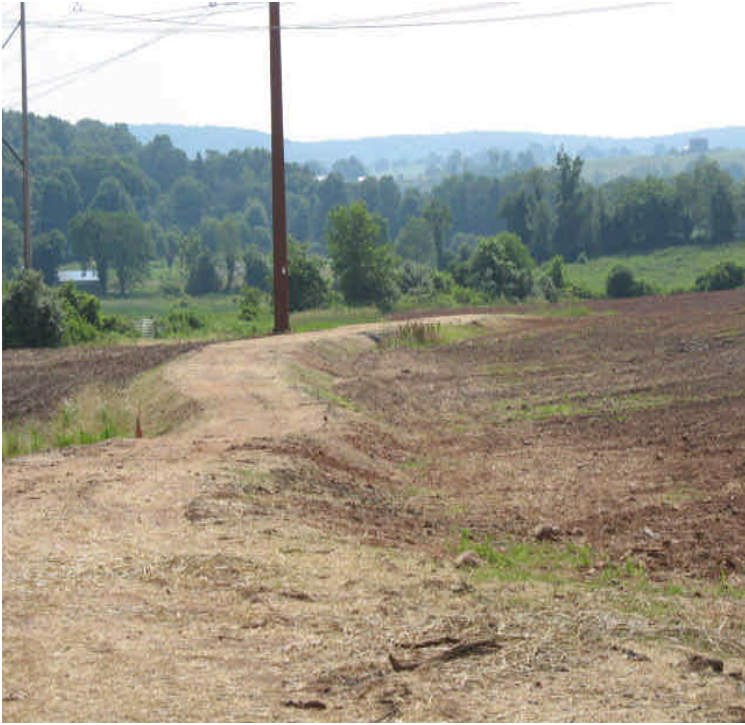
Tamarack Swamp: Access road pads narrowed and graded.

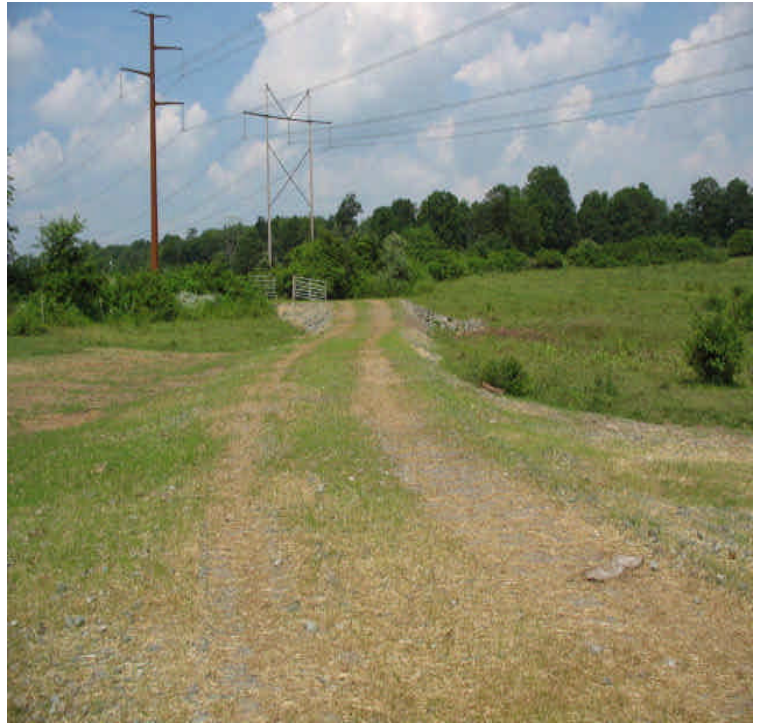
Tamarack Swamp Rd: Final restoration complete. Some grass growth noted.

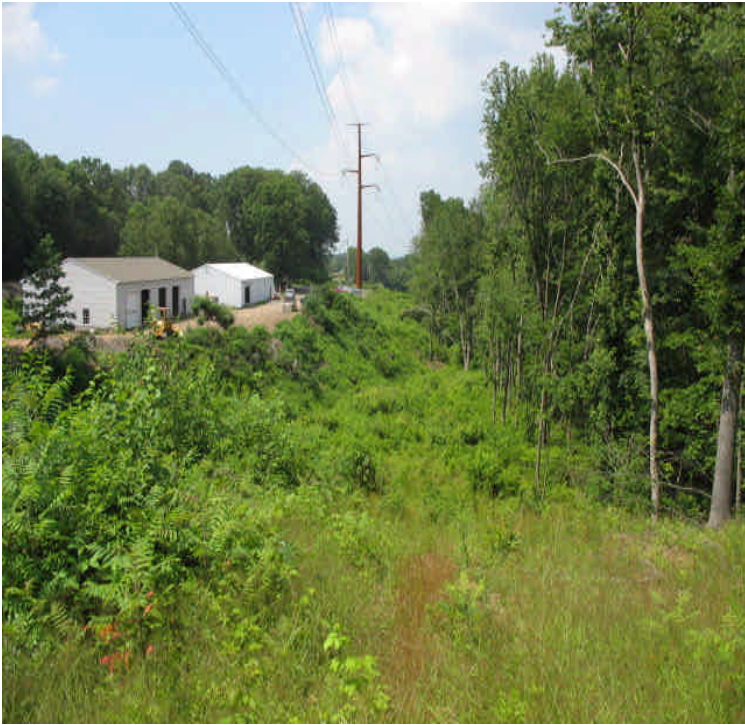
Woodhouse Rd: ROW no access crossing looking toward Harrison Rd. This area is vegetated and stable. Shrubs are starting to shade the brook.

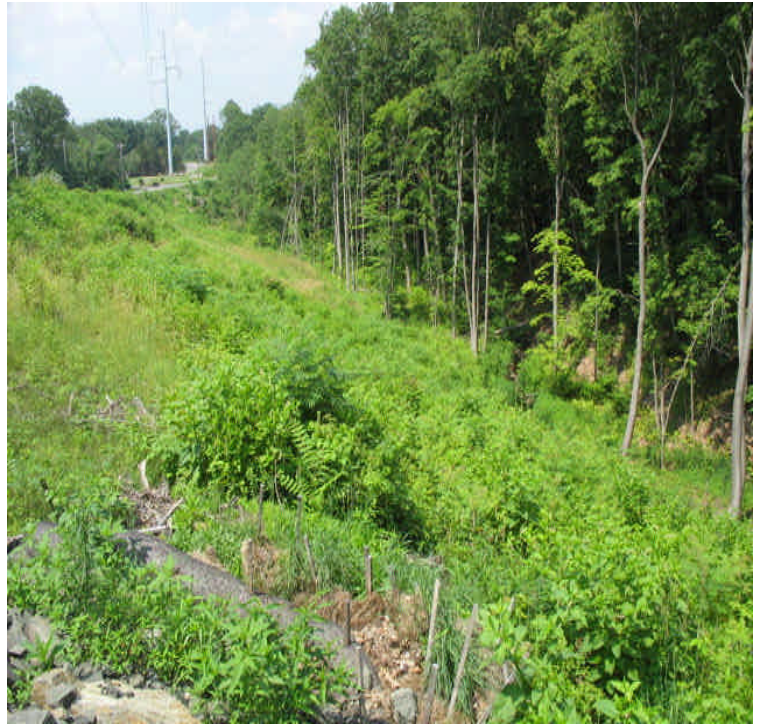
Harrison Rd: Re-vegetation continuing along the ROW from Woodhouse Rd. This steep slope is also stable.
