Docket No. 272 – Development and Management Plan Inspection

Segment 2a Inspection

Date: July 8, 2008

Location: Segment 2a – Beseck Switching Station to Cheshire/Hamden Town Line

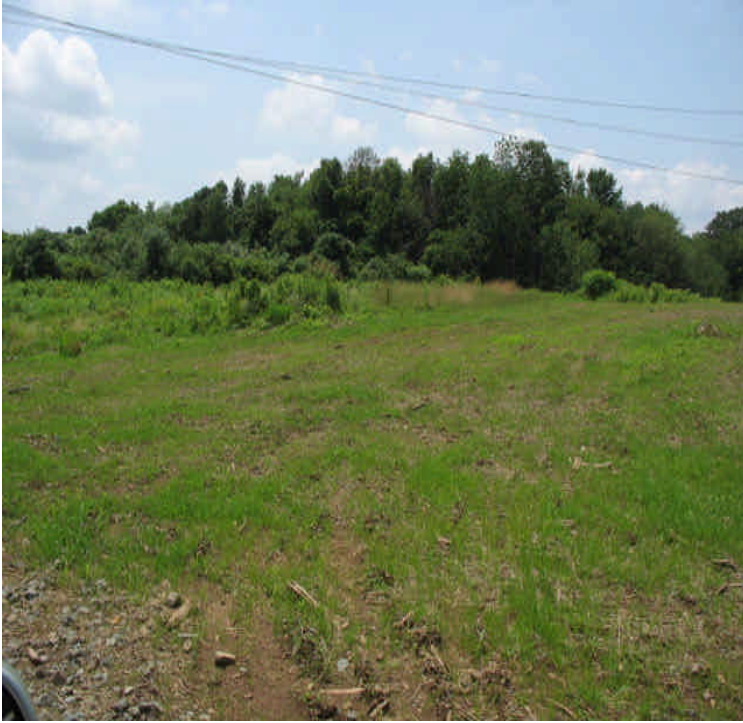
Carpenter Ln: Soil stockpiles were removed and the disturbed area remain graded and seeded. Some grass growth was noted.

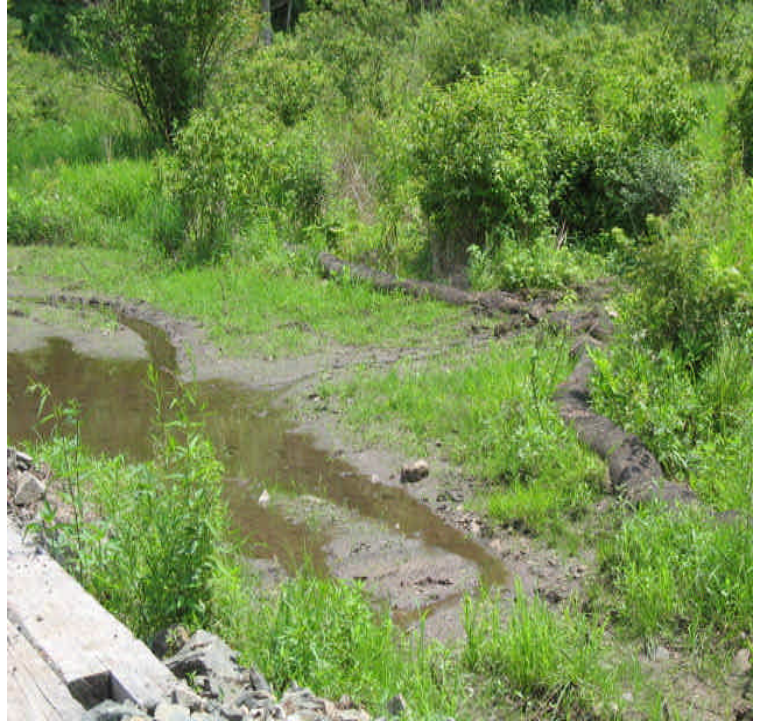
Carpenter Ln: Restoration work is complete within the wetlands. Minor seeding will be done when water subsides. Impacts were reduced from original permitted numbers and narrowed to a spur road.

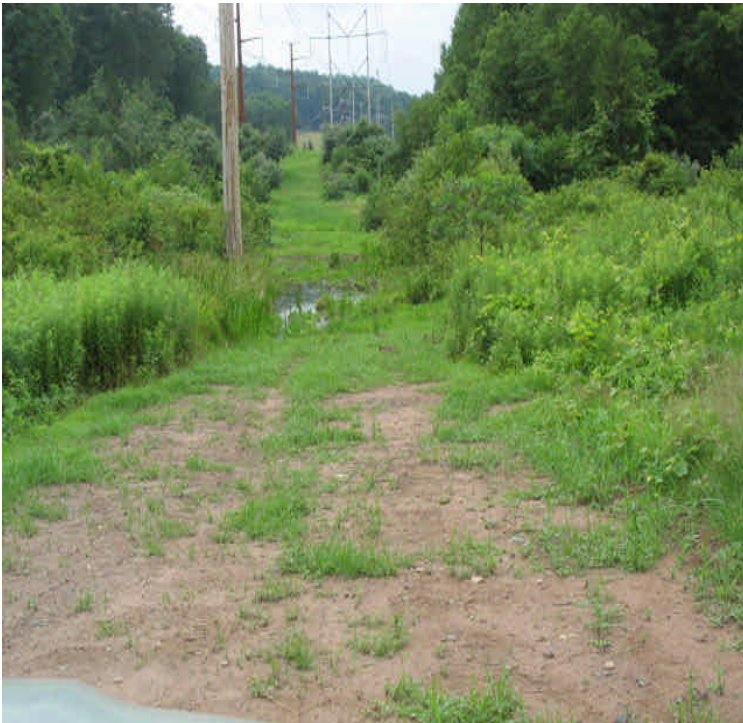
Durham Rd (South): Exposed access road sloping toward the wetlands. Needs minor controls to prevent run-off from entering the wetlands. The noted increase in vegetation will help filter run-off.

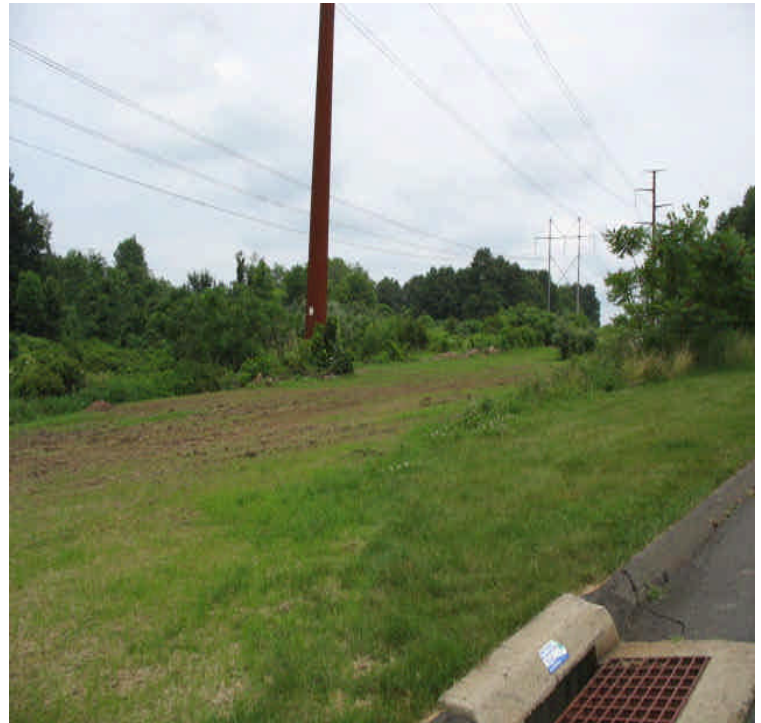
Stony Brook: Final grading/restoration complete. Topsoil, hay and seed remain in place.

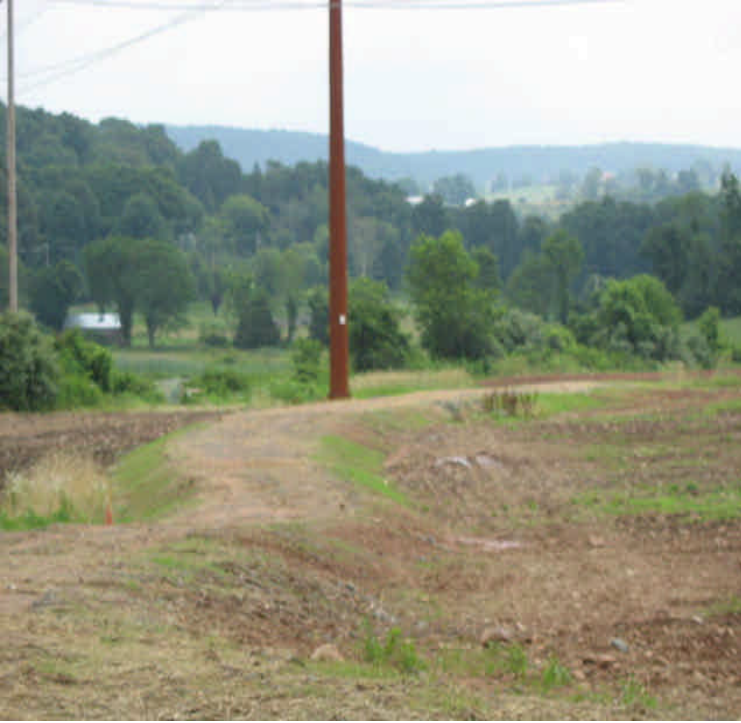
Tamarack Swamp Rd: Access road pads narrowed and graded.

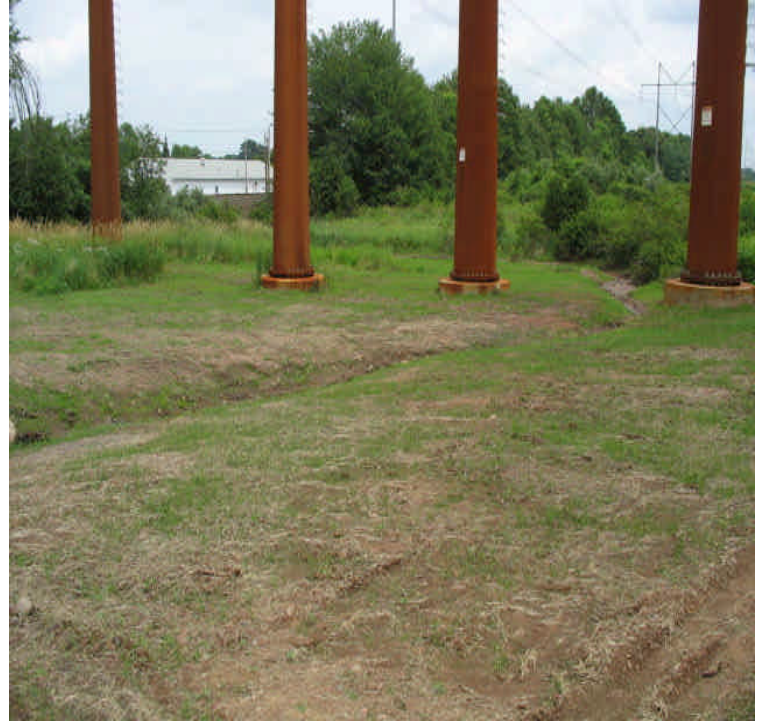
Powers Rd: Final restoration complete. Some grass growth noted. Additional seed may be needed along the banks if vegetation remains sparse.

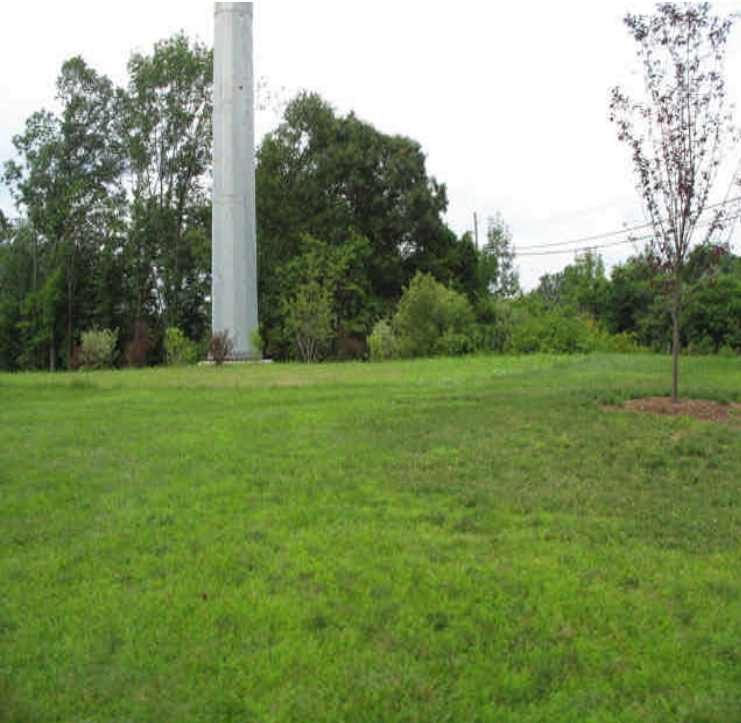
Harrison Rd: View of plantings around the structure located at the golf course entrance.

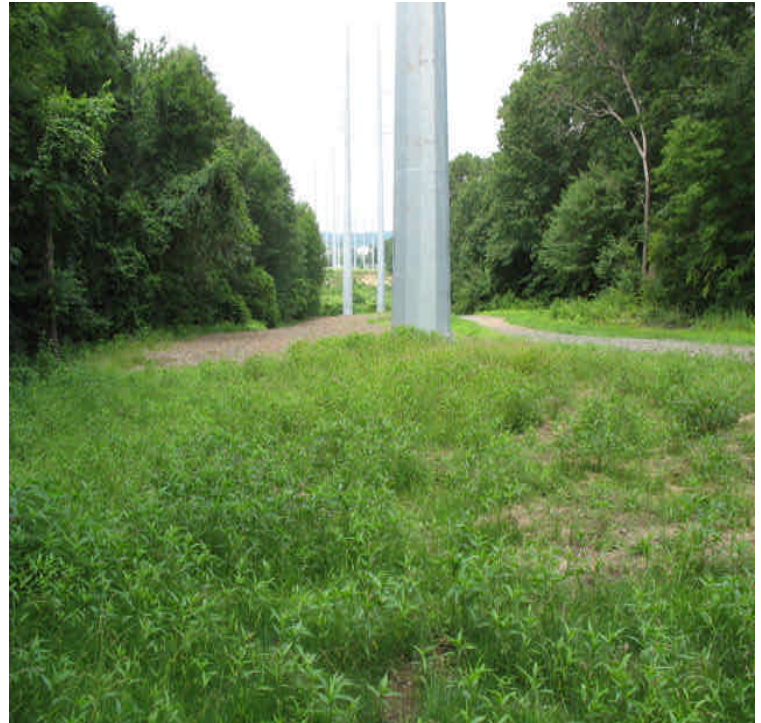
Blue Hills Orchard & Mansion Rd	A layer of heavy bark mulch has been applied along the slopes off Docker to stop the erosion/gully issues. The mulch is holding up well to ATV traffic. Adjacent areas are re-vegetating due to reduced ATV traffic. 7/8/08	Continue to maintain controls and monitor the effectiveness against the ATV traffic. ATV traffic will be difficult to control as they are accessing from abutting land and have always disturbed this area. 7/8/08	Heavy bark mulch is holding up and adjacent areas are re-vegetating.
Old Farms Rd.	Restoration complete through the orchard and Mansion. Hay and seed have been spread on exposed areas. 7/8/08	Monitor exposed area until stabilization is achieved. 7/8/08	Restoration complete.
	A drainage swale is in place (since 1/16) to prevent turbid run-off from the saturated driveway crossing however, run-off was noted during heavy rains when active. 7/8/08	Continue to stabilize disturbed areas to the extent feasible and ensure the area is contained by controls, including CB liners, as needed to filter run-off. Additional controls should be used in the drainage areas. 7/8/08	Continue to evaluate and stabilize. Area needs additional attention when active, in periods of heavy rain.

Docker Dr: Vegetation was establishing due to reduced ATV use. Bark mulch along the slope is holding up well.
