**Docket No. 272 – Development and Management Plan Inspection**

**Segment 2a Inspection**

**Date:** August 19, 2008

**Location:** Segment 2a – Beseck Switching Station to Cheshire/Hamden Town Line

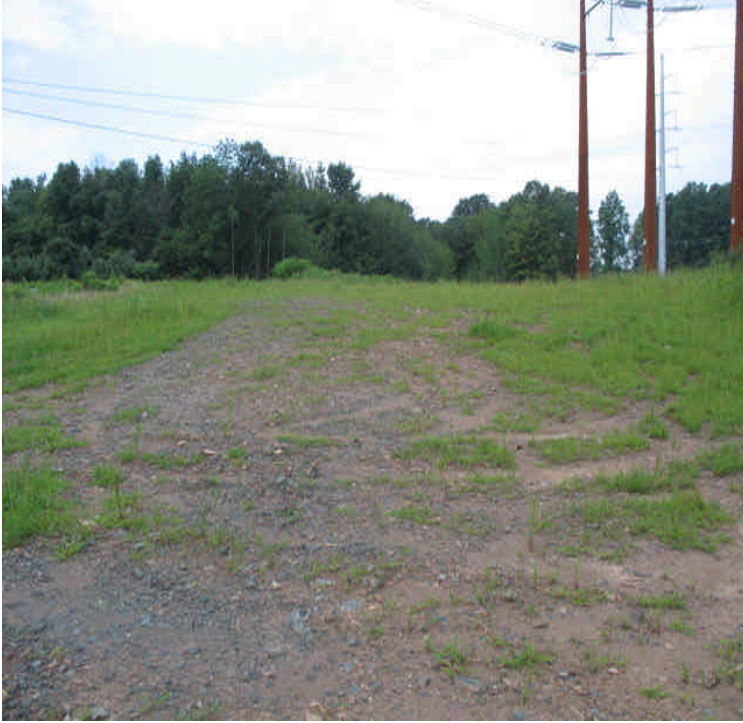
**Carpenter Ln:** The disturbed area remains graded and seeded but vegetative growth is still fairly sparse. Additional seed may be needed during more favorable conditions.

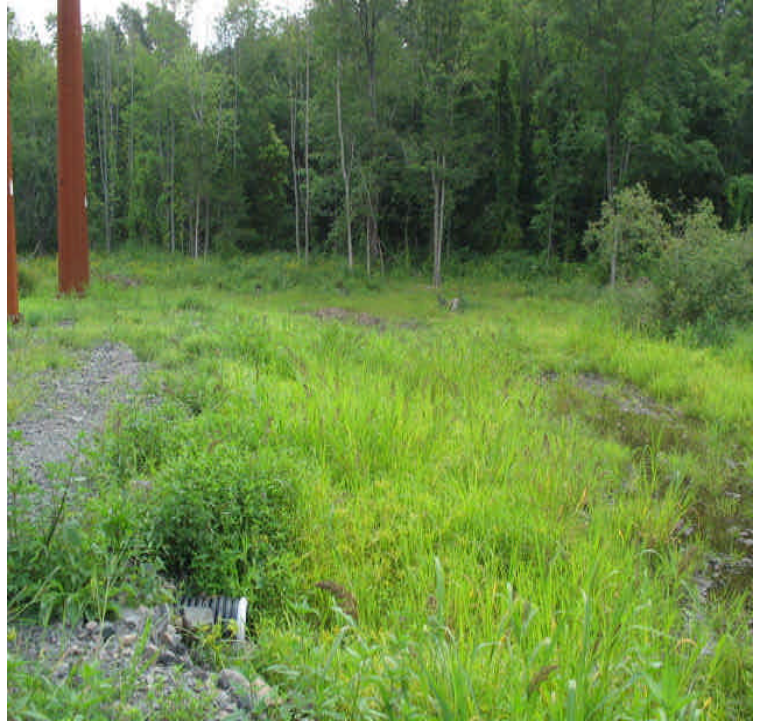
**Carpenter Ln:** Restoration work is complete within the wetlands. Areas were stabilizing with vegetative cover consisting mainly of native wetland species.

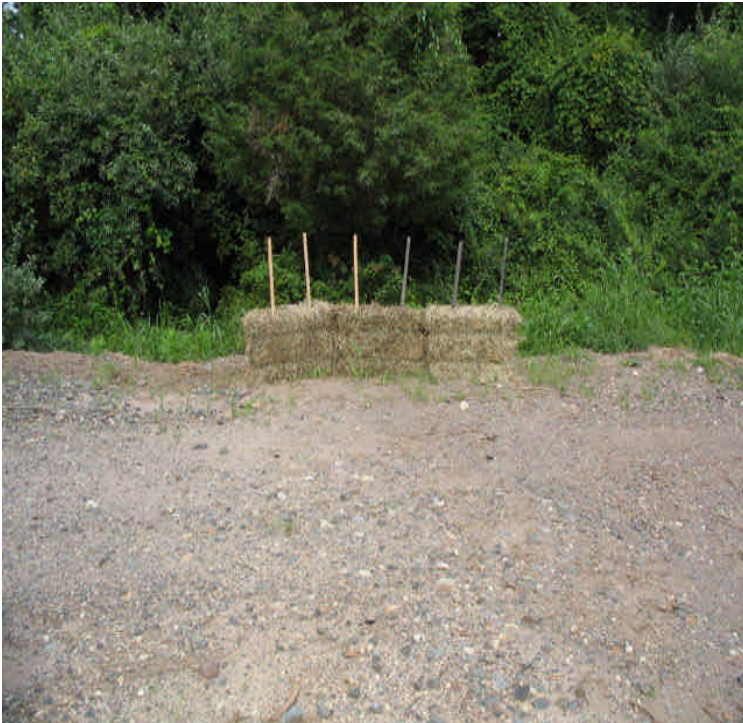
**High Hill Rd:** New haybales were installed to filter stormwater run-off from the access road.

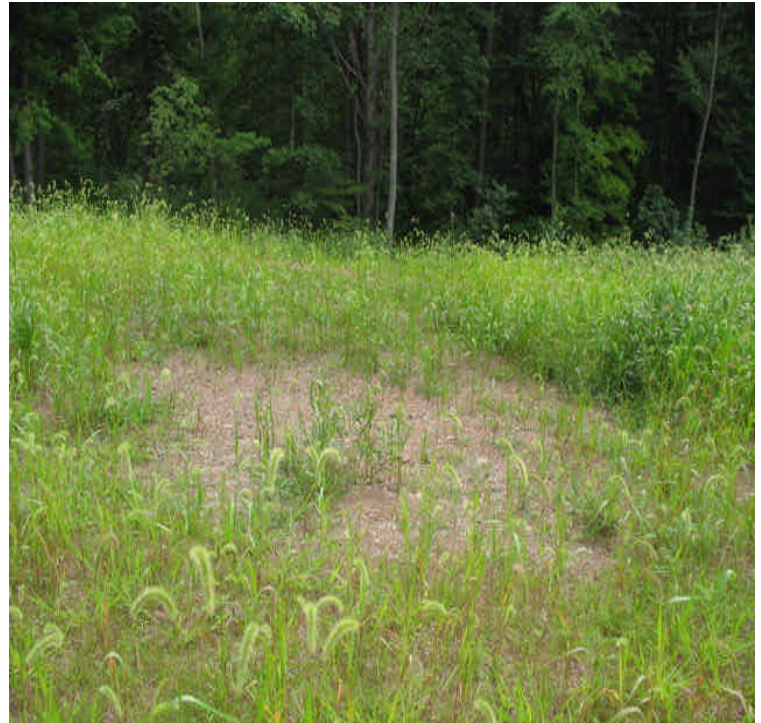
**Durham Rd (North):** Small sparsely vegetated areas located at the last structure. It will be evaluated if there is 70% cover overall.

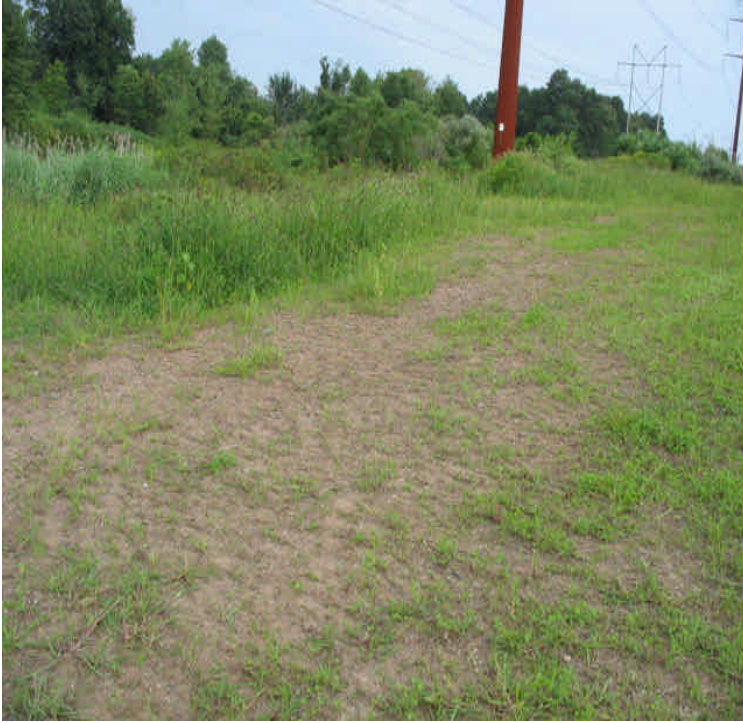
**Stony Brook Rd: Sparse area of vegetation located at the site entrance.**

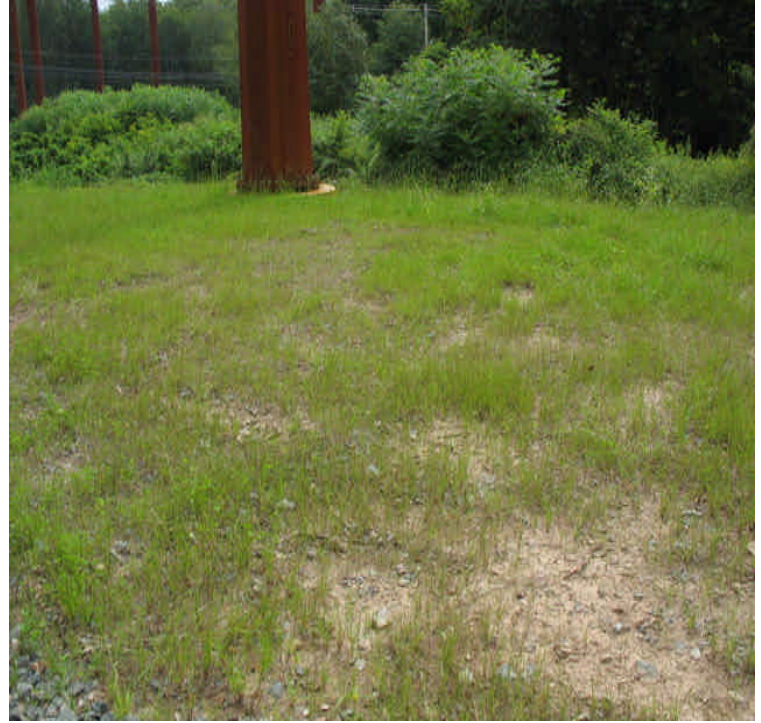
**Woodhouse Rd: Sparse vegetative cover noted near the site entrance. It will be evaluated if there is 70% cover overall.**

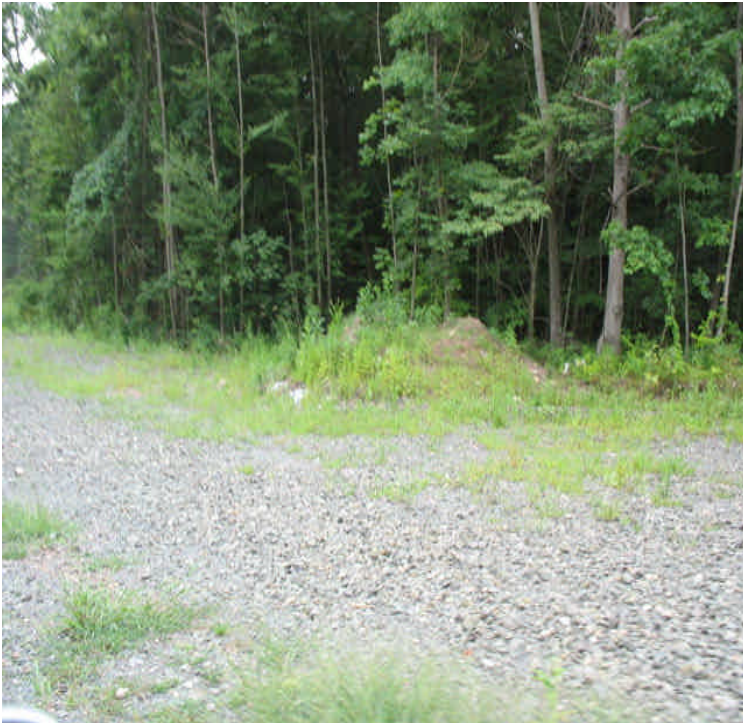
<b>Areas of Inspection</b>	<b>Observation</b>	<b>Recommended Action</b>	<b>Corrected Action</b>
	<b>stockpiles of soil/stone are associated with most pads along the ROW section off Tuttle Ave. 8/19/08</b>	<b>the landowner requested that materials remain. Evaluate whether additional reclamation can occur. 8/19/08</b>	
<b>Additional Observations</b>	<b>None 8/19/08</b>	<b>None</b>

**Tuttle Ave: One of several small stockpiles left behind at a pad. Stockpiles are relatively vegetated and stable. BSC was informed that the landowner requested that the material remain in place.**

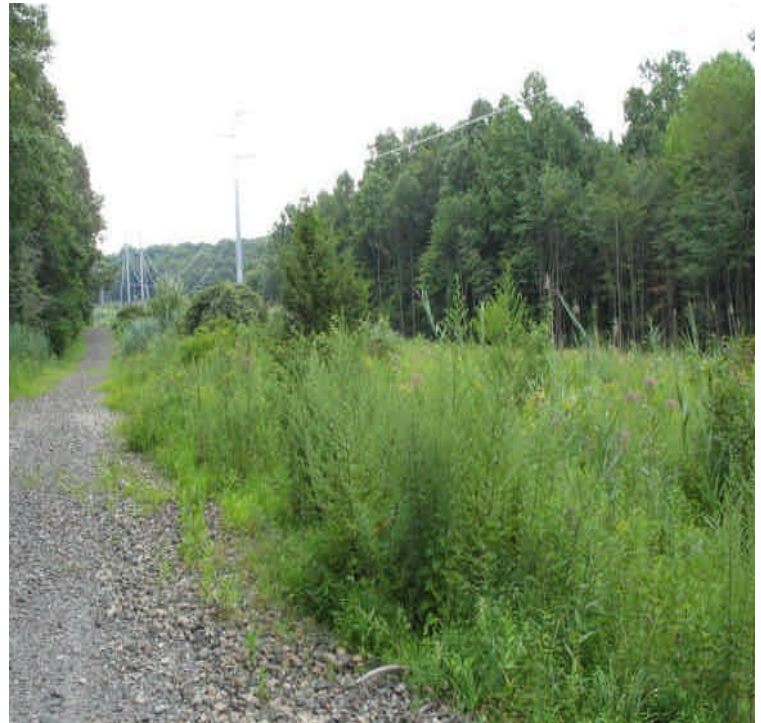
**Tuttle Ave: Vegetation has stabilized the wetland adjacent to the crossing.**
