Docket No. 272 – Development and Management Plan Inspection

Segment 2b Inspection

Date: January 4, 2008

Location: Segment 2b – Cheshire/Hamden Town Line to East Devon Substation

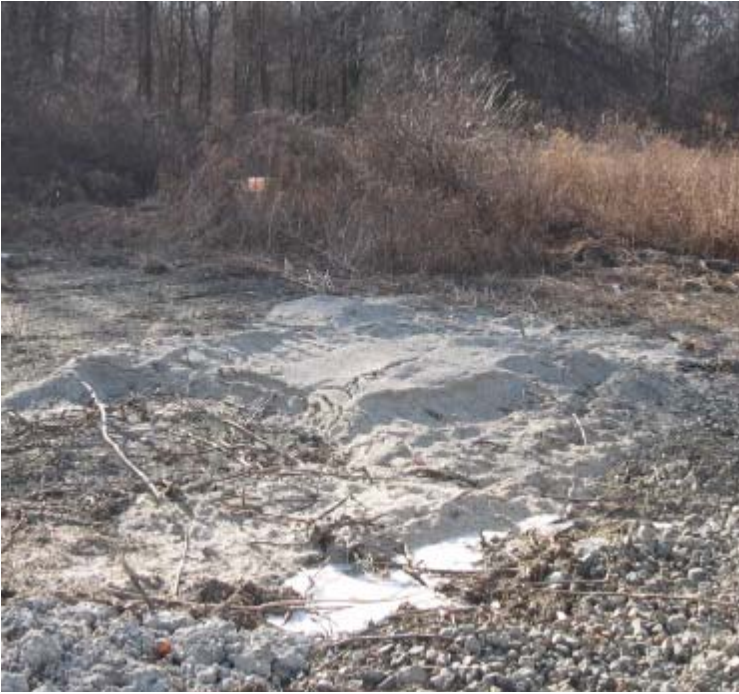
West River St (Milford): Sand used for foundation installation has been piled in a wetland area with no plastic liner above or beneath.

Areas of Inspection	Observation	Recommended Action	Corrected Action
121 and Oronoque Rd	wetlands in these sections. 1/4/08	1/4/08	
West River Street and Eisenhower Park	A stone access road remains within the wetland accessed from West River Street. Timber mat crane pads remain within the wetland areas in these sections. 1/4/08	Continue to monitor and add controls as necessary. 1/4/08	NA at this time
	Excess sediment from foundation drilling was observed on wetland timbermats in the ROW off West River St. 1/4/08	Remove sediment from wetland area. See EC Section. 1/4/08	Needs attention
	Equipment ruts were observed in the wetland near structure #24023. 112/14-1/4/08	Fill and stabilize ruts with appropriate material. 1/4/08	Needs attention
	Sand, used for foundation installation, is being stored in wetland areas near structures #24025 and #24023. 1/4/08	Sand should not be piled/stored in wetlands and should be contained in bins or placed on a plastic liner in an upland area. 1/4/08	Needs attention

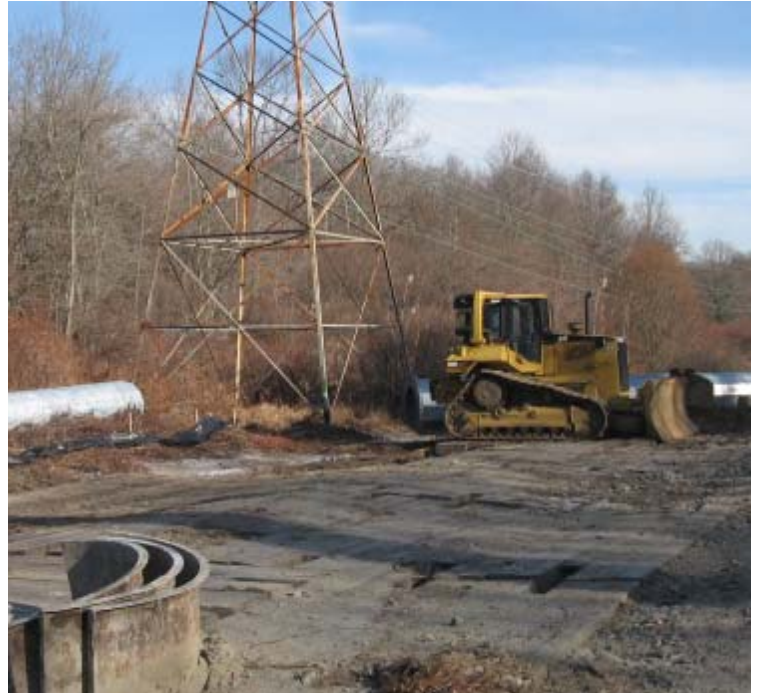
West River St: Equipment remains parked on a crane pad in a wetland area here.

Areas of Inspection	Observation	Recommended Action	Corrected Action
Eisenhower Park and West River Street Orange, CT Woodbridge, Bethany, and Hamden CT Rimmon Rd/B'Nai	Frac tanks are in place for dewatering in these sections. 1/4/08 Dewatering basins remain for 345kV foundation work. 1/4/08 A dewatering basin was constructed from a spoil pile near structure #24108 in Woodbridge. No erosion controls were installed around the perimeter. 1/4/08	Continue to monitor. 1/4/08 Continue to monitor. 1/4/08 Install the appropriate controls around the perimeter of the dewatering basin. 1/4/08	NA NA Needs attention
Blasting	No blasting is proposed at this time. 1/4/08	None. 1/4/08	NA
Spills, soils and material storage. Milford/ Orange, CT West River St Wheelers Farm Rd, West River St, Eisenhower Park and Rimmon Rd	Contractor receiving yard is set up near Shelland St. in Milford. See segment 3 report. 1/4/08 A small diesel fuel spill was observed on the timbermat pad near proposed structure #24023. 1/4/08 Equipment such as drill rigs, a crane, boom trucks, a dozer, and a generator, was observed parked on timbermats in wetlands and/or within 100 feet from wetlands in these areas. 12/14-1/4/08	In general, store materials and equipment appropriately. Ensure that vehicles are equipped with spill kits. All construction vehicles should be parked at least 100 feet from a wetland or waterbody when feasible. 1/4/08 Remove the affected timbermats and store/clean them appropriately. In general, proactively check equipment for leaks and use spill control materials when performing maintenance during refueling. 1/4/08 In general, all construction vehicles should be parked at least 100 feet from a wetland or waterbody when feasible. Monitor for leaks and remove equipment from wetland areas as soon as possible. 1/4/08	NA Needs attention Needs attention

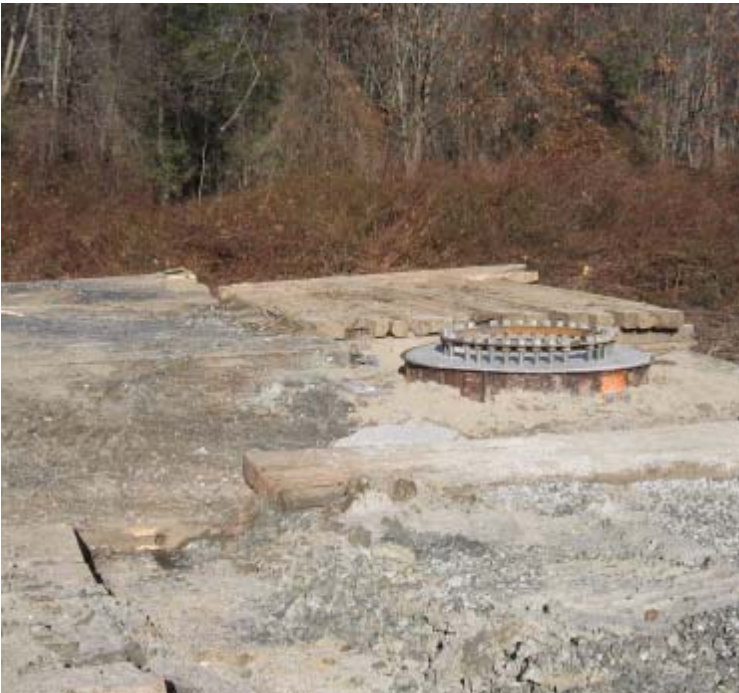
Eisenhower Park (Milford): Foundation installation is complete at structure #24026. Excess sediment remains on the crane pad and controls need to be installed around the perimeter of the pad.

Areas of Inspection	Observation	Recommended Action	Corrected Action
Eisenhower Park	Erosion controls are needed along the perimeter of the timbermat crane pad at proposed structure #24026. 1/4/08	Install the appropriate erosion controls along the perimeter of the timbermat pad. 1/4/08	Needs attention
	Silt fence controls are at capacity and in need of repair at structure #24027. 1/4/08	Repair/add controls as necessary. Remove excess sediment to restore capacity/function of controls. 1/4/08	Needs attention
Woodbridge, CT Glen Dam Reservoir	Exposed soils remain on the slope adjacent to structure #3950. 8/24-1/4/08	Continue to monitor and stabilize disturbed areas when work is complete and activity will not return within 21 days. Add/maintain controls as necessary. Ensure sufficient stabilization for winter months. 1/4/08	Needs attention when feasible
Pease Rd	The waterbar located at the entrance of the access road is no longer functional. Stormwater has eroded the access road and sediment has migrated onto Pease Road. 12/20-1/4/08	Replace/repair waterbar and add catch basin protection down gradient of the ROW access, on Pease road. 1/4/08	Needs attention

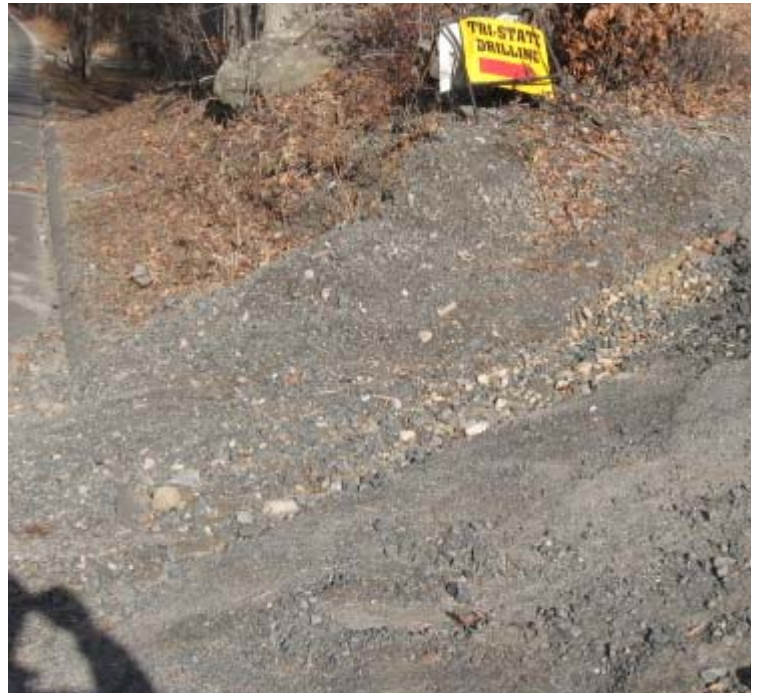
Pease Rd (Woodbridge): Stormwater runoff is eroding the access road here and sediment has migrated onto Pease Road.
