**Docket No. 272 – Development and Management Plan Inspection**

**Segment 2b Inspection**

**Date:** January 10, 2008

**Location:** Segment 2b – Cheshire/Hamden Town Line to East Devon Substation

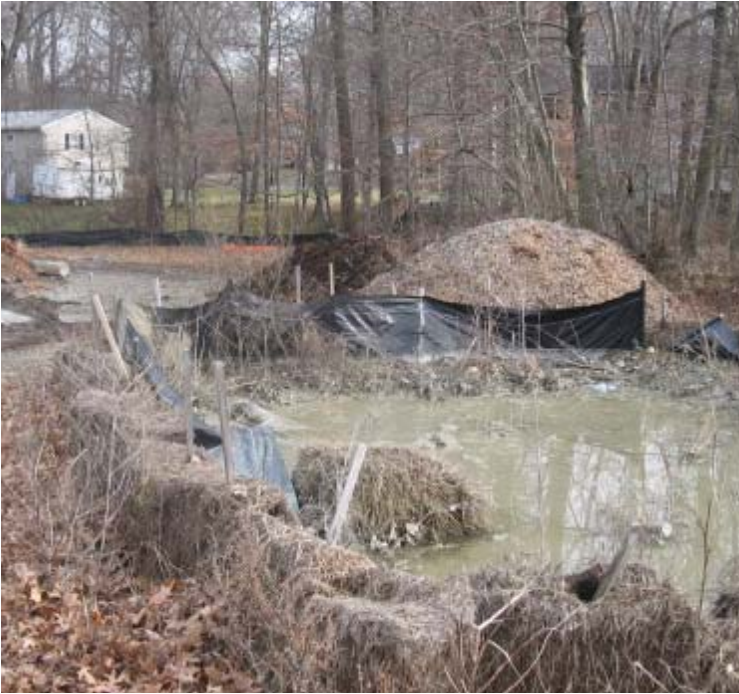
| Areas of Inspection | Observation | Recommended Action | Corrected Action |
|---|--|---|--|
| North St | A leaking dewatering basin was observed near structure #3845. Turbid water from the basin was observed flowing towards a wetland/intermittent stream 1/10/08 | Repair basin and/or add controls as necessary to contain turbid water. 1/10/08 | Needs attention |

North St (Milford): The dewatering basin near structure #3845 was leaking during the inspection and turbid water was observed flowing towards the wetland (located in background of photo).

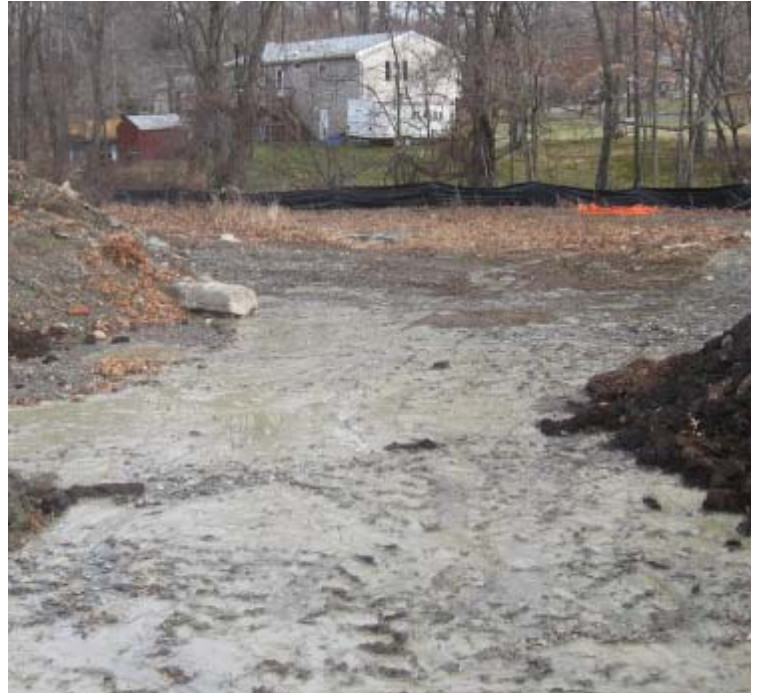
North St: View of the turbid water leaking from the dewatering basin near structure #3845.

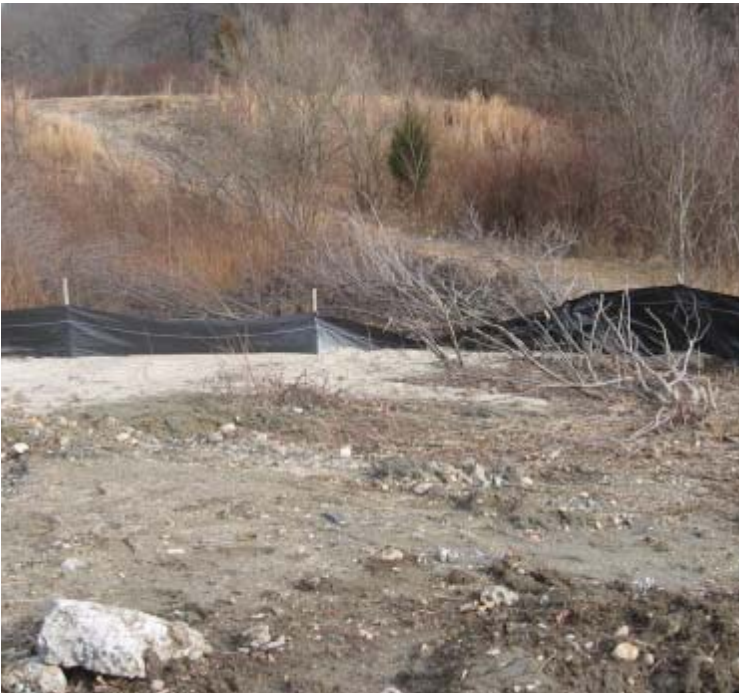
| Areas of Inspection | Observation | Recommended Action | Corrected Action |
|---|--|---|--|
| North St | <p>observed on wetland timbermats in this section. 1/10/08</p> <p>Erosion controls are needed along the perimeter of the timbermat crane pad at proposed structure #24026. 1/10/08</p> <p>Silt fence controls are at capacity and in need of repair at structure #24027. 1/4-1/10/08</p> <p>Excess sediment from foundation drilling was observed on wetland timbermats near structure #24030. 1/10/08</p> | <p>add/maintain controls as necessary. 1/10/08</p> <p>Install the appropriate erosion controls along the perimeter of the timbermat pad. 1/10/08</p> <p>Repair/add controls as necessary. Remove excess sediment to restore capacity/function of controls. 1/10/08</p> <p>Remove excess sediment from mats and add controls as necessary. 1/10/08</p> | <p></p> <p>Needs attention</p> <p>Needs attention</p> <p>Needs attention</p> |

Eisenhower Park (Milford): Sand, used during foundation installation, is overwhelming the controls near structure #24027.

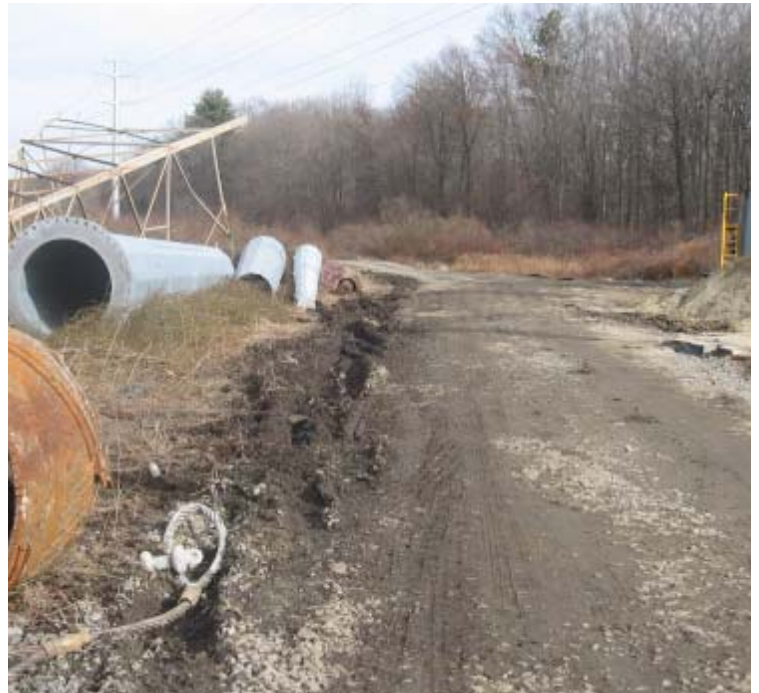
West River St (Milford): Tire ruts and a disassembled lattice tower remain in the wetland boundary near structure 24023.
