Docket No. 272 – Development and Management Plan Inspection

Segment 2b Inspection

Date: January 18, 2008

Location: Segment 2b – Cheshire/Hamden Town Line to East Devon Substation

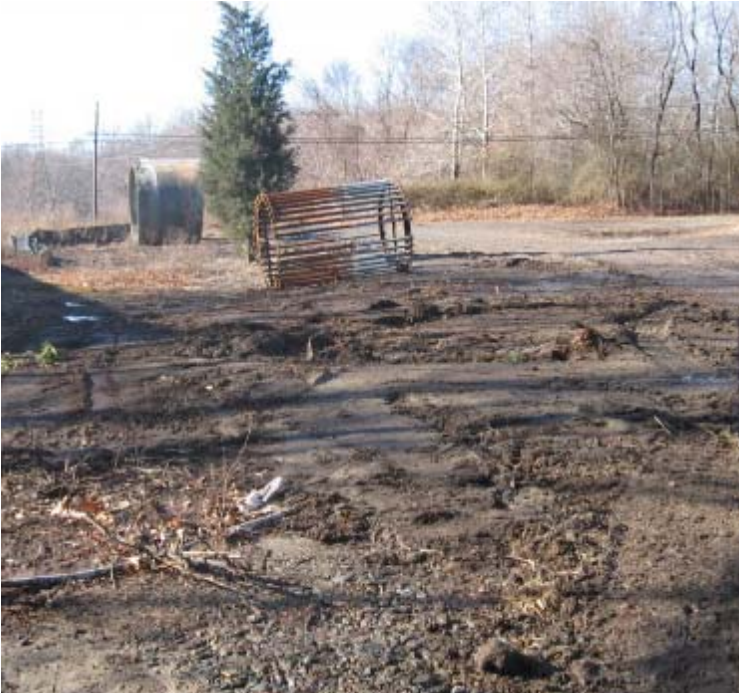
North St (Milford): The dewatering basin has been removed from the ROW near structure #3845.

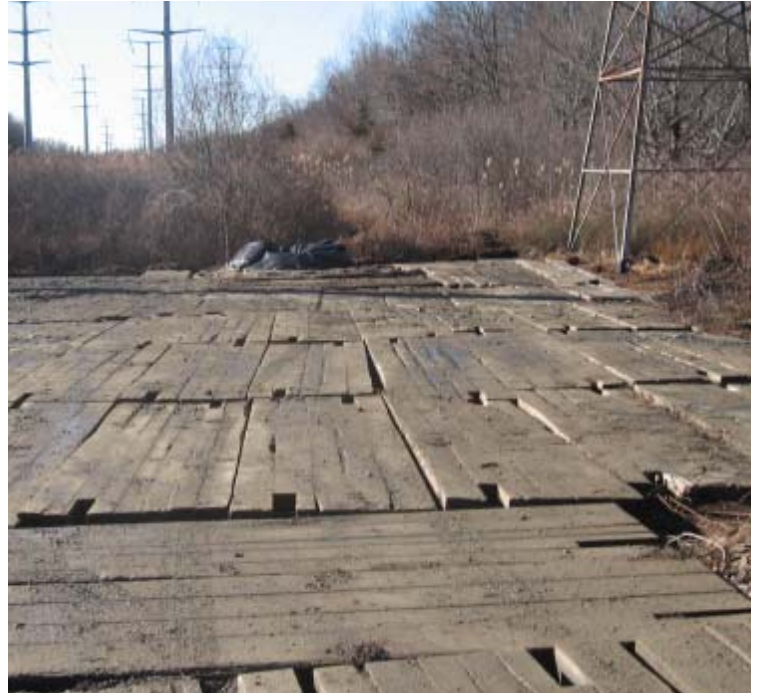
North St: Foundation installation is complete at structure #24032.

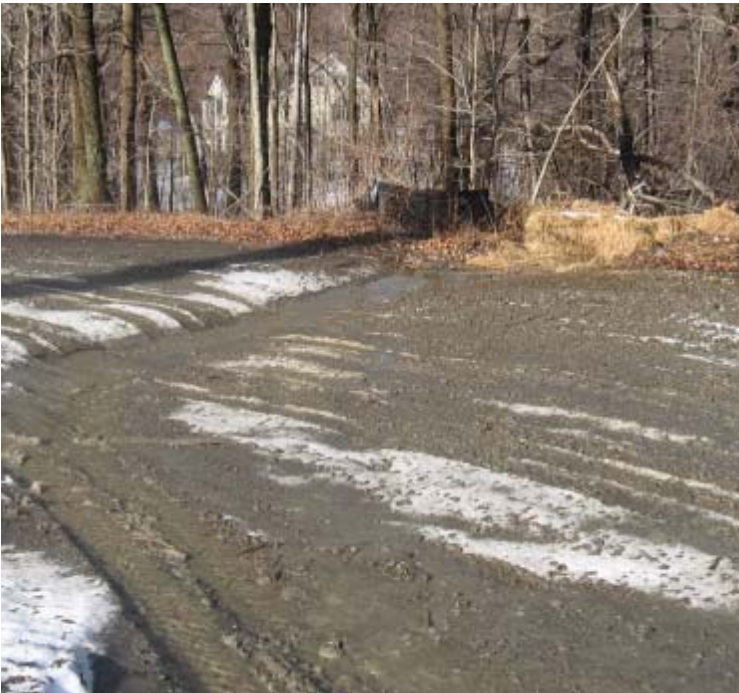
Pease Rd (Woodbridge): The waterbar was re-installed at the ROW access here.

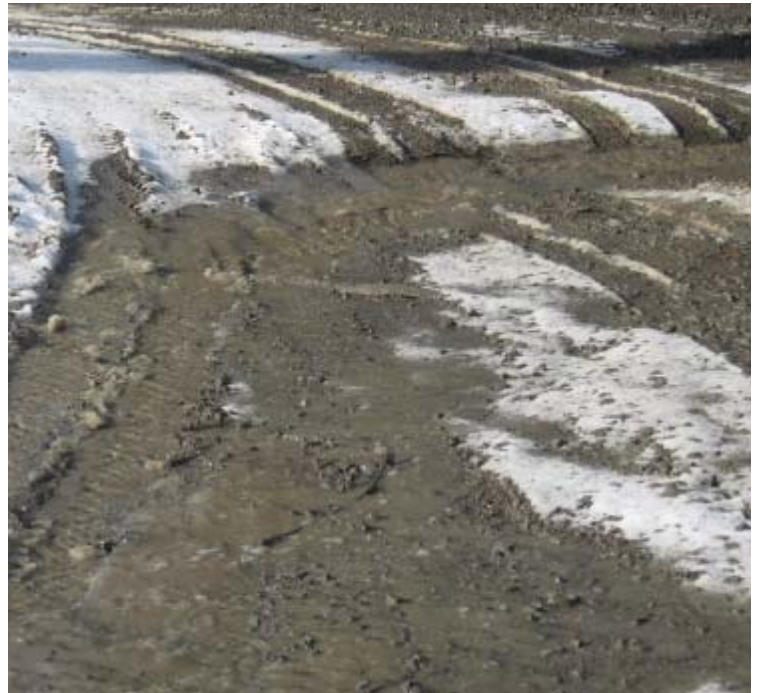
Pease Rd: View of stormwater being controlled by a waterbar.
