**Docket No. 272 – Development and Management Plan Inspection**

**Segment 2b Inspection**

**Date:** February 1, 2008

**Location:** Segment 2b – Cheshire/Hamden Town Line to East Devon Substation

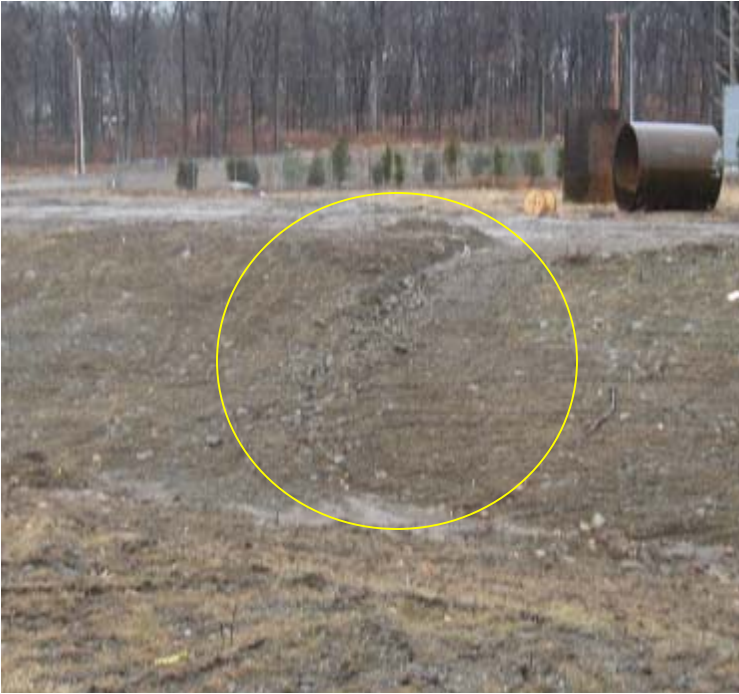
Plains Rd (Milford): Erosion is evident along the exposed slopes of the drainage swale located to the south of the East Devon substation.

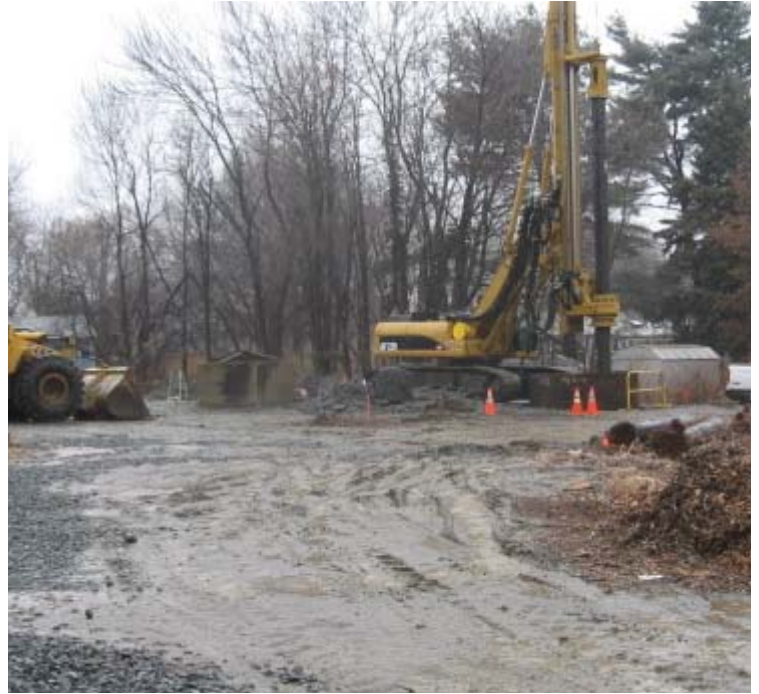
Russell Ave (Orange): Drilling continues at structure #24058. A pile of wood chips remains in the ROW here and new stone has been added to the tracking pad.

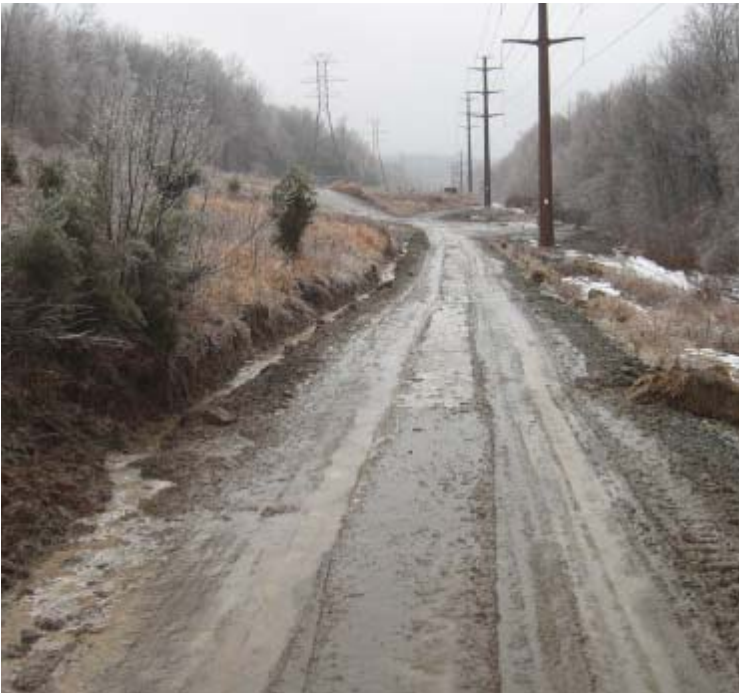
Gaylord Mtn Rd (Hamden): Additional waterbars were installed along the access road in an attempt to control stormwater runoff.

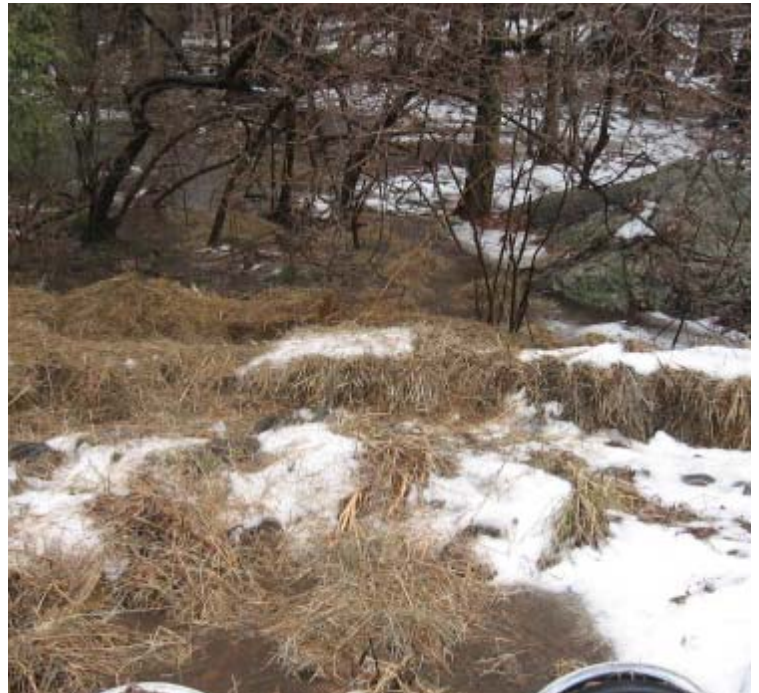
Gaylord Mtn Rd: Additional haybales were added to the sediment basin near structure #3992 to filter stormwater runoff.
