**Docket No. 272 – Development and Management Plan Inspection**

**Segment 2b Inspection**

**Date:** February 7, 2008

**Location:** Segment 2b – Cheshire/Hamden Town Line to East Devon Substation

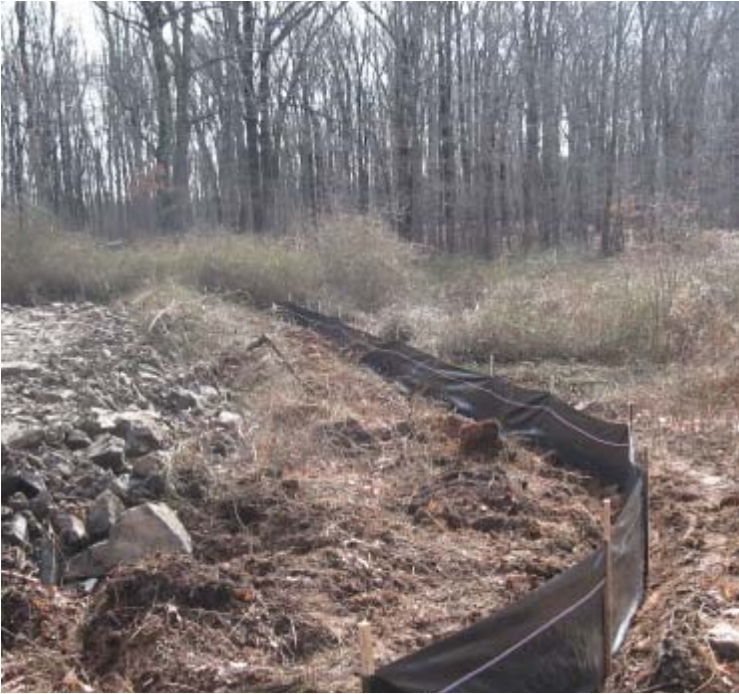
Route 34 (Orange): A new "line-pulling pad" was installed within the wetland buffer here. Proper controls are in place.

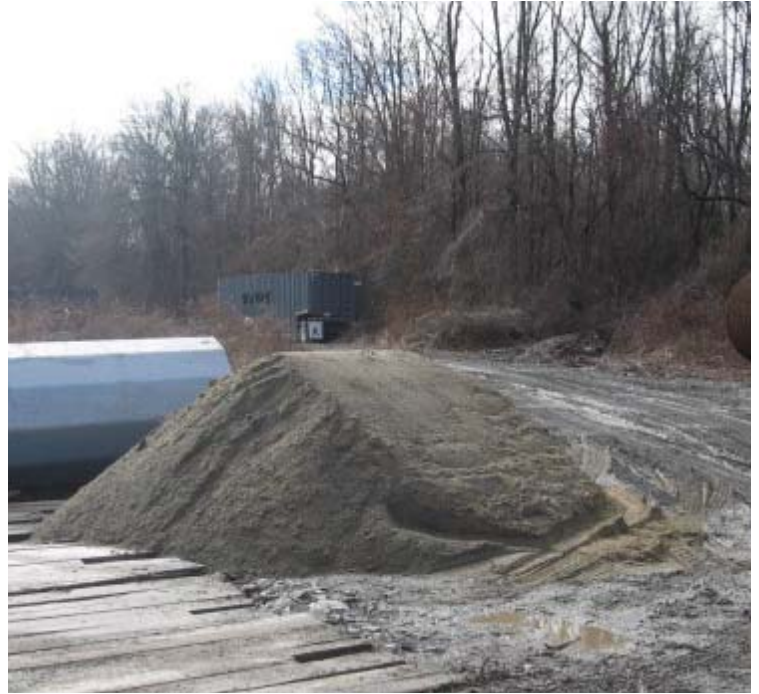
Manville Rd (Woodbridge): Sand, used during foundation installation, is being stored on the access road in this wetland area near structure #24103.

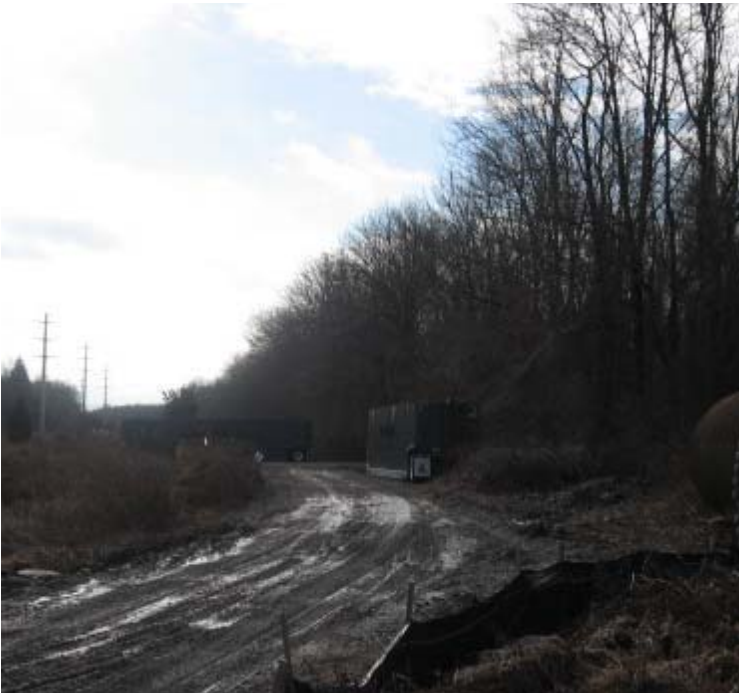
Manville Rd: Frac tanks are being used for dewatering in this area since the dewatering basin is no longer functional.

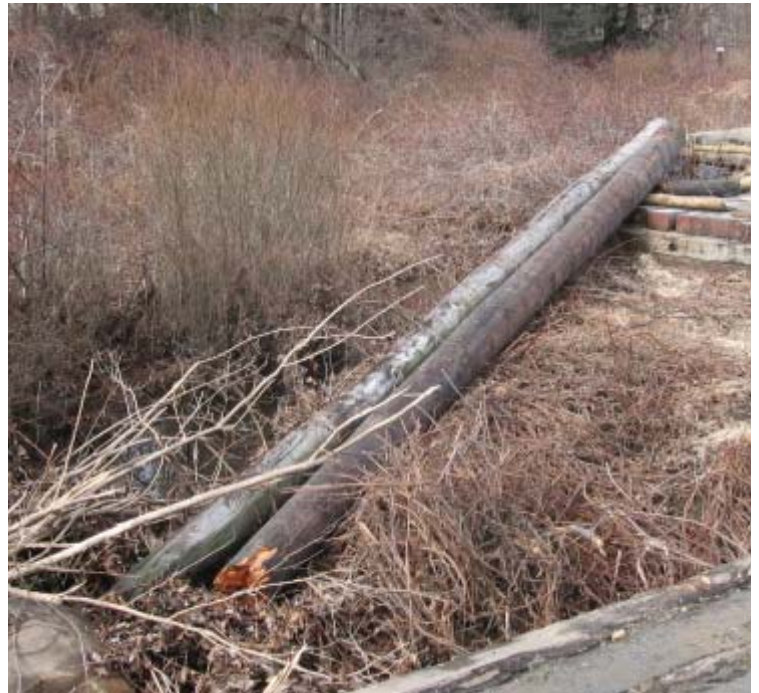
Rimmon Rd (Woodbridge): A disassembled "H-frame" structure remains in the wetland area here.

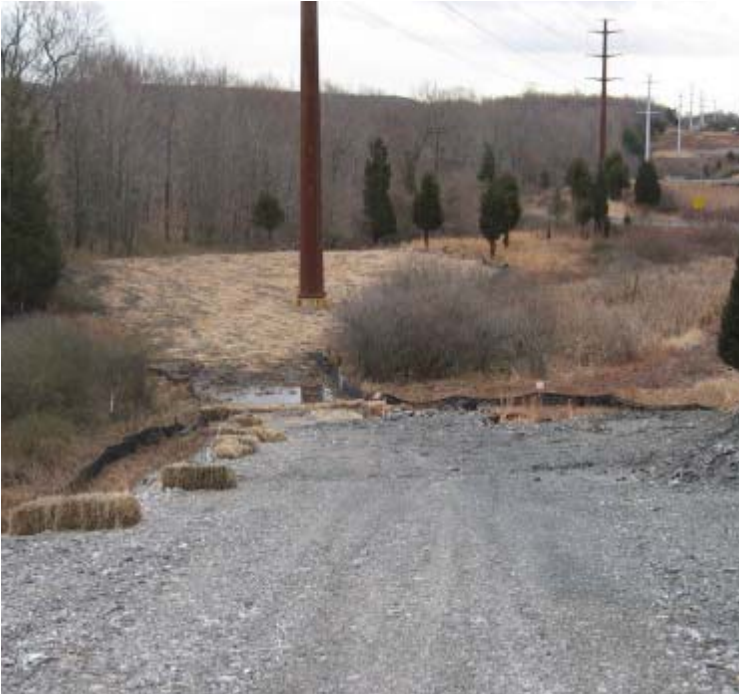
Litchfield Turnpike (Bethany): Wetland timber mats and the stone crane pad have been removed near structure #3961. Exposed soils have been graded and temporarily stabilized with mulch.

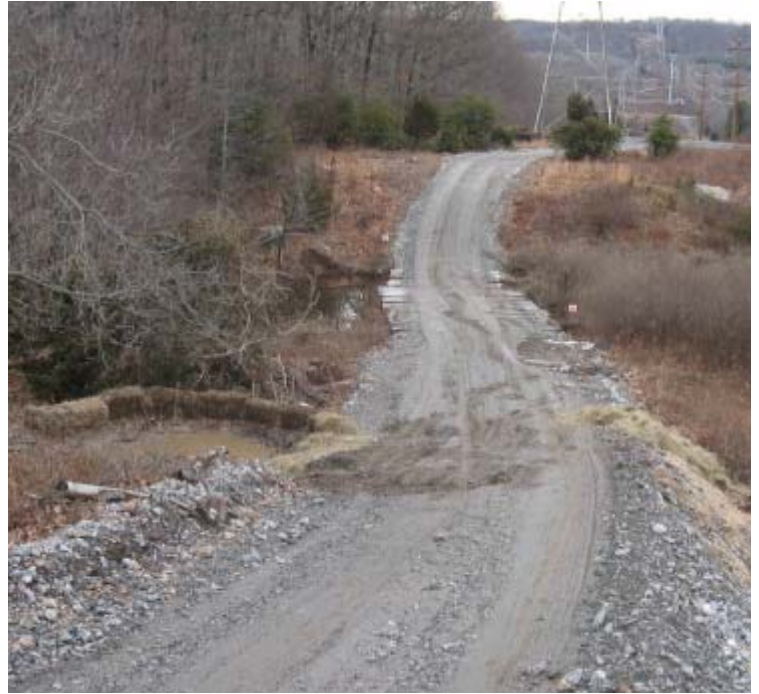
Brooksvale Ave (Hamden): Sediment from the access road has accumulated on the timber mats here. Some sediment has seeped through the mats and into the wetland.

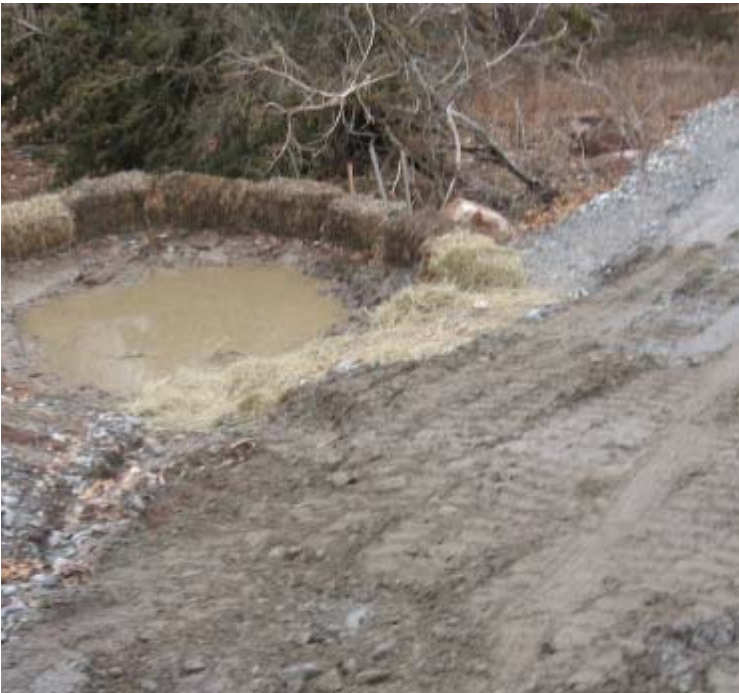
Brooksvale Ave: Existing controls remain functional, but additional controls are needed.

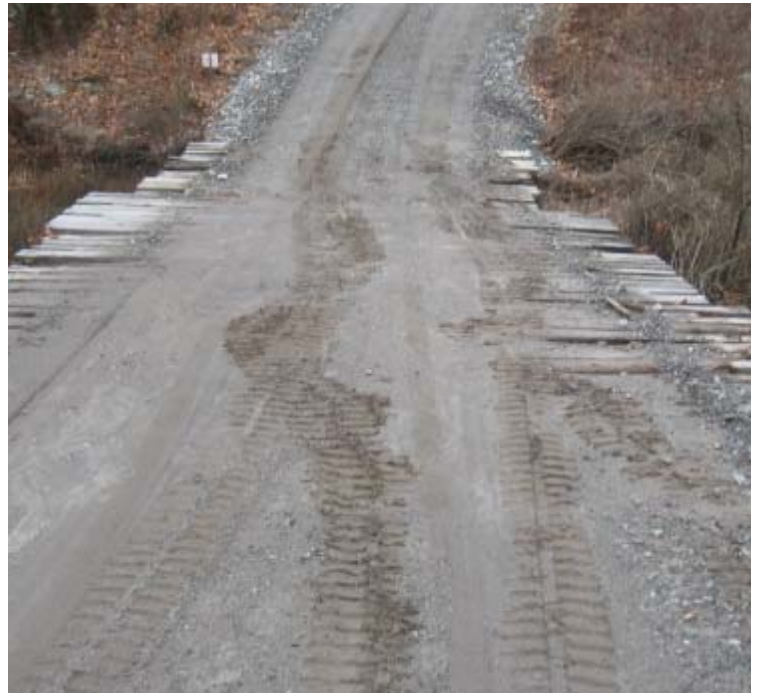
Brooksvale Ave: Additional view of sediment accumulation on the timber mats.
