**Docket No. 272 – Development and Management Plan Inspection**

**Segment 2b Inspection**

**Date:** February 15, 2008

**Location:** Segment 2b – Cheshire/Hamden Town Line to East Devon Substation

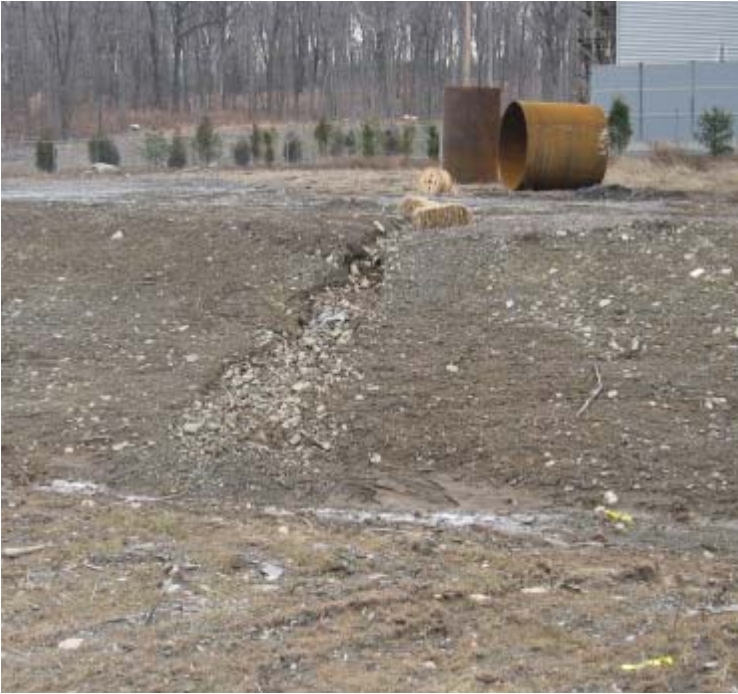
Plains Rd (Milford): Stormwater runoff has eroded the slope of the drainage swale between the ROW and the East Devon Substation.

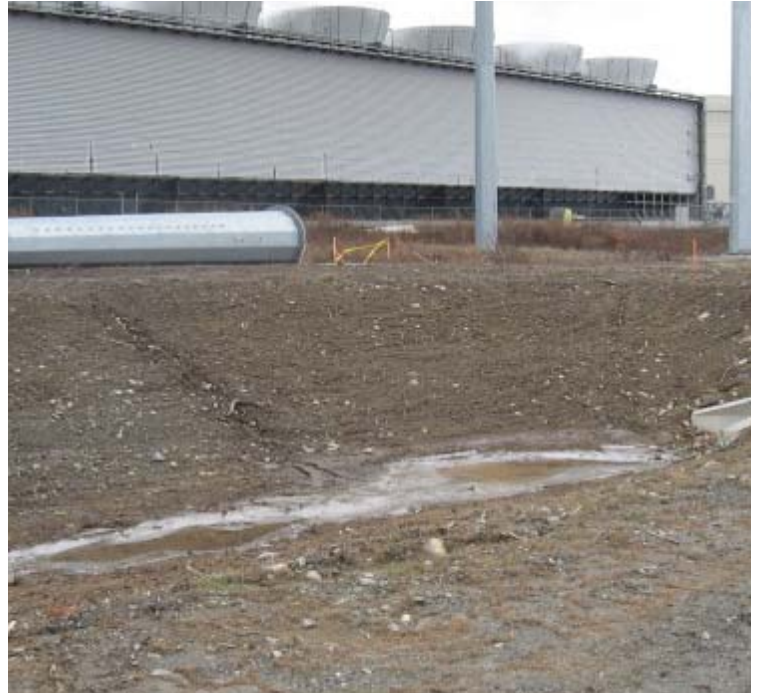
Plains Rd: An additional view of the slope erosion within the drainage swale.

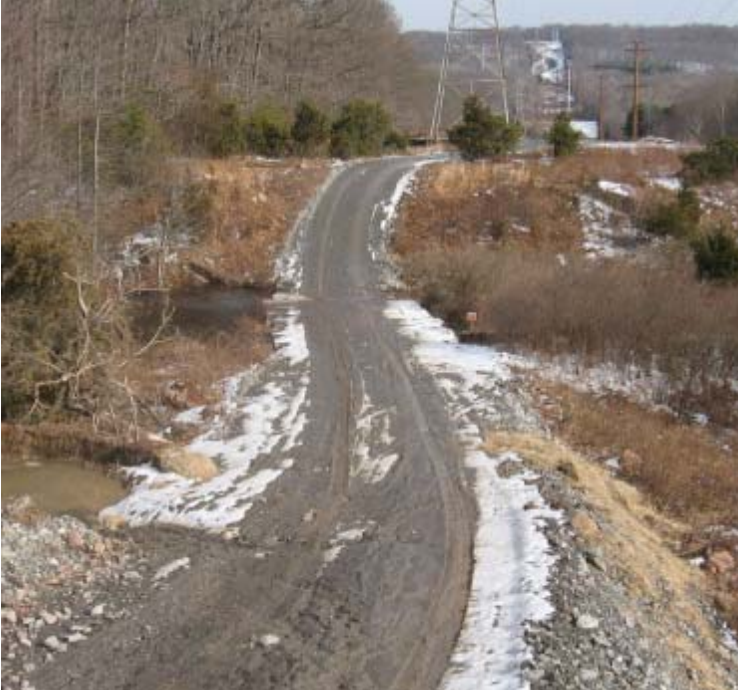
Brooksvale Ave	<p>Existing controls continue to function, but additional controls may be necessary. 2/15/08</p>	<p>Continue to monitor and add controls as necessary. 2/15/08</p>	<p>Needs evaluation</p>

Brooksvale Ave (Hamden): Existing access controls remain functional, but additional controls are needed to help prevent sedimentation on the timber mat crossing and within the wetland.

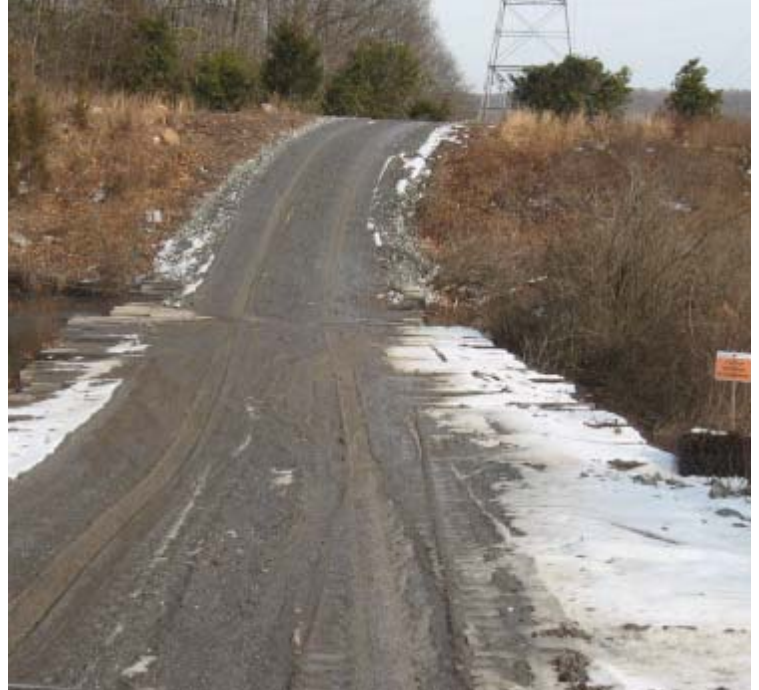
Brooksvale Ave: A view of sediment accumulation on the timber mat crossing. Controls are needed on both sides of the access road, near wetland #100.
