**Docket No. 272 – Development and Management Plan Inspection**

**Segment 2b Inspection**

**Date:** February 25, 2008

**Location:** Segment 2b – Cheshire/Hamden Town Line to East Devon Substation

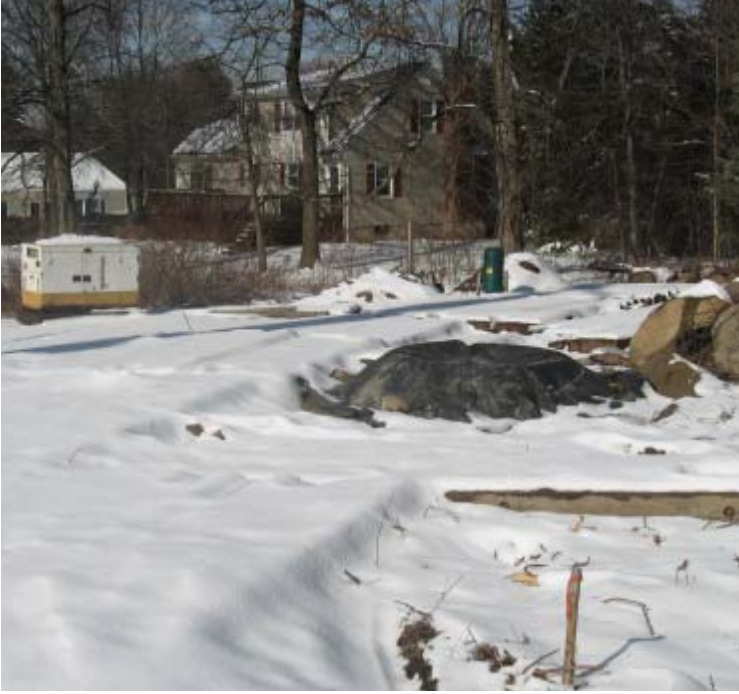
Racebrook Rd (Orange): Foundation installation appears complete at structure #24057.

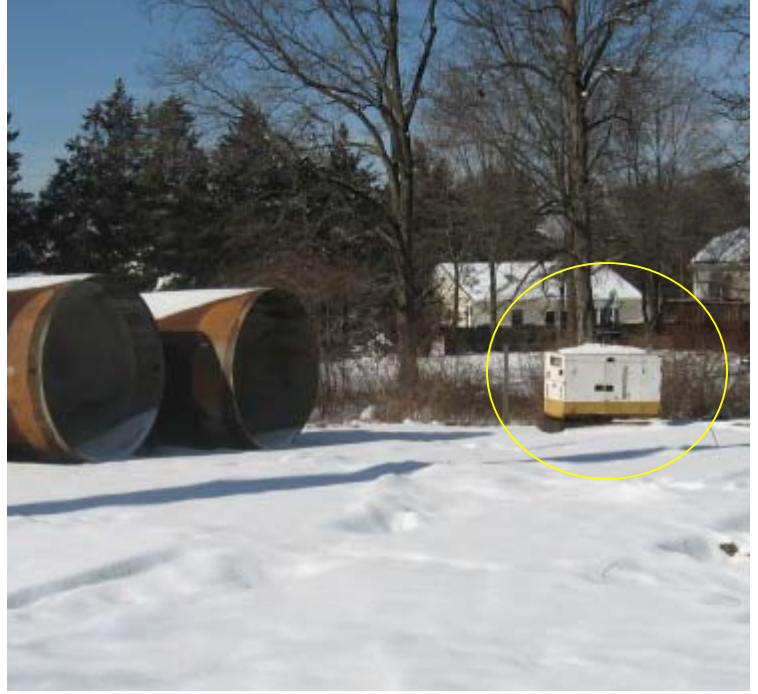
Racebrook Rd: A gas powered generator remains in the wetland area here.

<b>Orange, CT</b> Racebrook Rd	A gas-powered generator was observed within the wetland boundary in this area. 2/25/08	In general, all construction equipment should be stored at least 100 feet from a wetland or waterbody when feasible. Monitor for leaks and remove equipment from wetland areas as soon as possible. 2/25/08	Needs attention
Russell Ave	A dozer was observed parked in a wetland here. 2/25/08	In general, all construction vehicles should be parked at least 100 feet from a wetland or waterbody	Needs attention

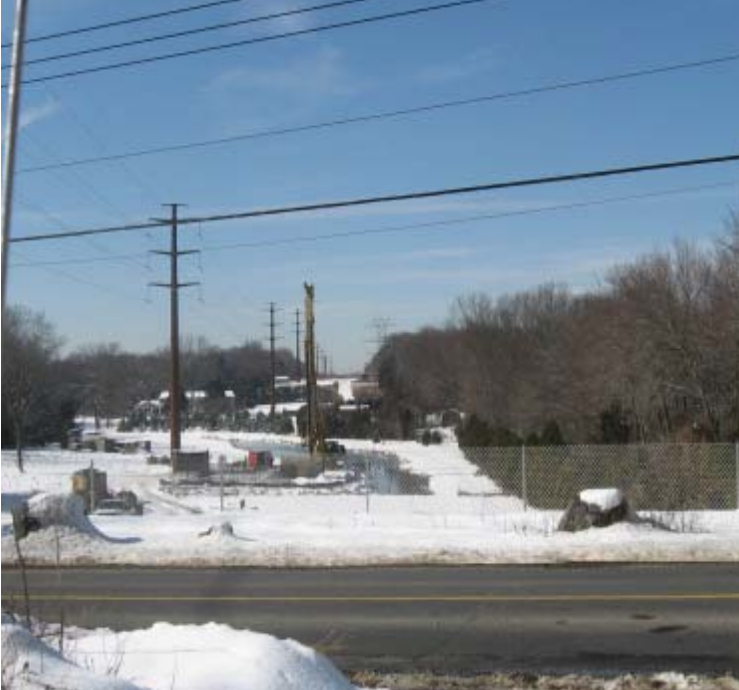
Dogwood Rd (Orange): Drilling has begun for proposed structure #24065. Proper controls are in place to protect the wetland in this location.

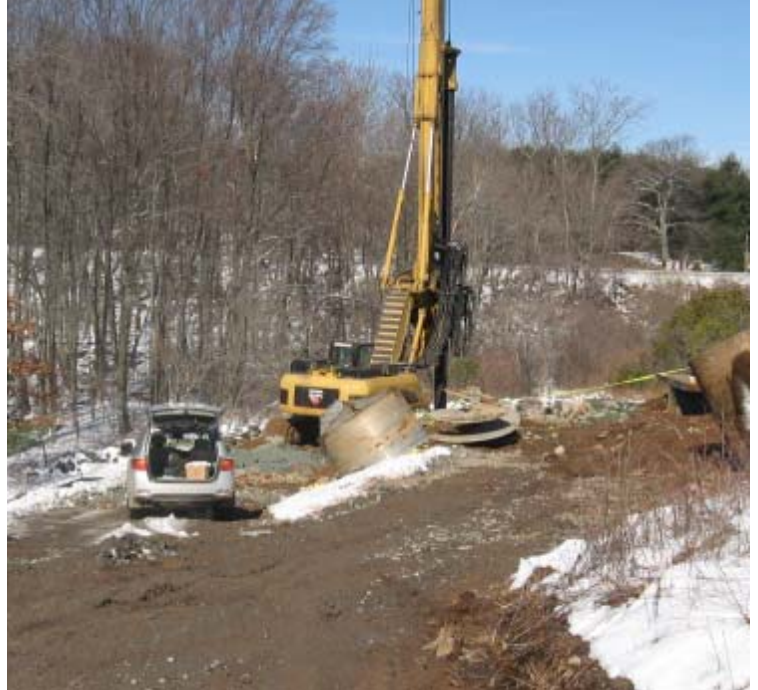
Route 34 (Orange): Drilling continues at proposed structure #24074.

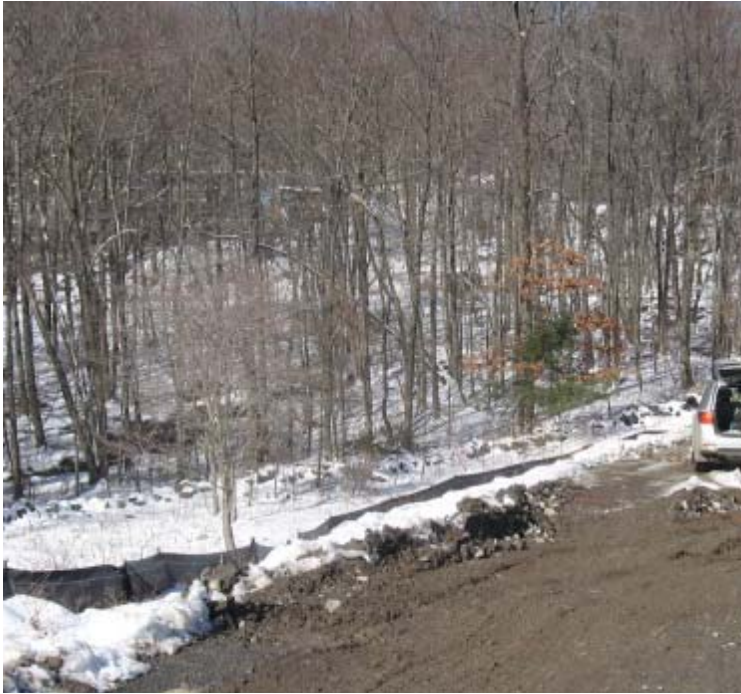
Route 34: Silt fence controls remain in place in order to protect the wetland in this area (near structure #24074).

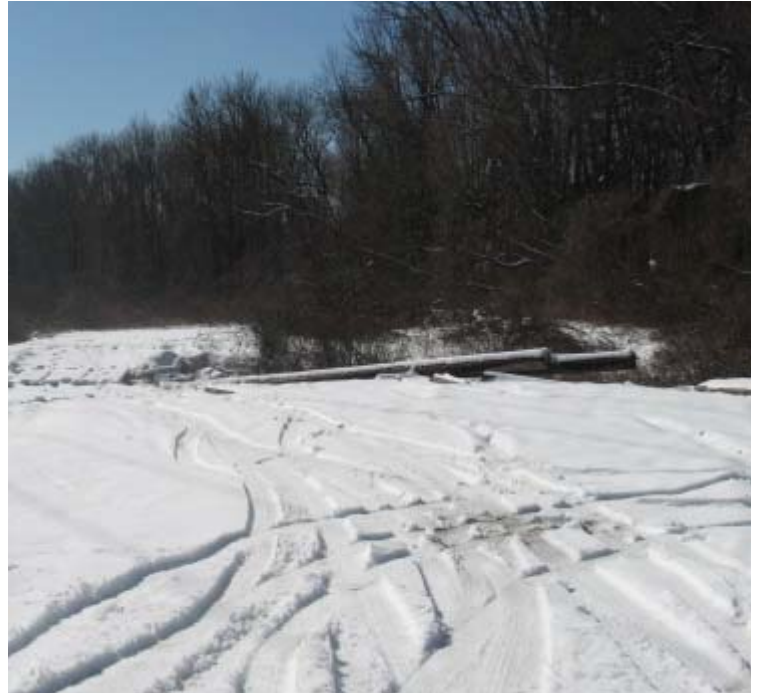
Areas of Inspection	Observation	Recommended Action	Corrected Action
Rimmon Rd	<p>A timber mat crane pad (installed for lattice tower removal 12/7/07) remains adjacent to/within a tributary stream of Race Brook near structure #24105. 2/25/08</p> <p>A disassembled “H” frame structure remains in the wetland here. 2/25/08</p>	<p>Continue to monitor. 2/25/08</p> <p>Remove structure from the wetland. 2/25/08</p>	<p>NA</p> <p>Needs attention</p>
Oak Lane CC, Cow Path Lane, Salem Rd, Rimmon Rd, Brookwood Dr, Center Rd, Ansonia Rd, Manville Rd and Clear Ln to Rte 15	<p>Timber mat crane pads remain within the wetlands in these sections. 2/25/08</p>	<p>Continue to monitor. 2/25/08</p>	<p>NA at this time</p>
Glen Dam	<p>A disassembled lattice tower remains in a wetland between structures #24140-40. 2/25/08</p>	<p>Remove structure from the wetland. 2/25/08</p>	<p>Needs attention</p>
<b>Bethany, CT</b> Morris to Hatfield	<p>A stone access road and timber mats are in place in the wetland areas in this section. 2/25/08</p>	<p>Continue to monitor. 2/25/08</p>	<p>NA</p>

Rimmon Rd (Woodbridge): A disassembled "H" frame structure remains in the wetland area near structure #24105.

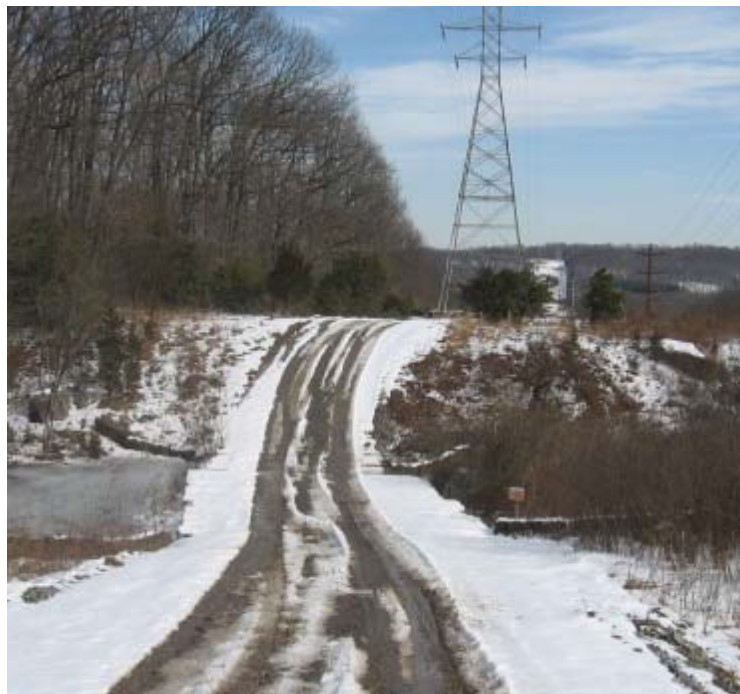
<p>Brooksvale Ave</p>	<p>Silt fence controls are at capacity along the perimeter of the ROW. The sediment basin near structure #3989 needs to be cleaned. 2/25/08</p> <p>Additional haybales were added to the sediment basin near structure #3992, but it appears additional controls are needed here. 2/25/08</p>	<p>Monitor and maintain controls as necessary to control and filter stormwater runoff. 2/25/08</p> <p>Continue to monitor and maintain controls to prevent further sedimentation to the wetlands. See Wetland Section. 2/25/08</p>	<p>Needs attention</p> <p>Additional haybales have been added to the sediment basin but <i>further attention is needed</i></p>
<p>Brooksvale Ave</p>	<p>Existing controls continue to function, but additional controls may be necessary. 2/25/08</p> <p>Sediment has once again accumulated on the timber mat crossing at wetland #100. 2/25/08</p>	<p>Continue to monitor and add controls as necessary. 2/25/08</p> <p>Continue to monitor and remove excess sediment from timber mat crossing. 2/25/08</p>	<p>Needs attention</p> <p>Needs attention</p>

Brooksvale Ave (Hamden): Excess sediment remains accumulated on the timber mat crossing at wetland #100. Additional controls are recommended for this area.
