Docket No. 272 – Development and Management Plan Inspection

Segment 2b Inspection

Date: February 29, 2008

Location: Segment 2b – Cheshire/Hamden Town Line to East Devon Substation

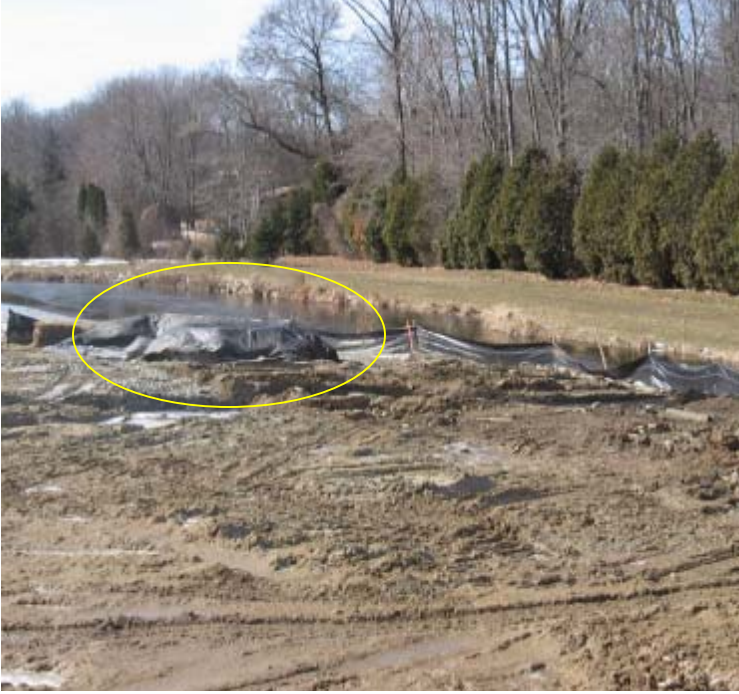
Dogwood Rd (Orange): Foundation installation appears complete at structure #24065.

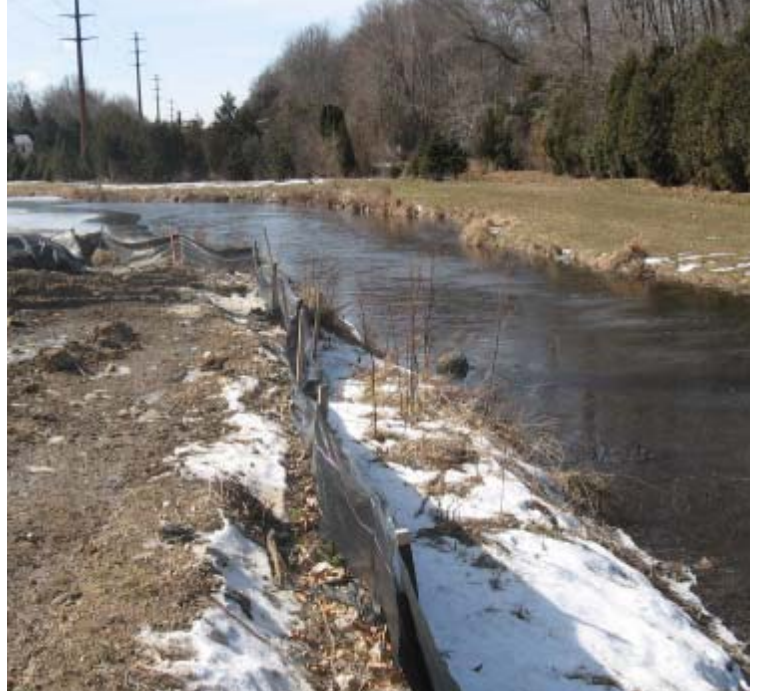
Dogwood Rd: Erosion controls are in place and functioning properly.

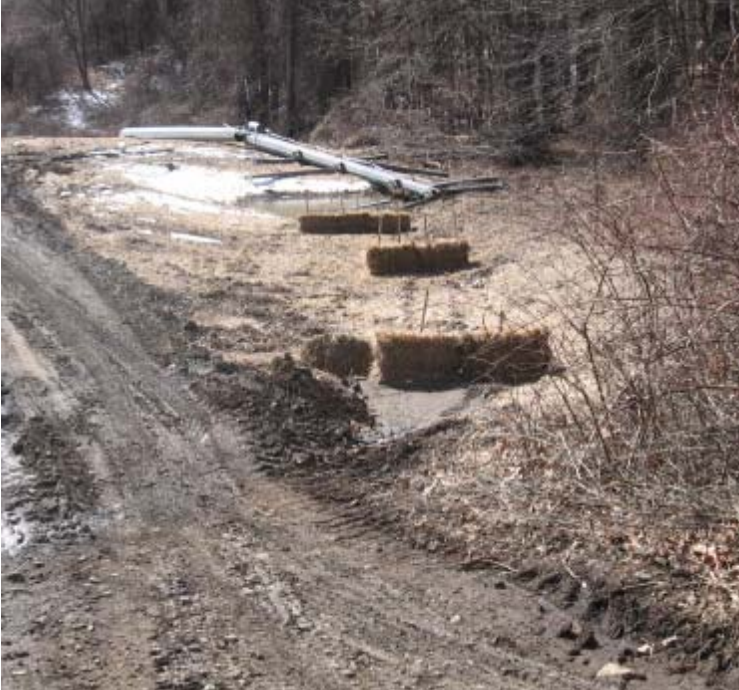
Glen Dam (Woodbridge): Access road controls have been improved. Water bars were re-established, hay bale check dams were installed, terracing was implemented, and mulch was applied as a temporary stabilization measure.

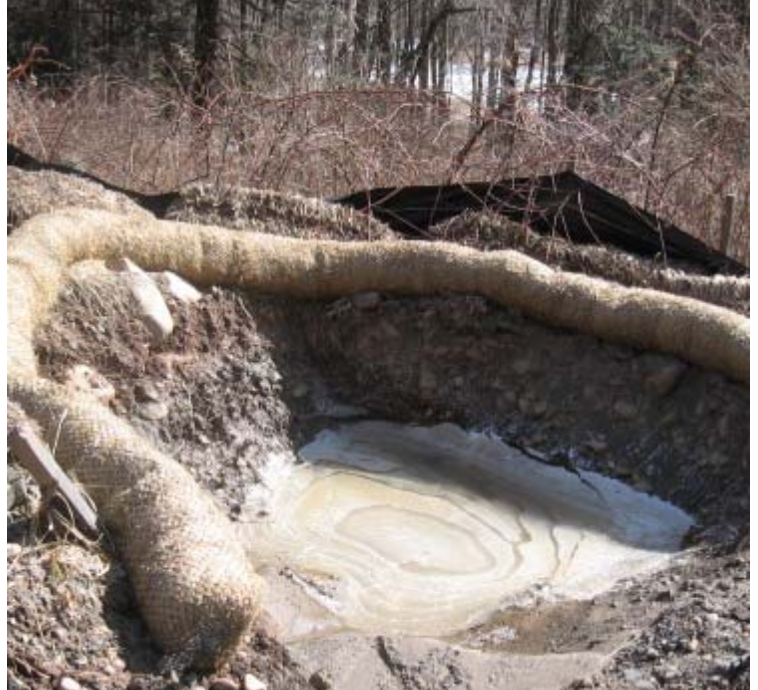
Glen Dam: Sediment has been removed from the basins along the access road, returning function to the sediment basins.
