Docket No. 272 – Development and Management Plan Inspection

Segment 2b Inspection

Date: March 6, 2008

Location: Segment 2b – Cheshire/Hamden Town Line to East Devon Substation

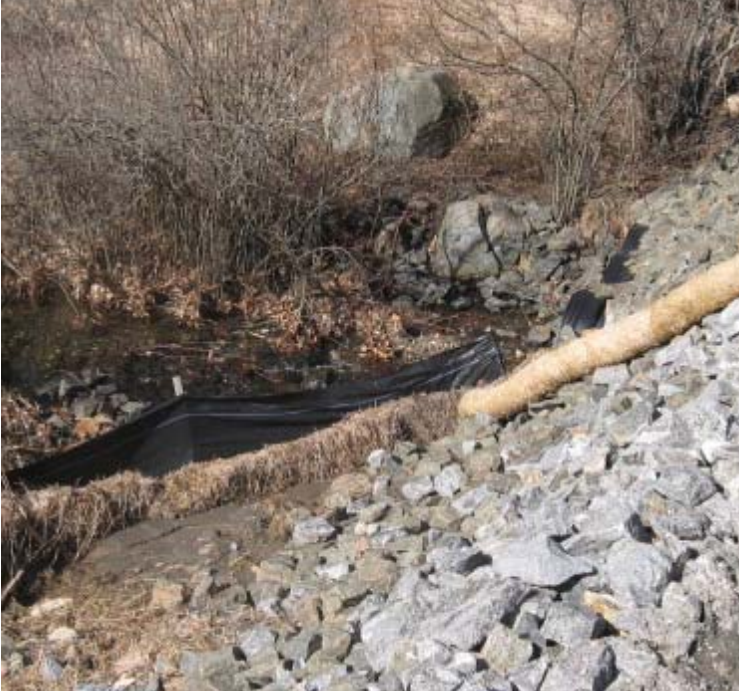
Litchfield Turnpike (Bethany): Access road controls are functioning properly, at the stream crossing, between structures #24156-57. Due to the proximity of the controls to the stream channel, sediment should be removed from the controls.

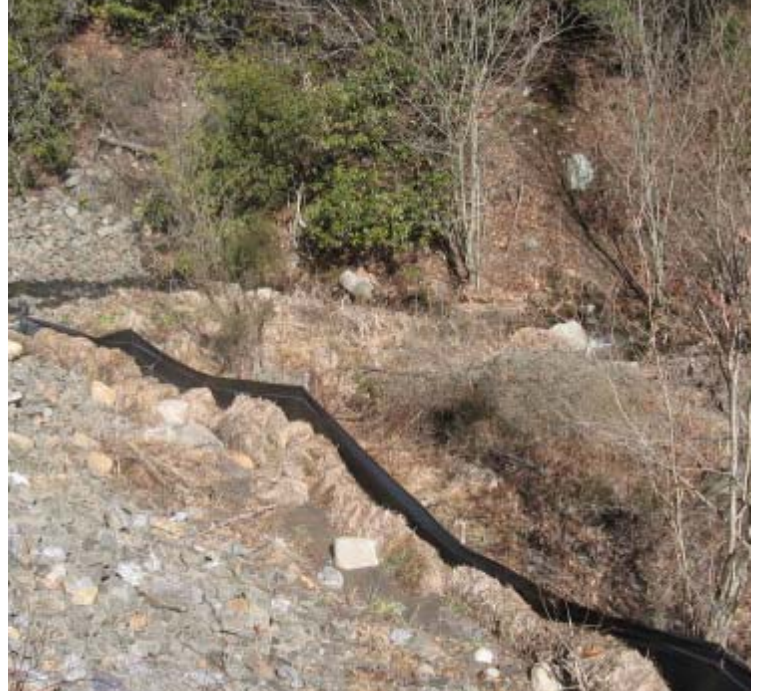
Litchfield Turnpike: A view of the controls on the opposite side of the stream crossing between structures #24156-57. Sediment is accumulating against the controls.

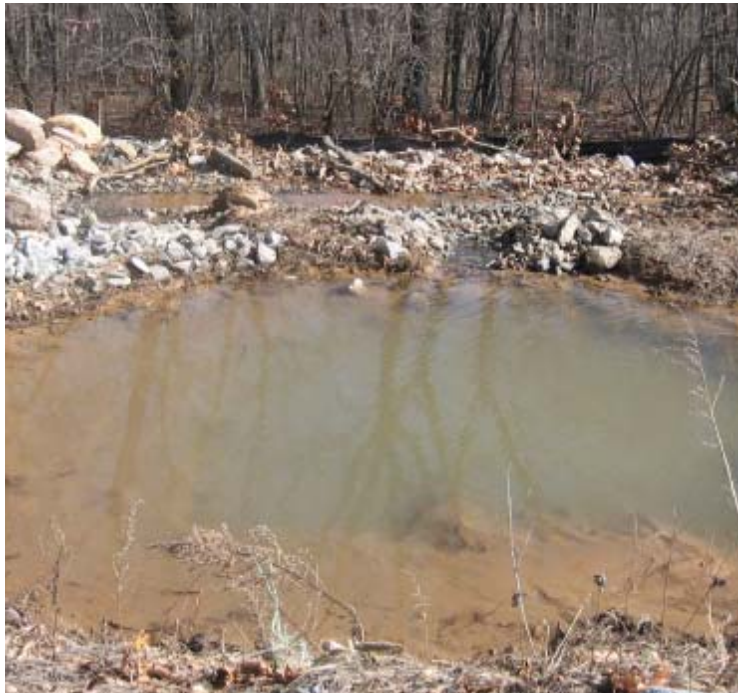
Gaylord Mtn Rd (Hamden): Sediment was removed from the basin near structure #3989.
