Docket No. 272 – Development and Management Plan Inspection

Segment 2b Inspection

Date: March 12, 2008

Location: Segment 2b – Cheshire/Hamden Town Line to East Devon Substation

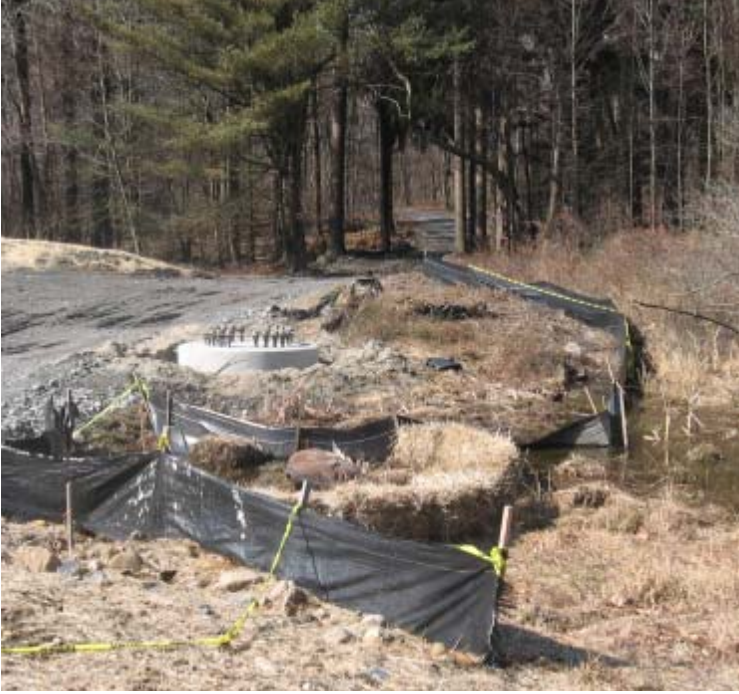
Areas of Inspection	Observation	Recommended Action	Corrected Action
Clearview Lane	The foundation for structure #24090 has been installed on the edge of the wetland here (as approved). Spoils from foundation drilling remain within the wetland buffer. 3/12/08	Remove spoils from wetland buffer and store in an appropriate upland location. See EC Section. 3/12/08	Needs attention
JCC/B’Nai Jacob	The wetland areas near the JCC and B’Nai Jacob have been cleared as a result of the permitted re-location of the ROW. Stone access roads remain in portions of the wetlands in these sections. 3/12/08	Continue to monitor. Adjust controls as necessary. 3/12/08	NA at this time
	Sediment was noted in the stream channel near structure #24119 at the JCC (8/7/07). No further accumulation has been observed. 3/12/08	Continue to monitor. Evaluate sediment accumulation within the stream channel. Carefully remove sediment during the dry season if it is greater than 2” in depth. See EC Section. 3/12/08	Needs evaluation

Clearview Ln (Woodbridge): The foundation for structure #24090 has been installed. The foundation is located on the edge of a wetland.

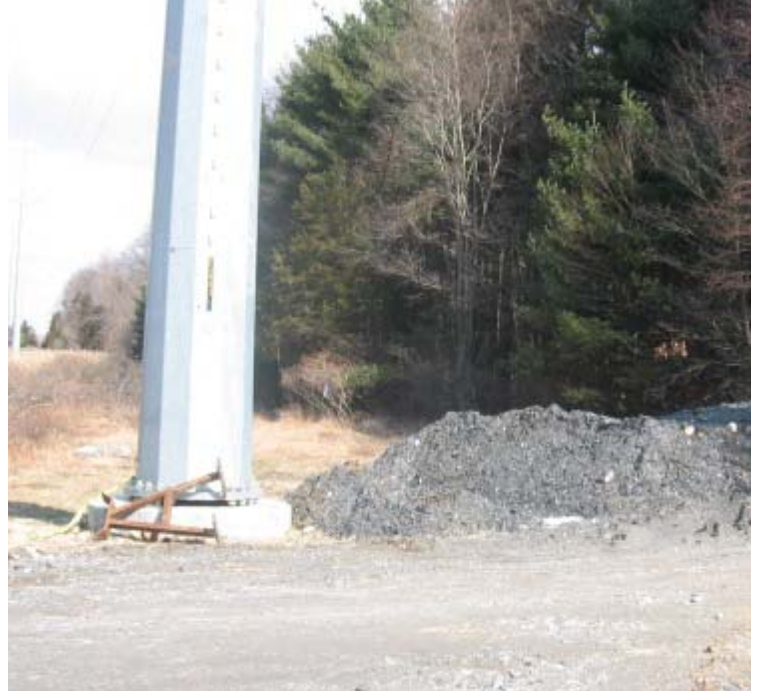
Clearview Ln	Spoils remain within a wetland buffer in the ROW near structure #24090. 2/29-3/12/08. Sediment migration was observed this week. 3/12/08	Install controls as necessary to contain sediment and/or remove spoils from wetland buffer and store in an appropriate upland location. 3/12/08	Needs attention
Bethany, CT Litchfield Turnpike	Erosion controls are functioning properly at the stream crossing between structures #24156-57, but sediment has accumulated against the controls. 3/6-12/08	Remove sediment from controls to restore function/capacity. Continue to monitor, and add controls as necessary. 3/12/08	Needs attention
	Spoils remain within the wetland buffer near structure #24157. 3/12/08	Remove spoils from wetland buffer and store in an appropriate upland location. 3/12/08	Needs attention
Hamden, CT West Todd Street/ Gaylord Mountain	In approximately three areas, stormwater pooled along the perimeter controls and filtered through as concentrated	Monitor during large rain events and investigate additional solutions to prevent stormwater conveyances off site.	Good efforts were made but <i>needs additional evaluation/monitoring</i>

Clearview Ln: Spoils from structure #24090 remain piled in a wetland buffer. No controls have been installed to contain the pile.

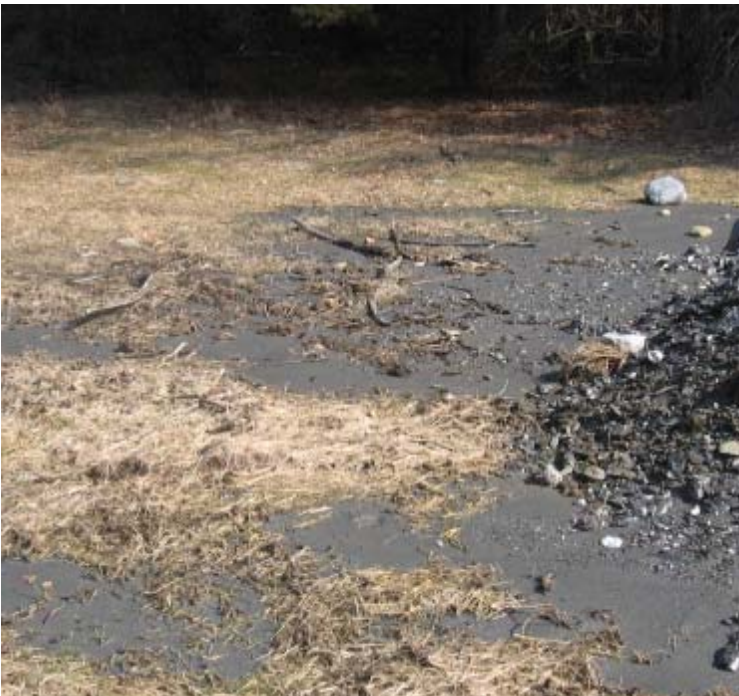
Clearview Ln: Sediment has begun to migrate from the spoil pile near structure #24090.

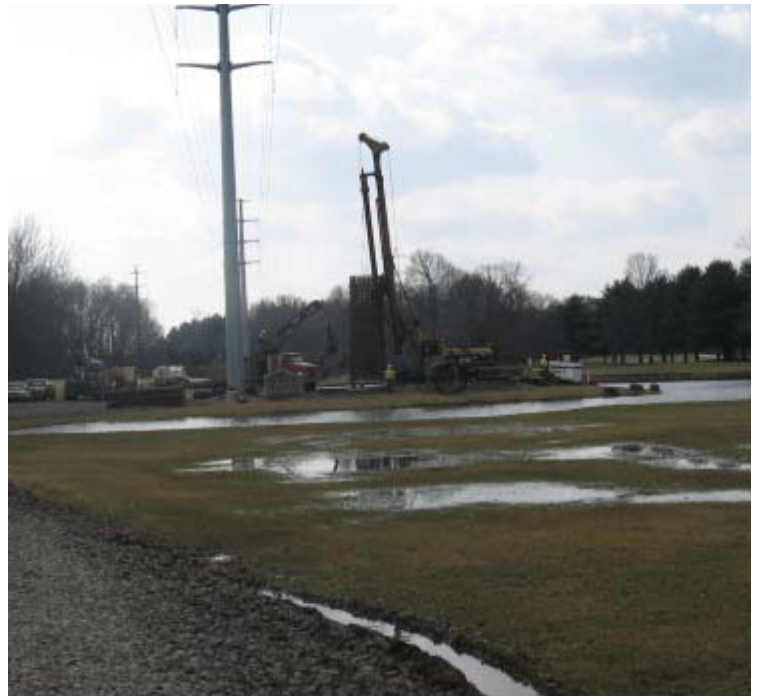
Oak Ln Country Club (Woodbridge): Drilling continues at structure #24093.
