**Docket No. 272 – Development and Management Plan Inspection**

**Segment 2b Inspection**

**Date:** March 26, 2008

**Location:** Segment 2b – Cheshire/Hamden Town Line to East Devon Substation

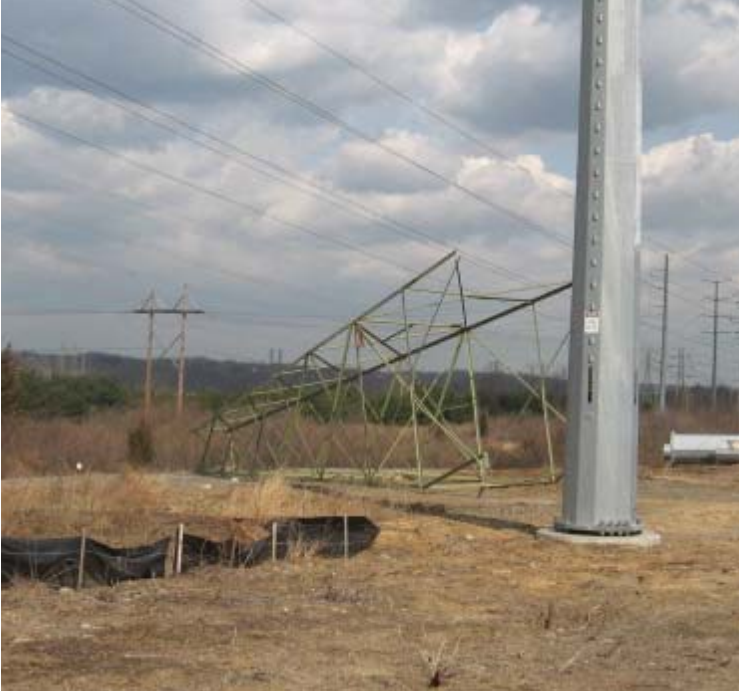
Naugatuck Ave (Milford): Lattice tower removal continues in this area (Naugatuck to Oronoque).

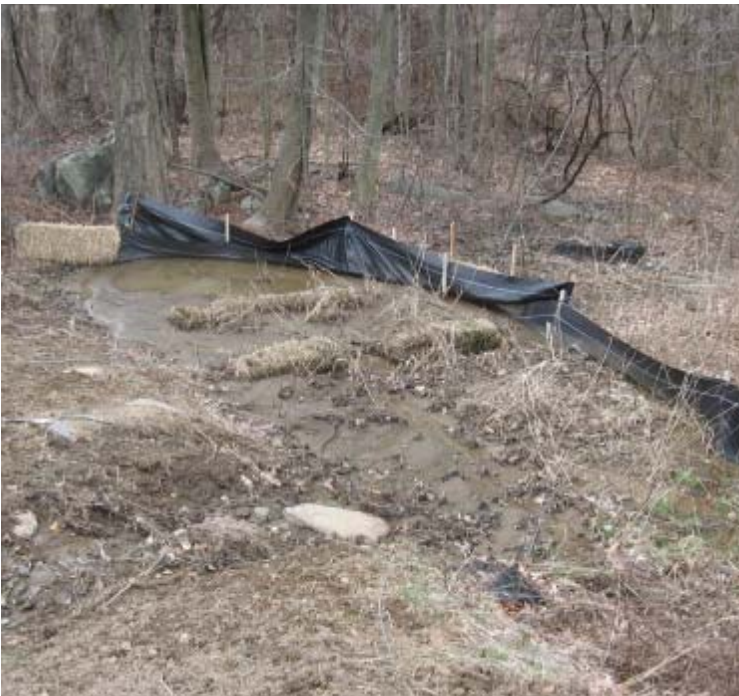
Wheelers Farm Rd: Silt fence controls are in place but haybale controls are at capacity near structure #3832.

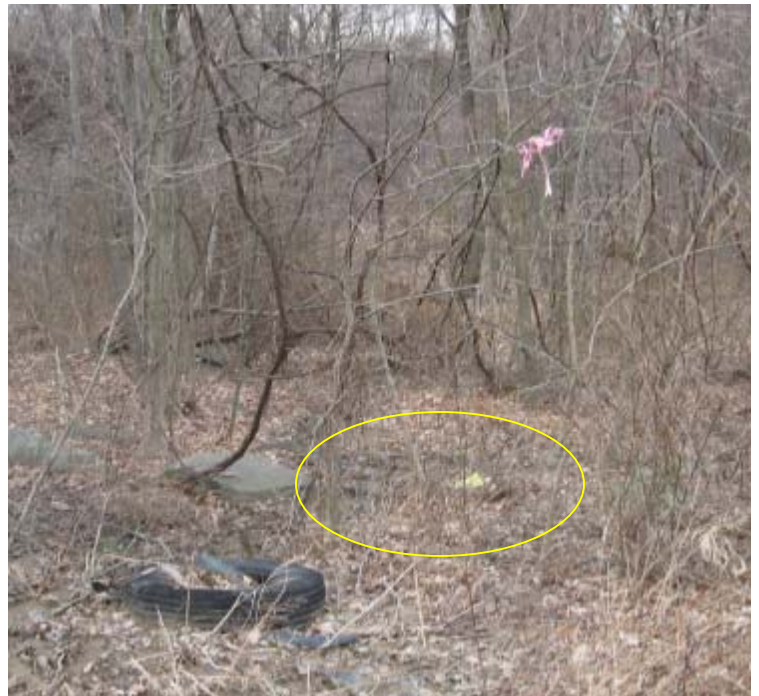
Wheelers Farm Rd: A small amount of sediment has migrated off the ROW near structure #3832.

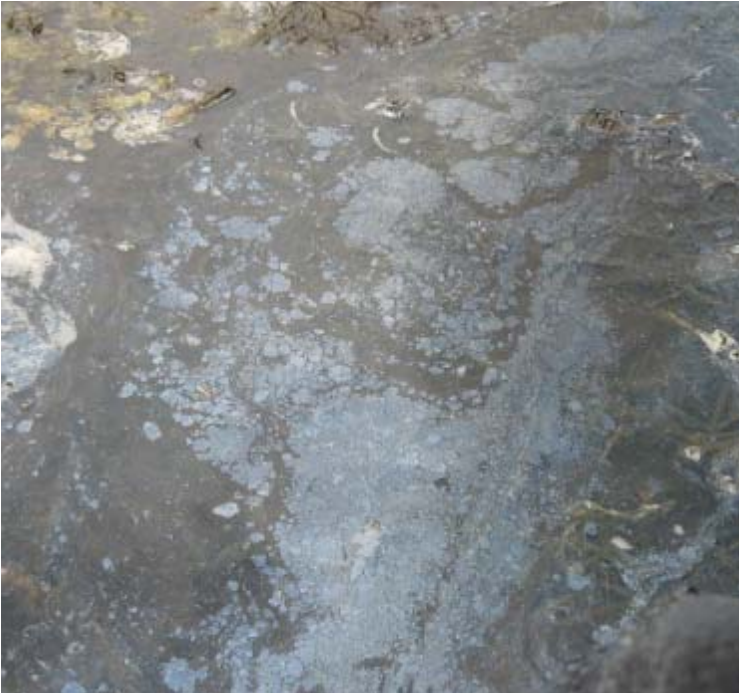
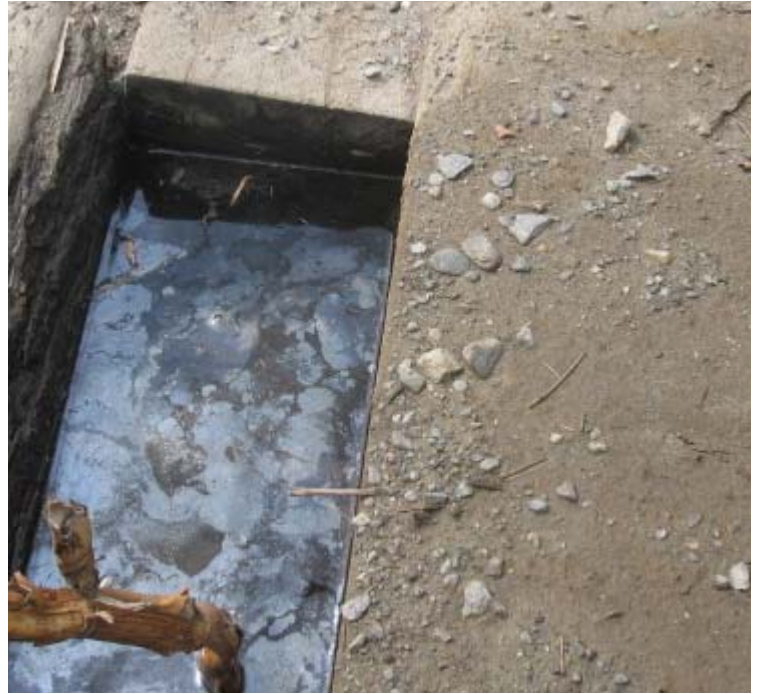
West River St (Milford): An oily sheen was observed on the water near structure #24023. Evaluate sheen to determine whether natural or project related.

West River St: An additional view of the oily sheen observed near structure #24023.

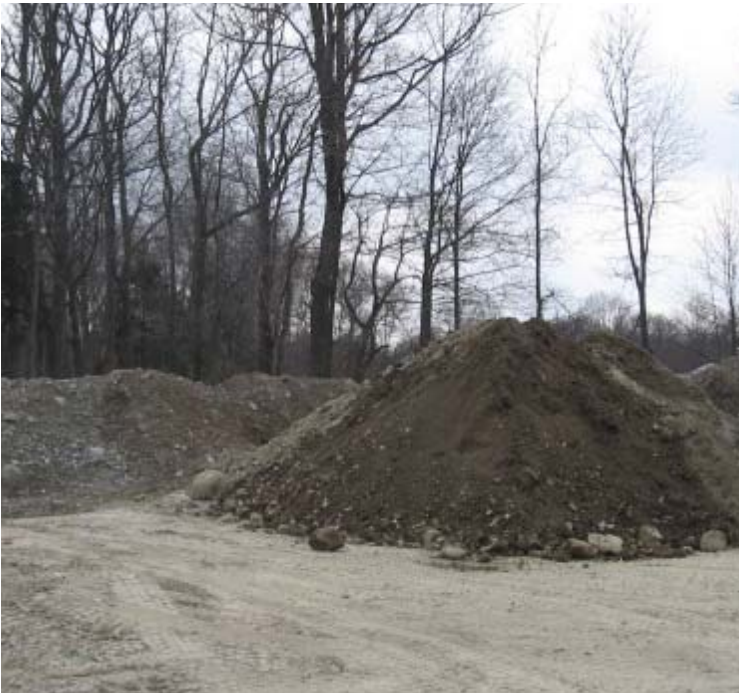
Dogwood (Orange): Stock piling continues near structure #3879.

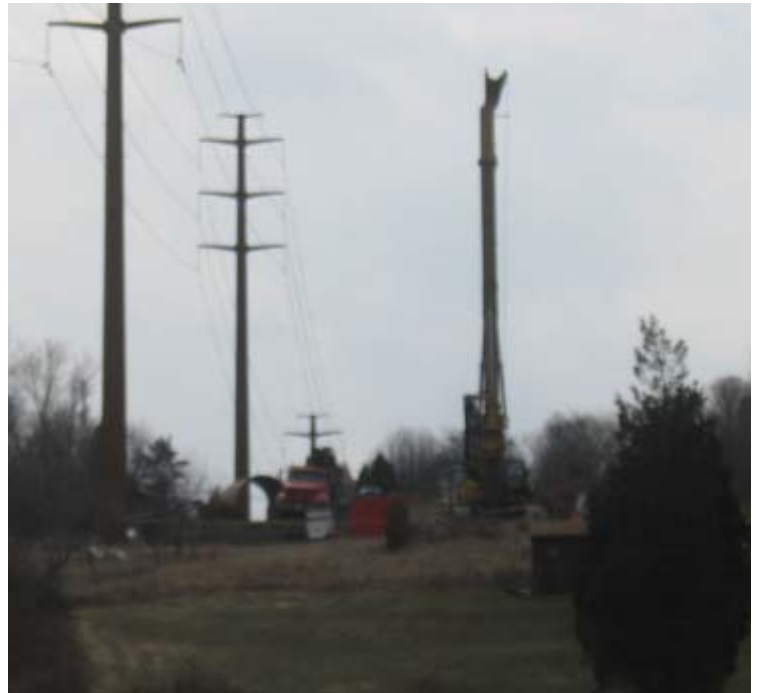
Saddle Ridge Rd (Orange): Drilling continues at structure #24071.

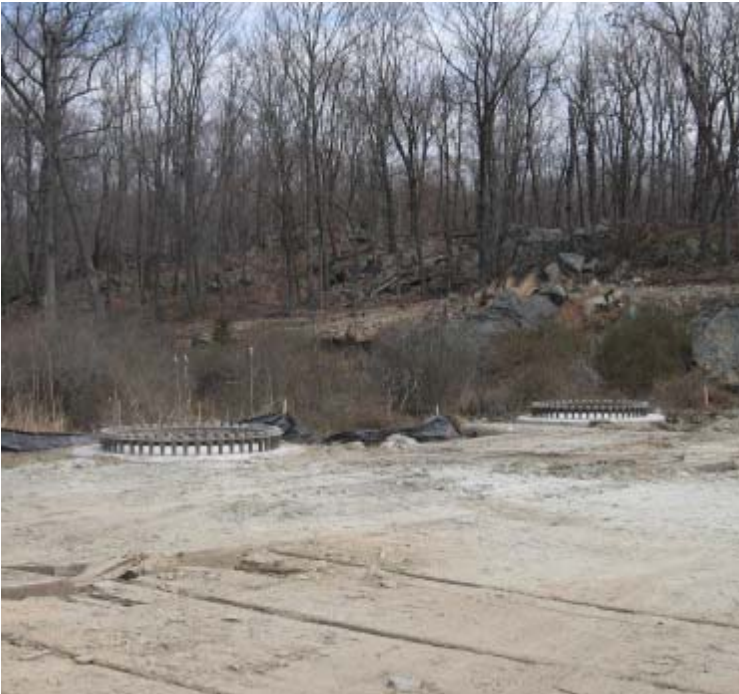
Route 34 (Orange): Two foundations have been installed in a wetland for structure #24072.

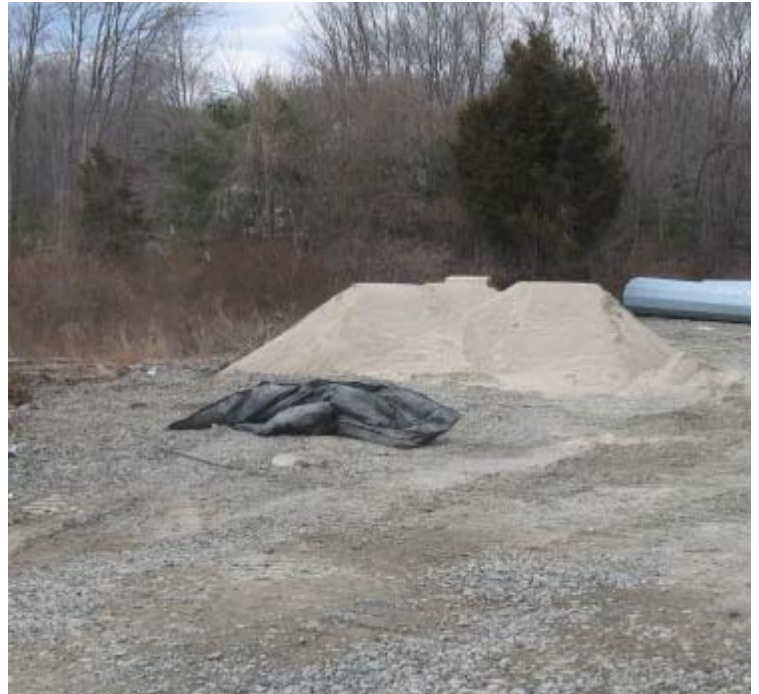
Oak Ln (Woodbridge): Sand, used for foundation installation, remains piled upgradient of the wetland near structure #24092.

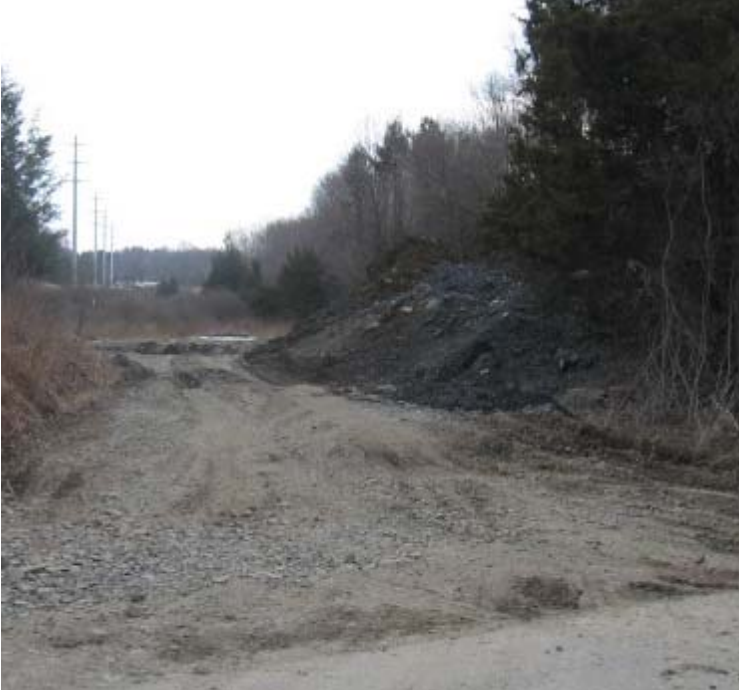
Brookwood Dr (Woodbridge): Stockpiling continues near structure #24096.

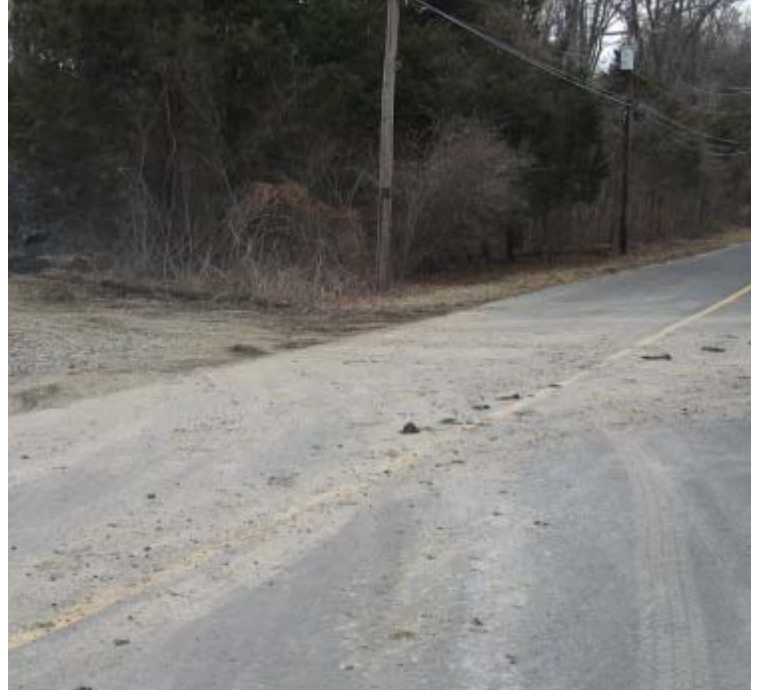
Brookwood Dr: Sediment tracking was evident here this week.

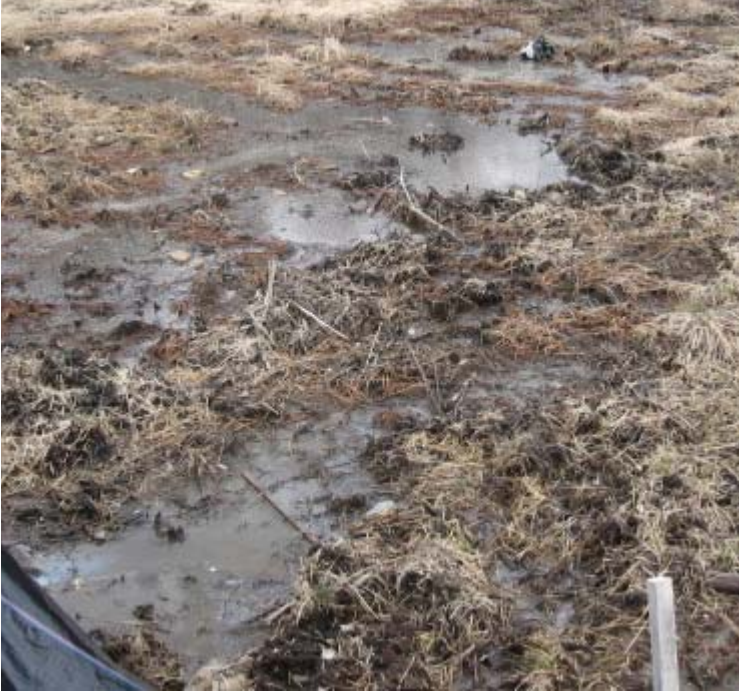
Manville Rd North (Woodbridge): An oily sheen was noted on the water surface near structure #24103.

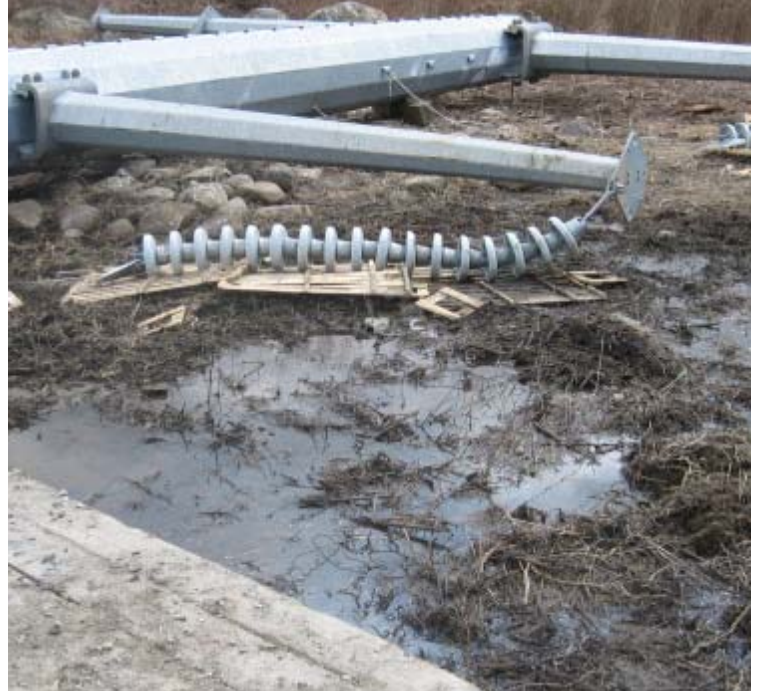
Manville Rd South: An oily sheen was noted on the water surface near structure #24102.

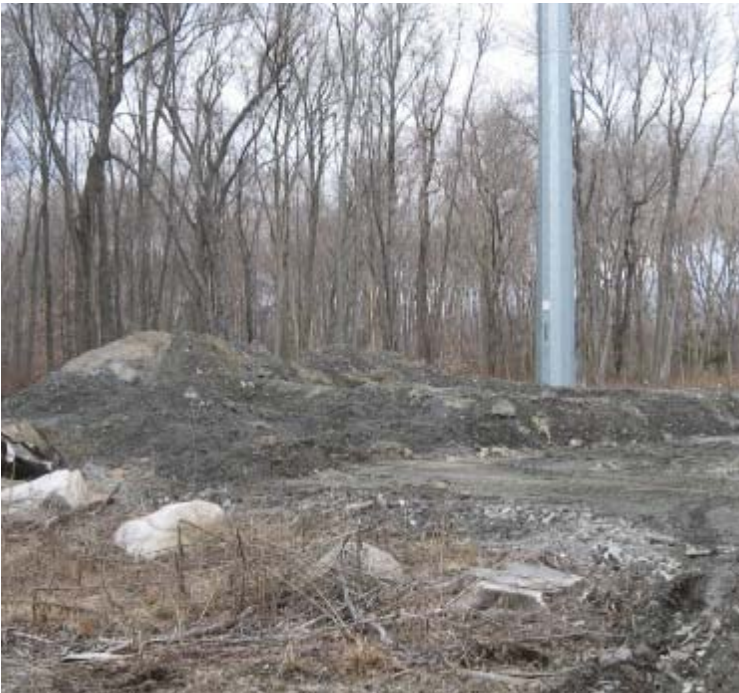
Pease Rd (Woodbridge): Stock piling continues near structure #24112.

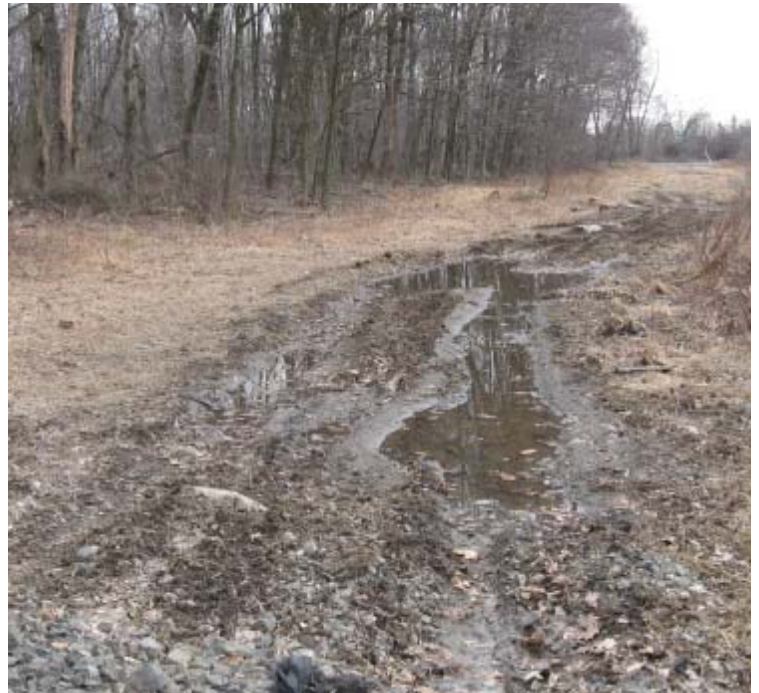
Pease Rd: Tire ruts remain within the wetland located in the abandoned ROW.

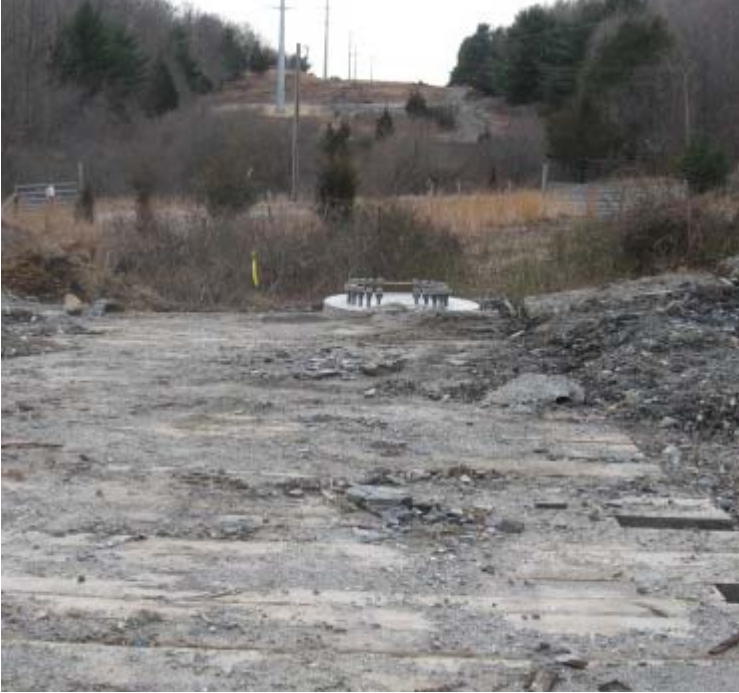
Morris Rd (Woodbridge): Structure #24146 has been installed within wetland #121.

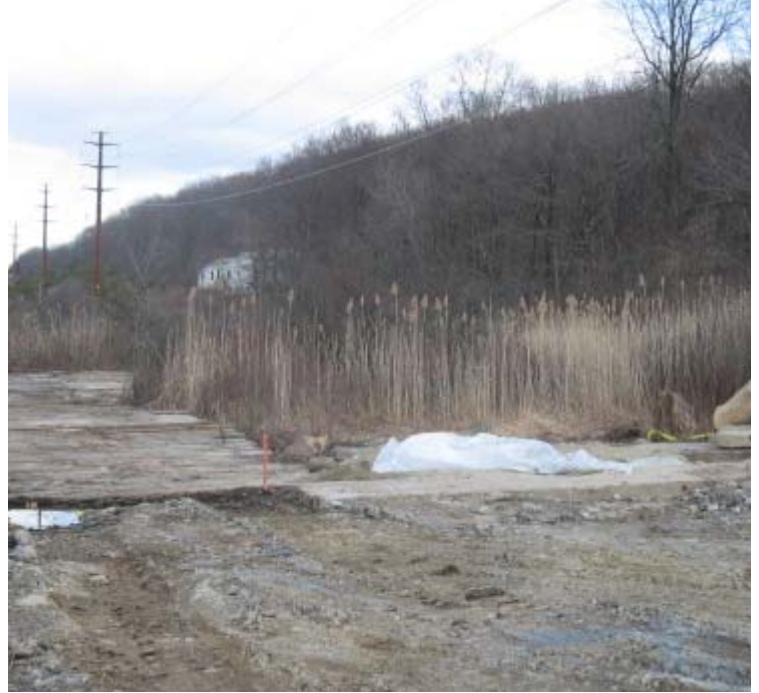
Hatfield Rd (Hamden): Structure #24166 has been installed within wetland #109. Additional timber mats were placed in the wetland here to gain access for lattice tower removal.

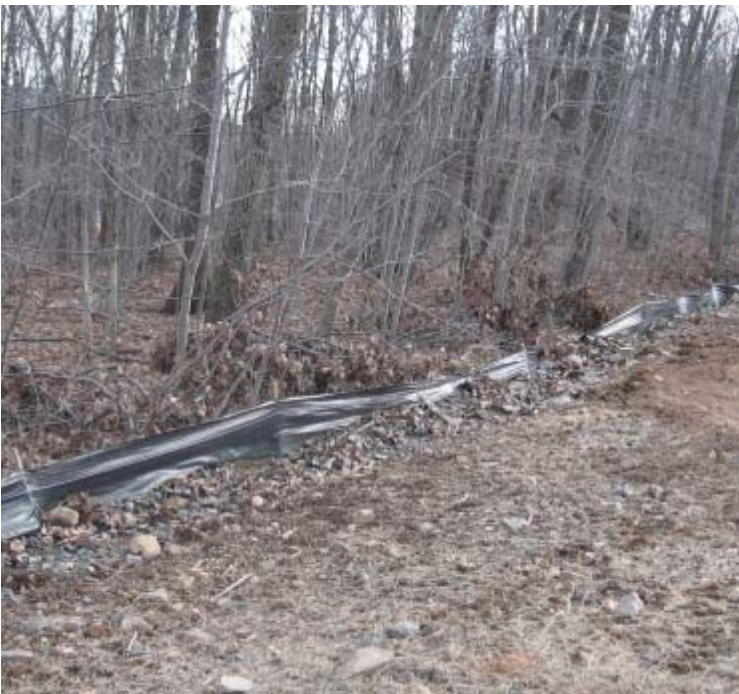
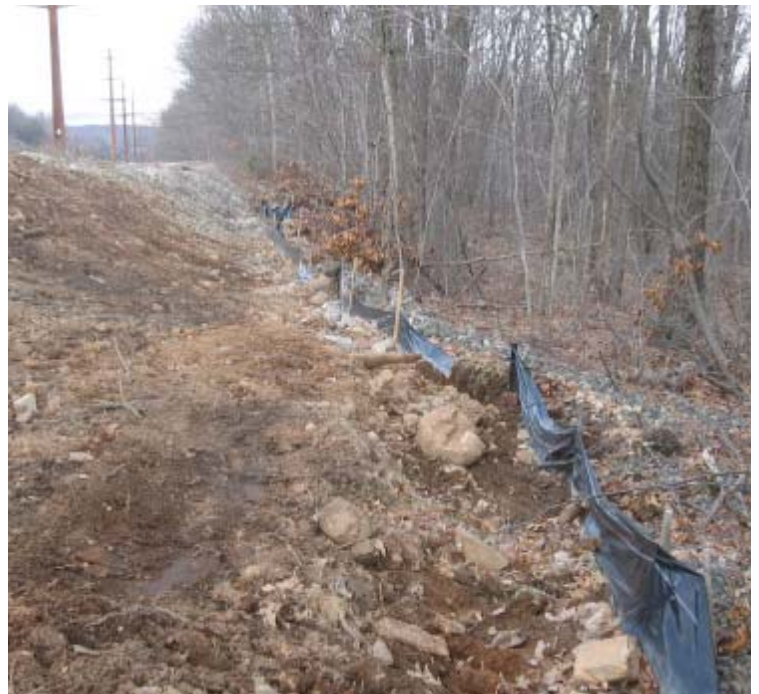
Gaylord Mtn Rd (Hamden): ROW perimeter controls remain functional but are nearing capacity in some locations.

Gaylord Mtn Rd: An additional view of ROW perimeter controls. Stone and waterbar trenches were added in this area to help control stormwater runoff.
