Docket No. 272 – Development and Management Plan Inspection

Segment 2b Inspection

Date: April 11, 2008

Location: Segment 2b – Cheshire/Hamden Town Line to East Devon Substation

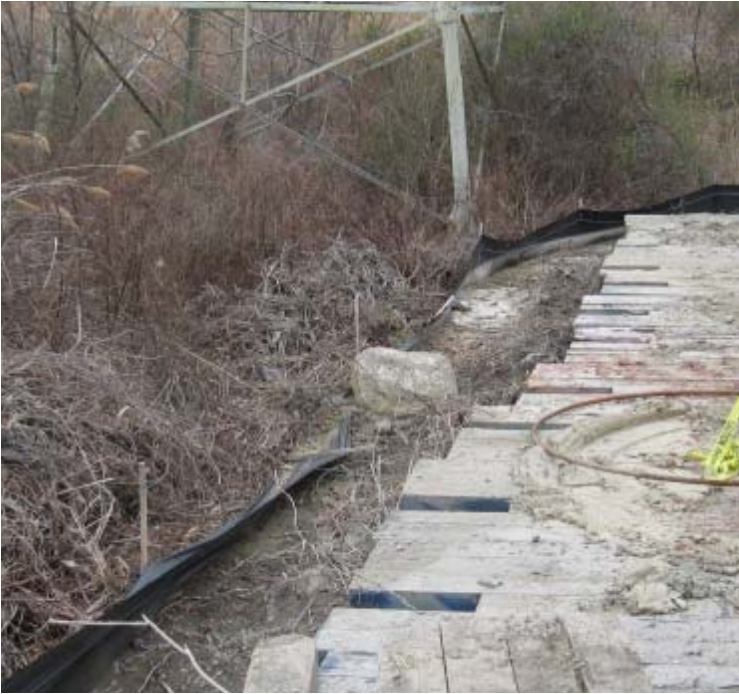
Naugatuck Ave (Milford): Silt fence is in need of repair near structure #3804.

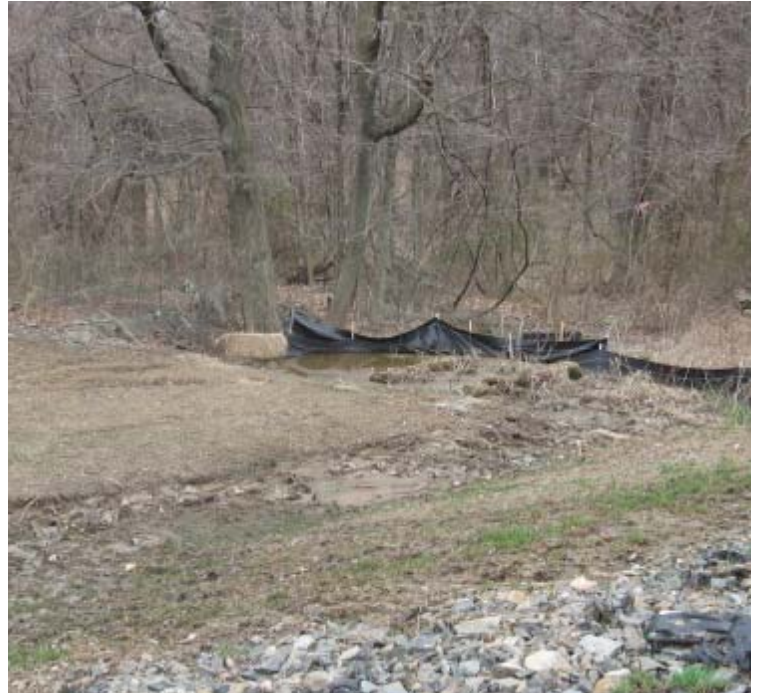
Whealers Farm Rd (Milford): Perimeter controls are nearing capacity and the erosive gully remains.

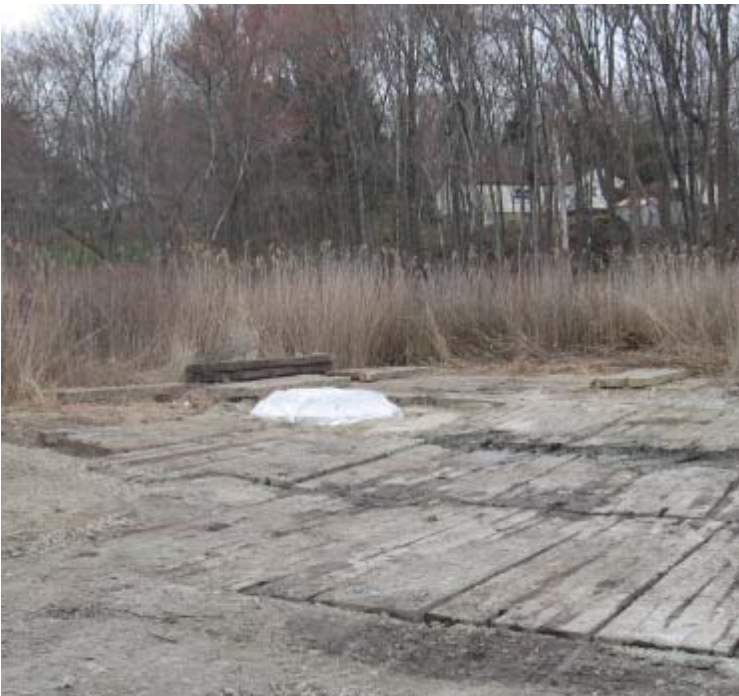
Hunting Hill Rd (Orange): Structure #24068 has been installed in the wetland here, as approved.

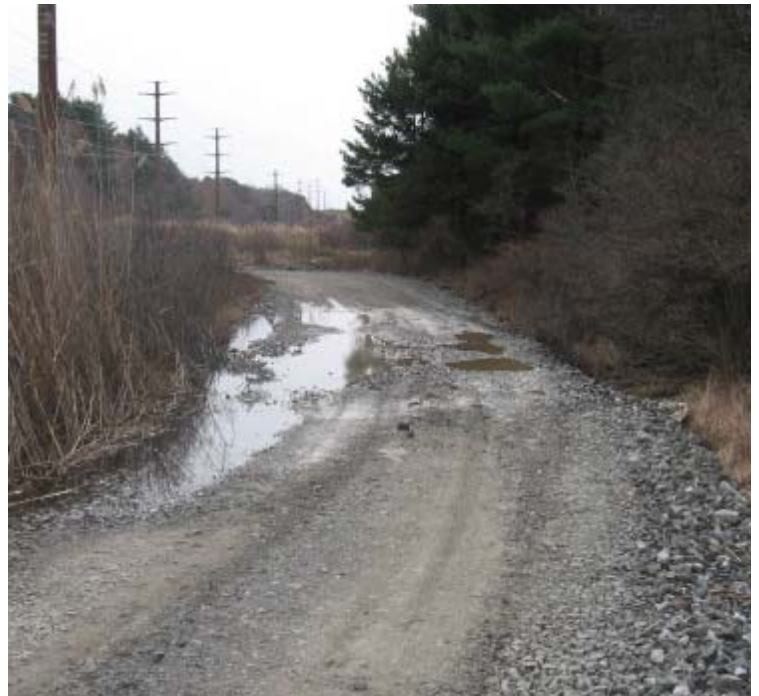
Clearview Ln (Woodbridge): Sediment laden storm water is flowing across the access road and into the adjacent wetland.

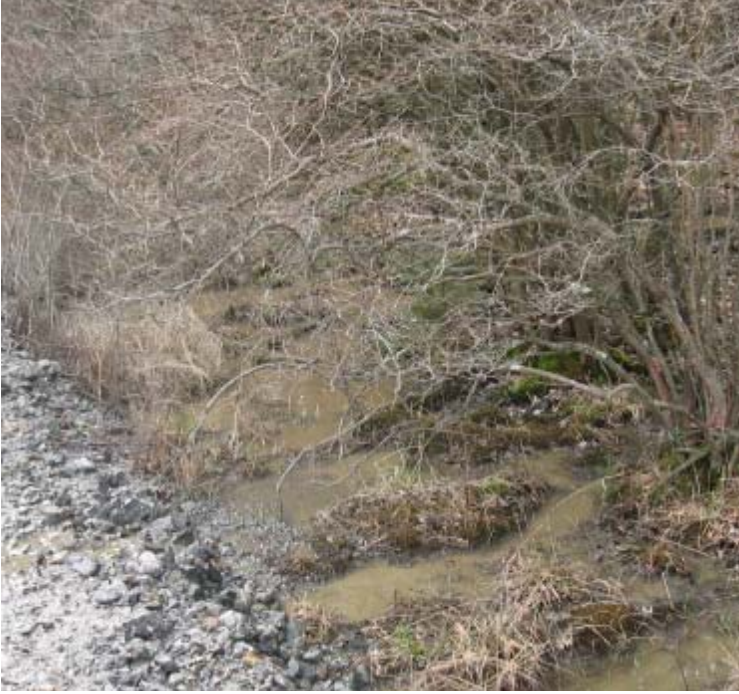
Clearview Ln: View of turbid water entering the wetland.

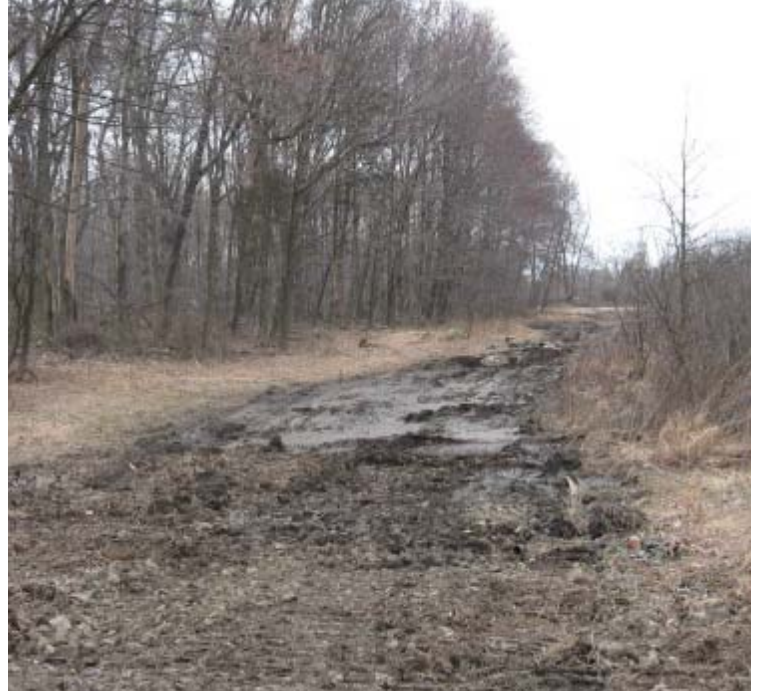
Pease Rd (Woodbridge): The tire ruts located within the abandoned portion of the ROW have been graded.

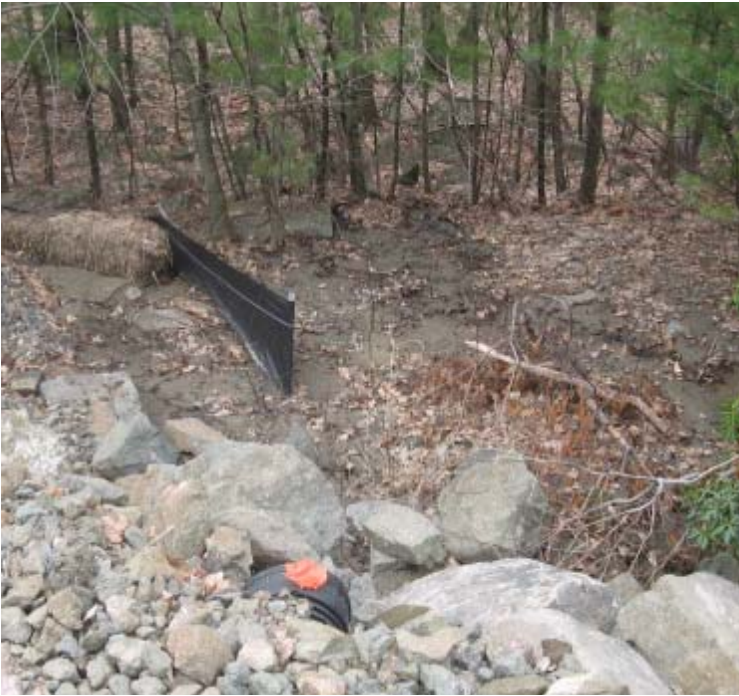
Downs Rd (Bethany): Sediment laden runoff is bypassing controls near structure #24169.

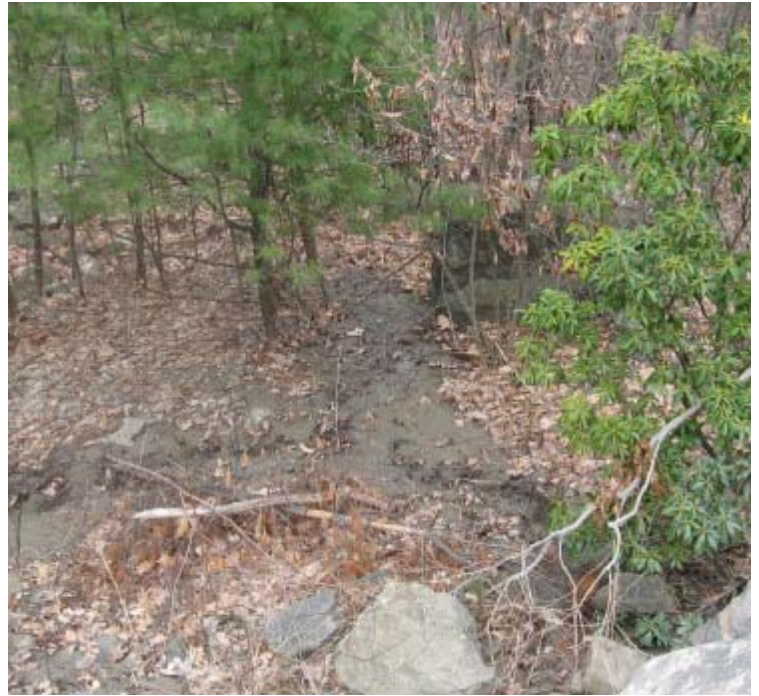
Downs Rd: An additional view of sediment migrating off the ROW near structure #24169.
