**Docket No. 272 – Development and Management Plan Inspection**

**Segment 2b Inspection**

**Date:** May 2, 2008

**Location:** Segment 2b – Cheshire/Hamden Town Line to East Devon Substation

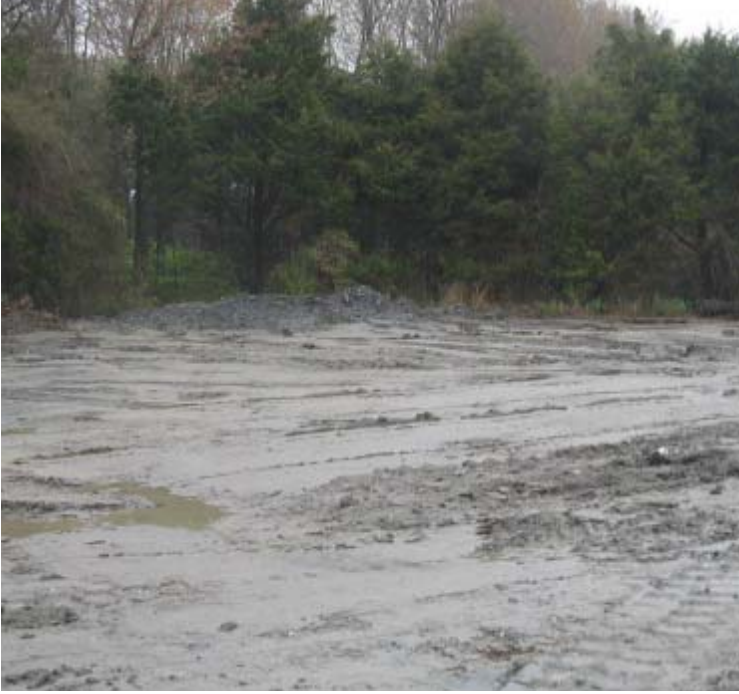
Brookwood Ave (Woodbridge): Spoils have been removed from the ROW near structure #24096.

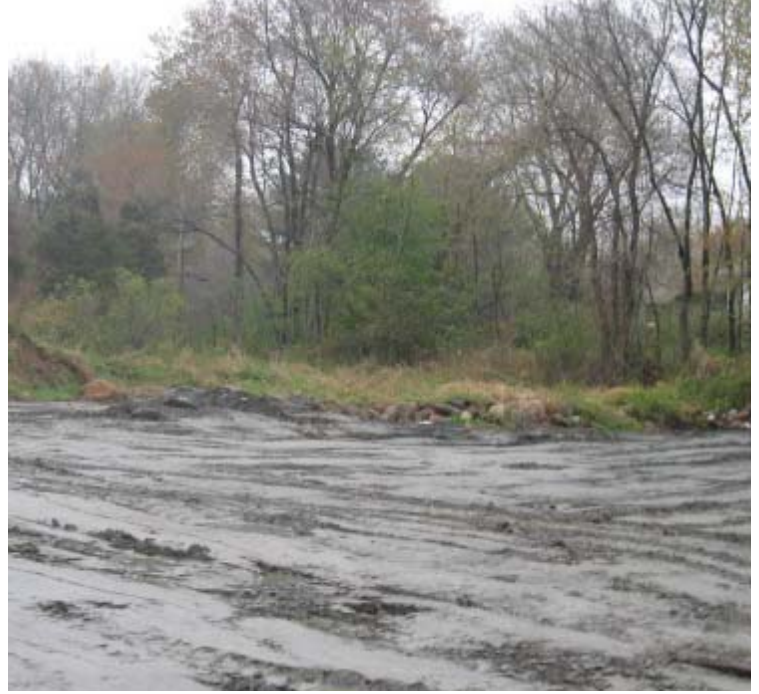
Brookwood Ave: Spoils located within the wetland buffer have been removed from the ROW.
