**Docket No. 272 – Development and Management Plan Inspection**

**Segment 2b Inspection**

**Date:** May 9, 2008

**Location:** Segment 2b – Cheshire/Hamden Town Line to East Devon Substation

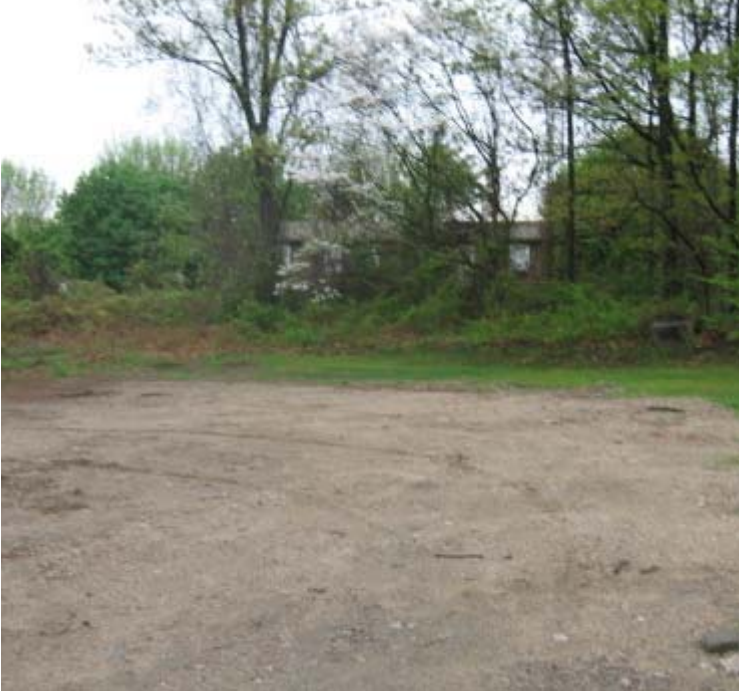
Plains Rd (Milford): A view of 115 kV restoration efforts at structure #3816.

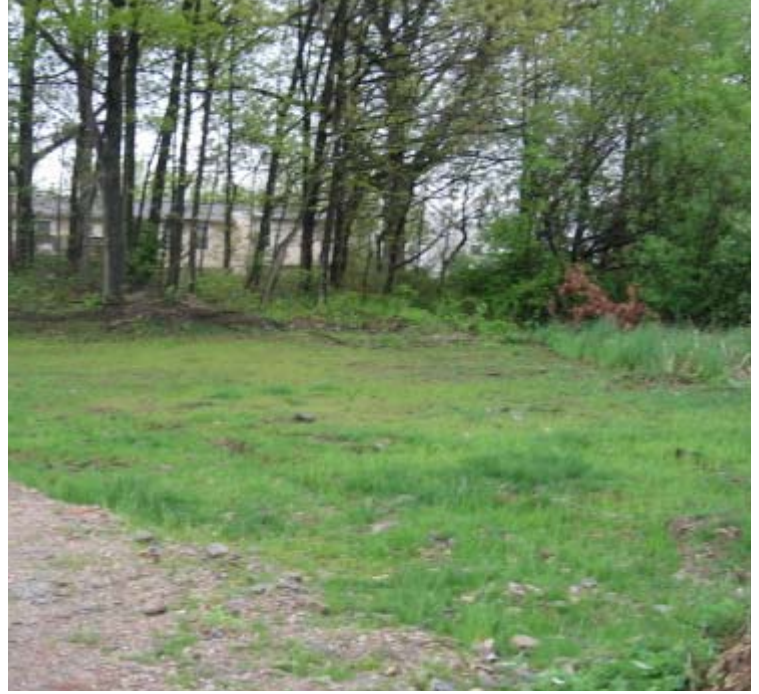
Plains Rd: Vegetation growth near structure #3816.

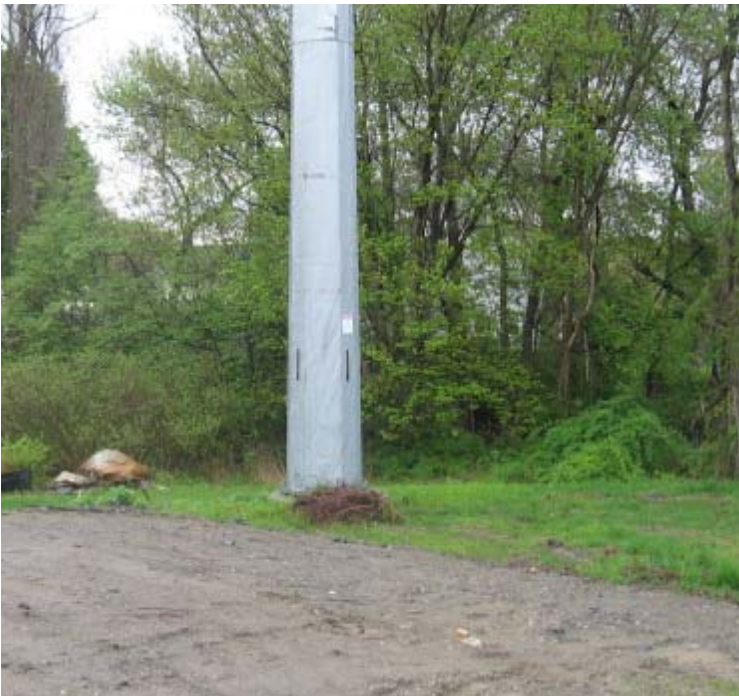
Oronoque Rd (Milford): A view of 115kV restoration efforts near structure #3821.

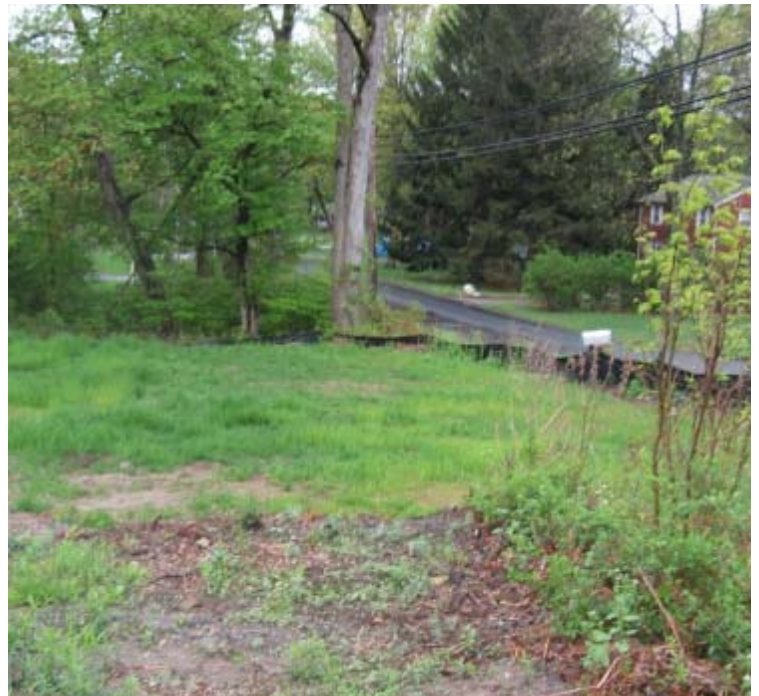
Oronoque Rd: Vegetation growth near structure #3821.

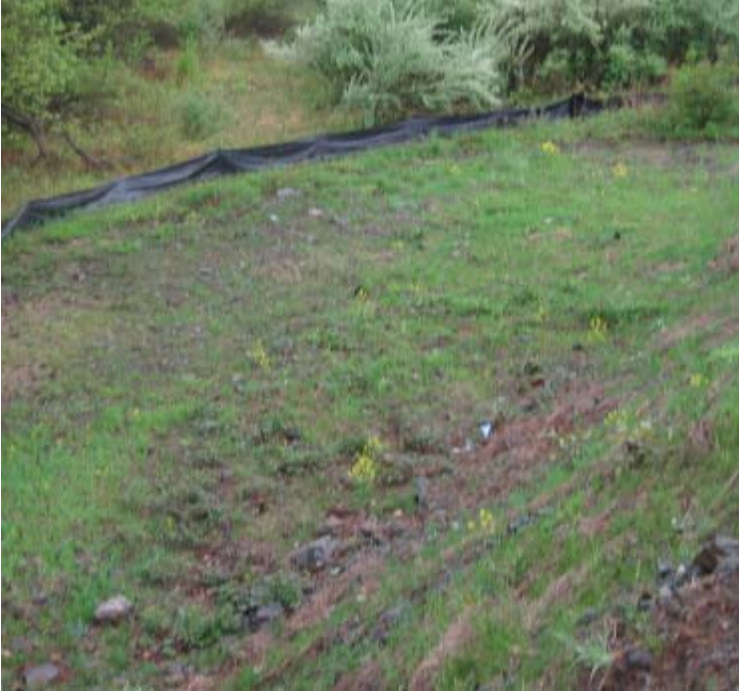
Lexington Way (Milford): A view of 115 kV restoration efforts near structure #3826.

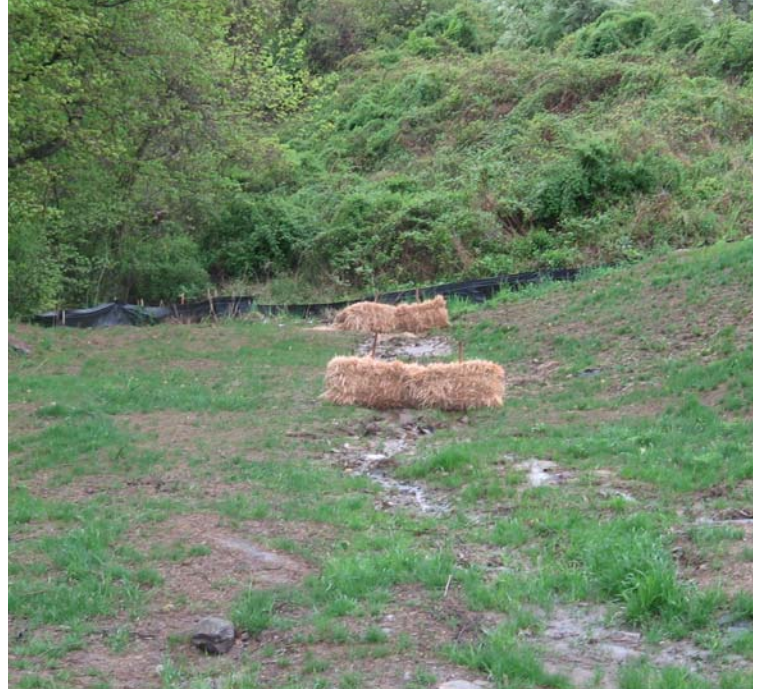
Whealers Farm Rd (Milford): Haybale controls have been added to help control stormwater runoff near structure #3832.

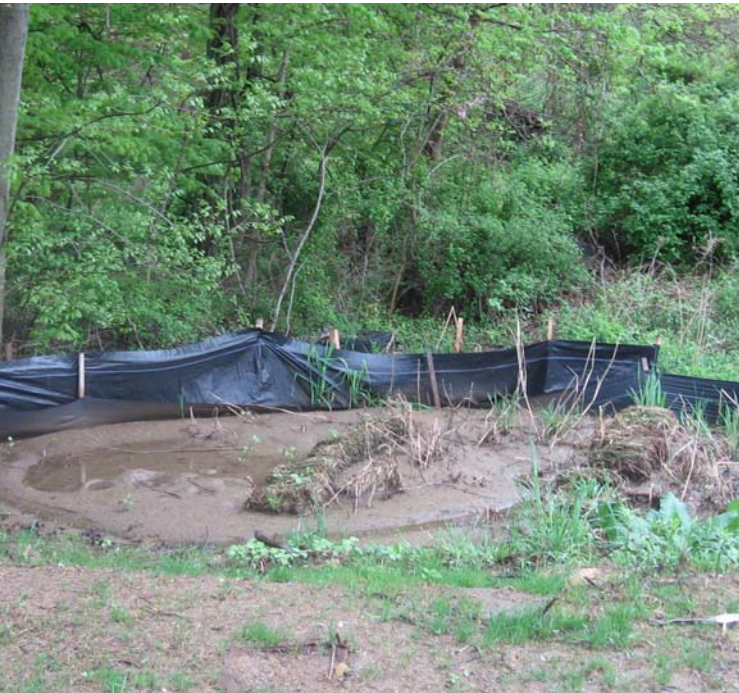
Whealers Farm Rd: Silt fence controls are nearing capacity near structure #3832.

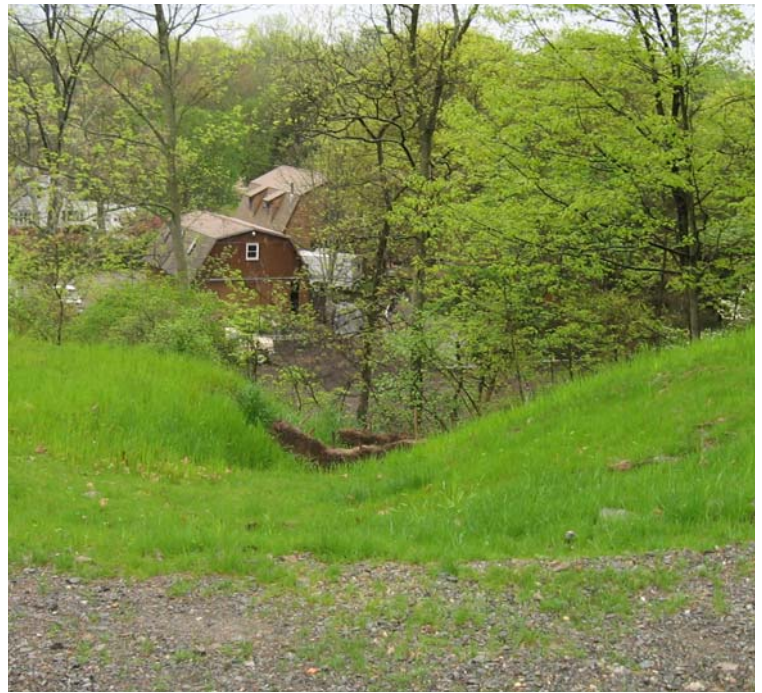
Fresh Meadow Ln (Milford): The vegetated swale near structure #3835 appears stable at this time.

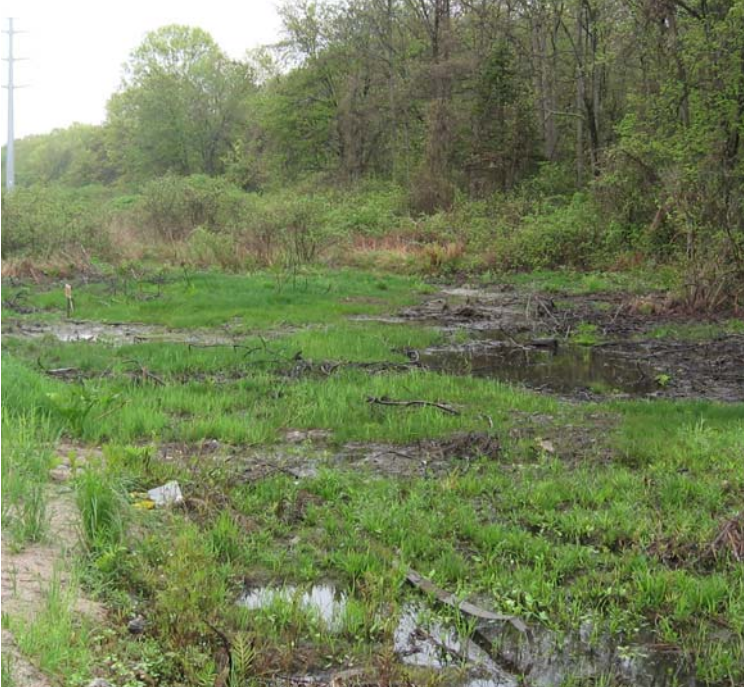
West River St (Milford): A view of 115 kV restoration efforts near structure #3837.

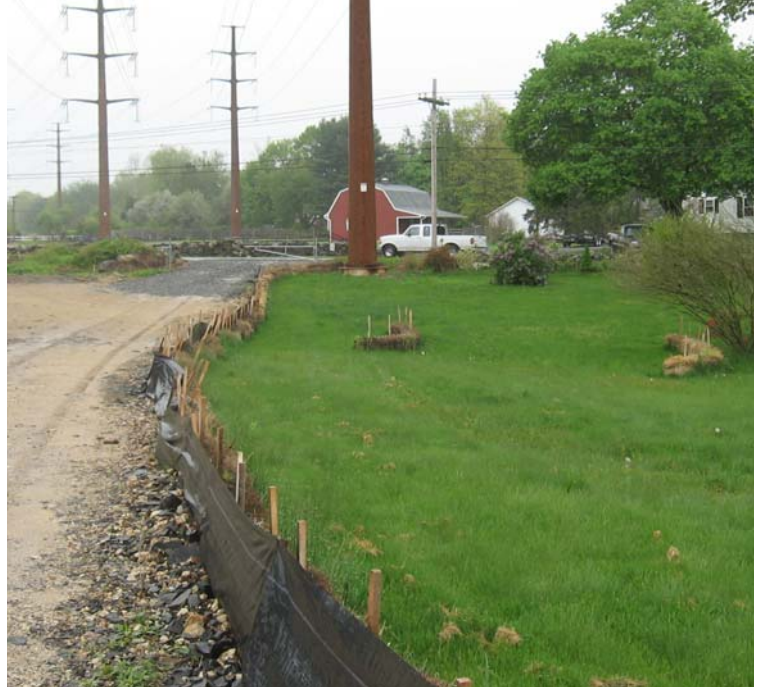
Ridge Rd (Orange): A view of 115 kV restoration efforts near structure #3848.

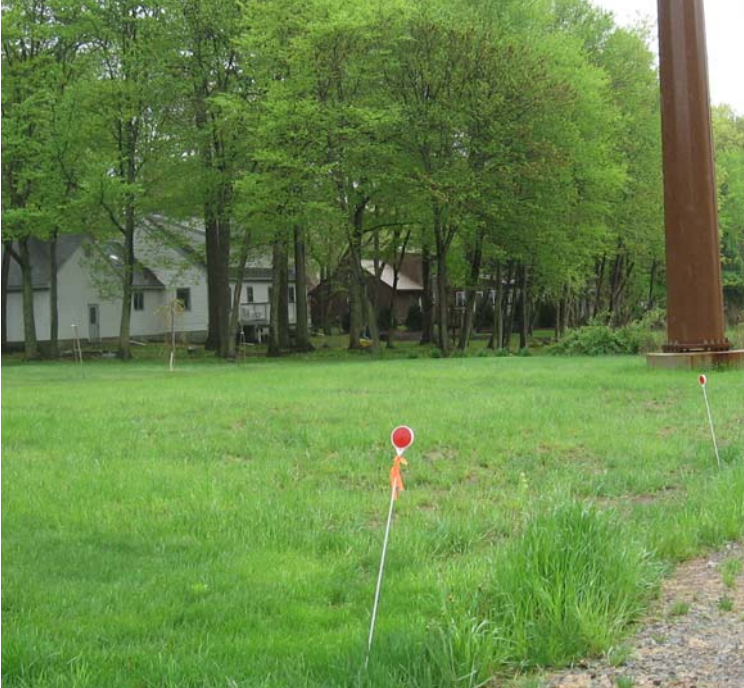
Pine Tree Dr (Orange): A view of 115 kV restoration efforts near structure #3855.

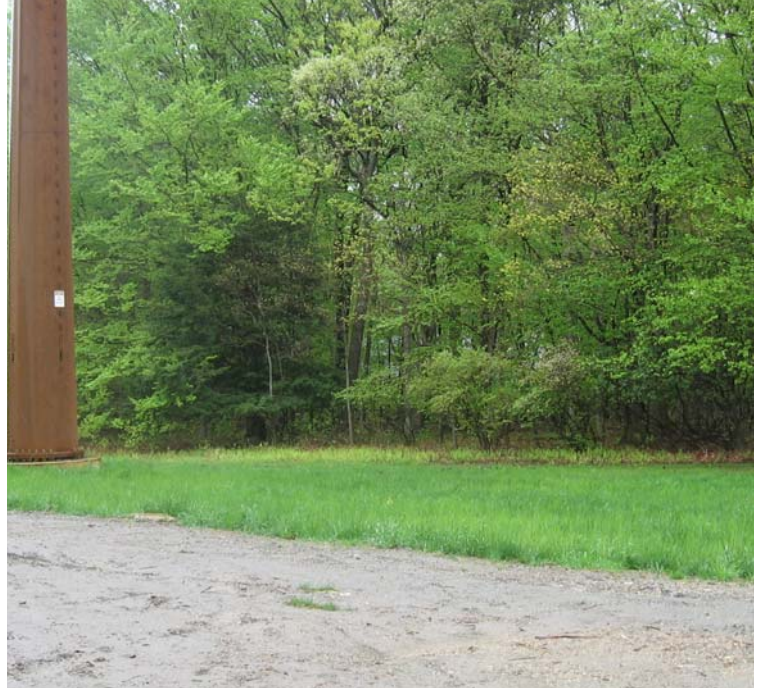
Pine Tree Dr: A view of 115 kV restoration efforts near structure #3857.

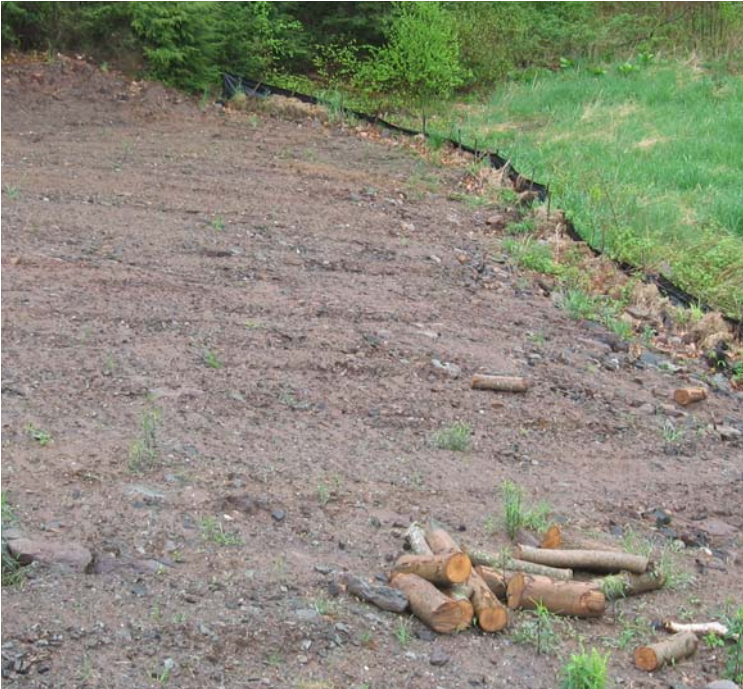
<b>Orange, CT</b> Russell Ave	A trench was installed along the access road here in an effort to control stormwater runoff. 5/9/08	Continue to monitor. 5/9/08	NA
Lambert Rd	Grading/pad reclamation continues near structure #3863 in order to decrease the slope on the southern side of the crane pad. Exposed soils appear stable. 5/9/08	Continue to monitor. 5/9/08	NA
Dogwood Rd	Silt fence is in need of repair near structure #24067. 3/12-5/9/08	Repair/add controls as necessary. 5/9/08	Needs attention when feasible
Dogburn Rd	Access road controls are still in need of repair and waterbars are no longer	Repair/add controls as necessary. 5/9/08	Needs evaluation/attention

Lambert Rd (Orange): Grading/115 kV pad reclamation continues near structure #3863 in order to decrease the slope on the southern side of the crane pad. Exposed soils appear stable at this time.

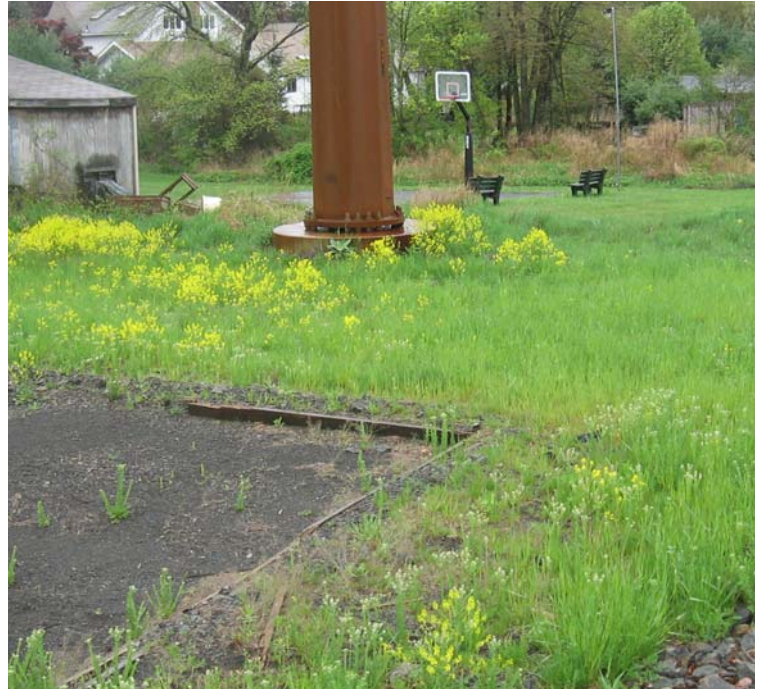
Sunset Dr (Orange): A view of 115 kV restoration efforts near structure #3865.

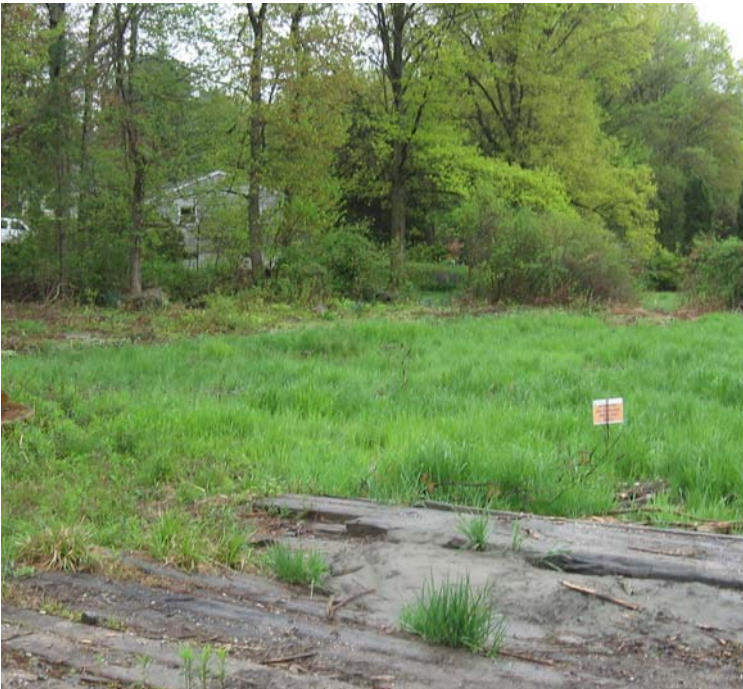
Racebrook Rd (Orange): A view of 115 kV restoration efforts near structure #3870.

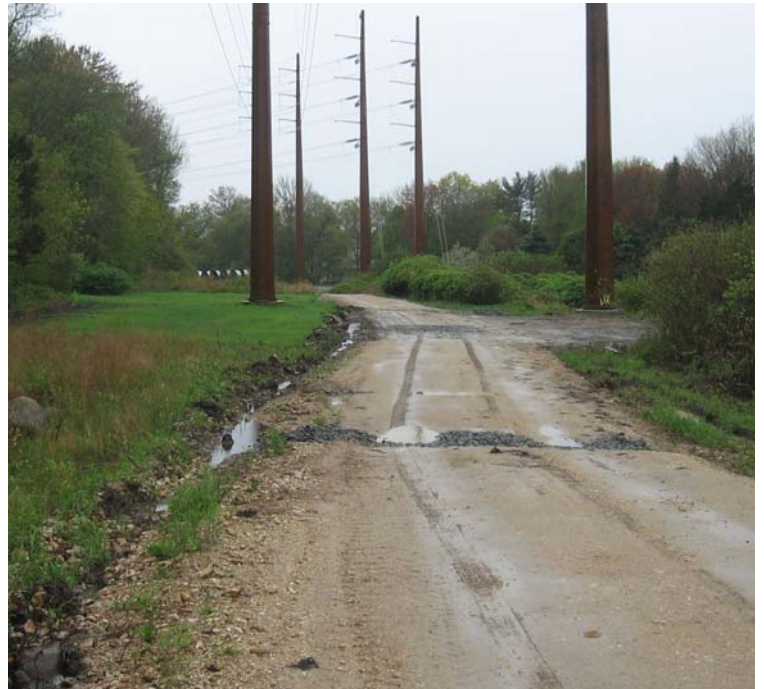
Russell Ave (Orange): A trench was installed along the access road in this area to help control stormwater runoff. Vegetation growth has been noted in this area near 115 kV structures.

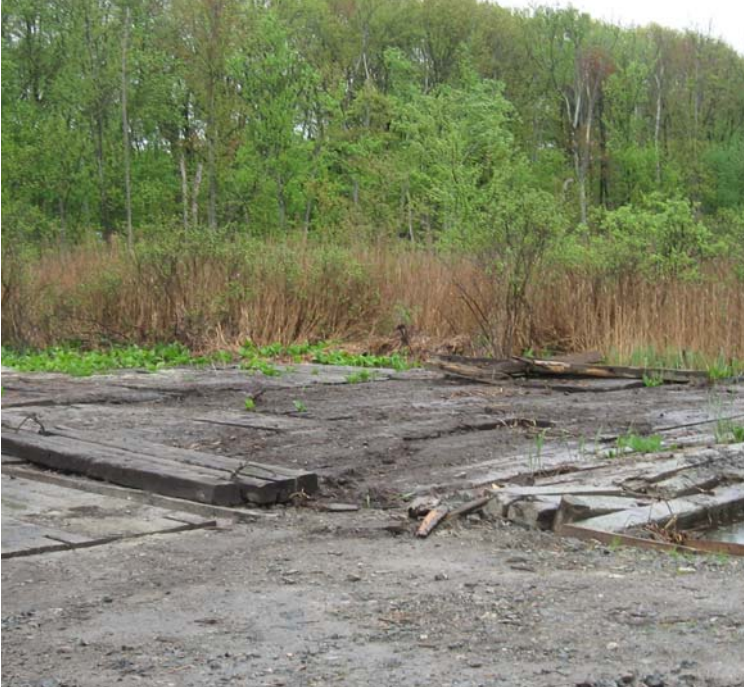
Hunting Hill Rd (Orange): Wetland timber mats remain for access to structures #3881/24068.

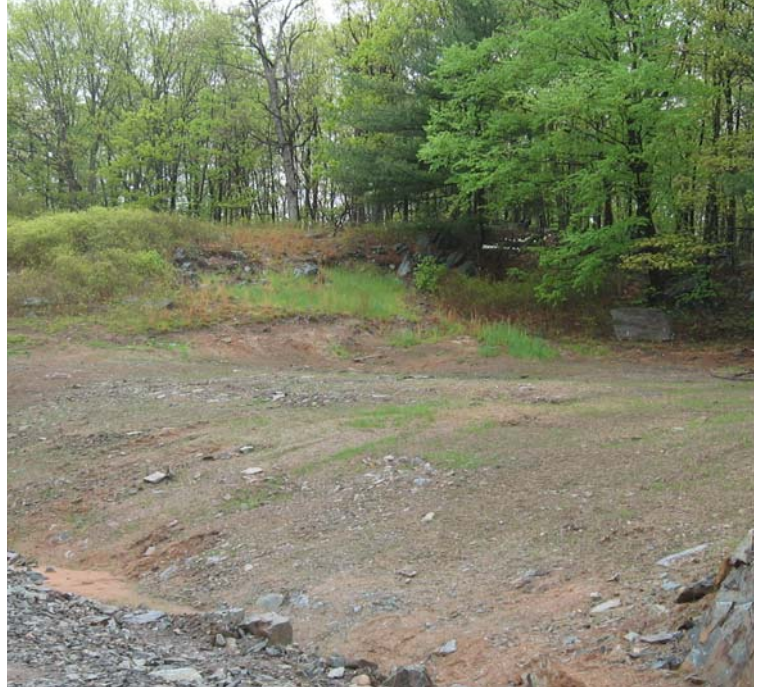
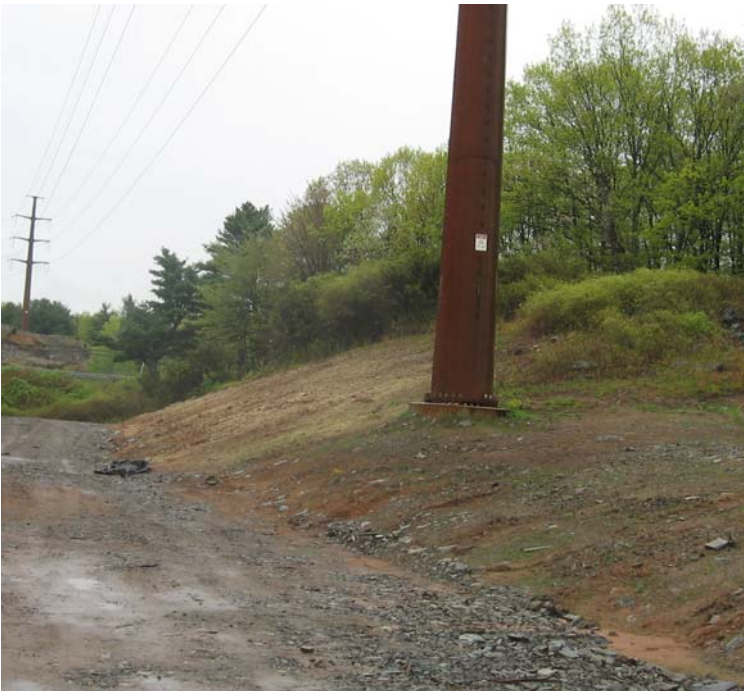
Rt 34 (Orange): A view of 115 kV restoration efforts near structure #3887.

Rt 34: A view of 115 kV restoration efforts near structure #3887.

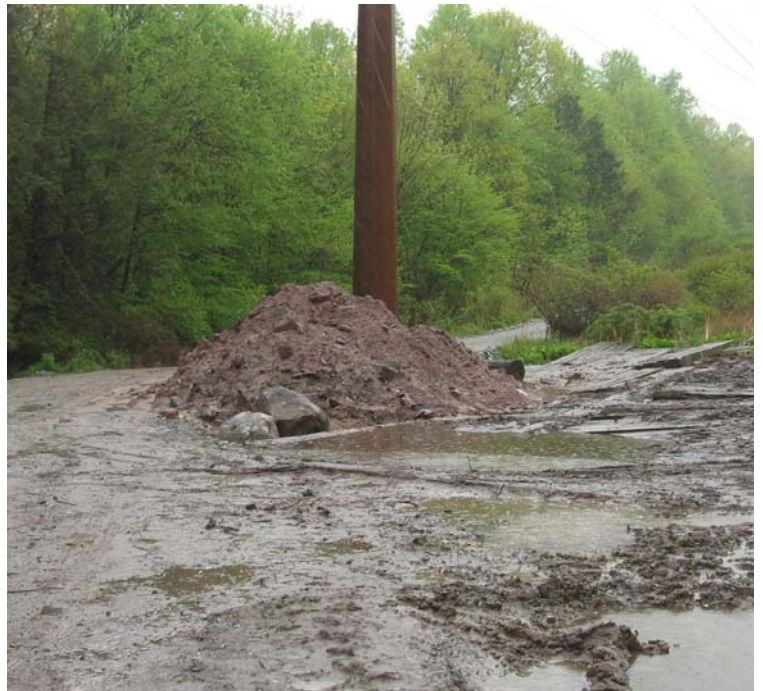
Gaylord Mtn Rd (Hamden): A spoil pile remains in the wetland area near structure #24179.
