**Docket No. 272 – Development and Management Plan Inspection**

**Segment 2b Inspection**

**Date:** May 16, 2008

**Location:** Segment 2b – Cheshire/Hamden Town Line to East Devon Substation

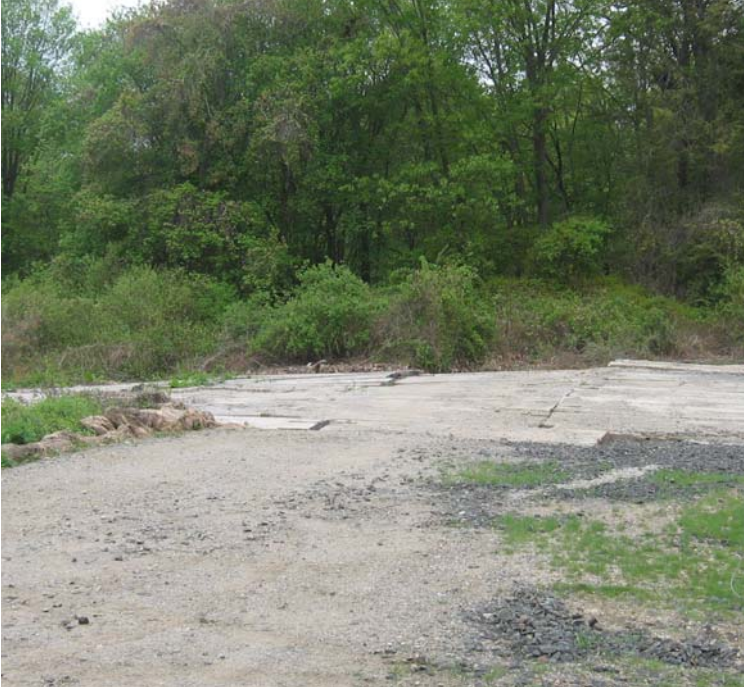
Eisenhower Park (Milford): Wetland timber mats remain near structure #3839/24026.

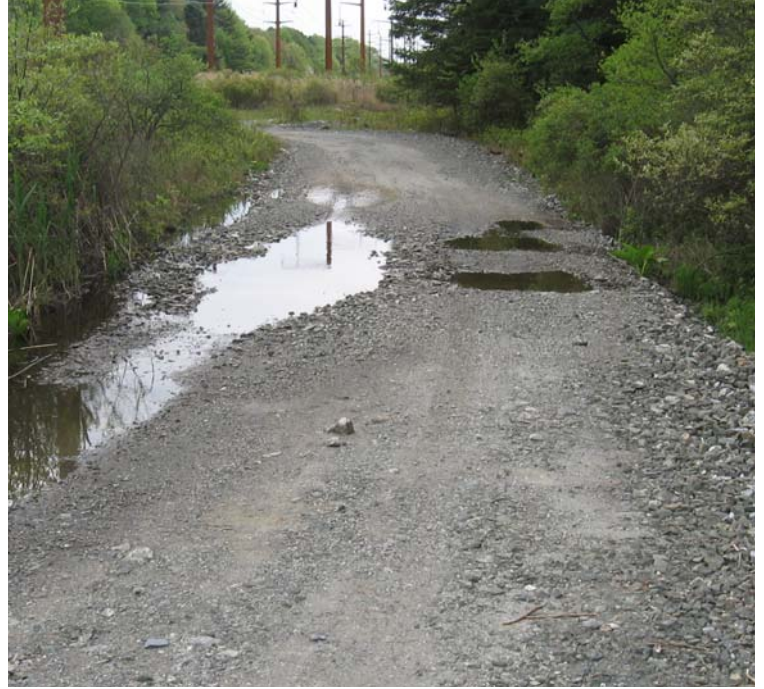
Clearview Ln (Woodbridge): The access road to structures #3899/24086 is impeding water flow from the eastern portion of wetland to the western portion.

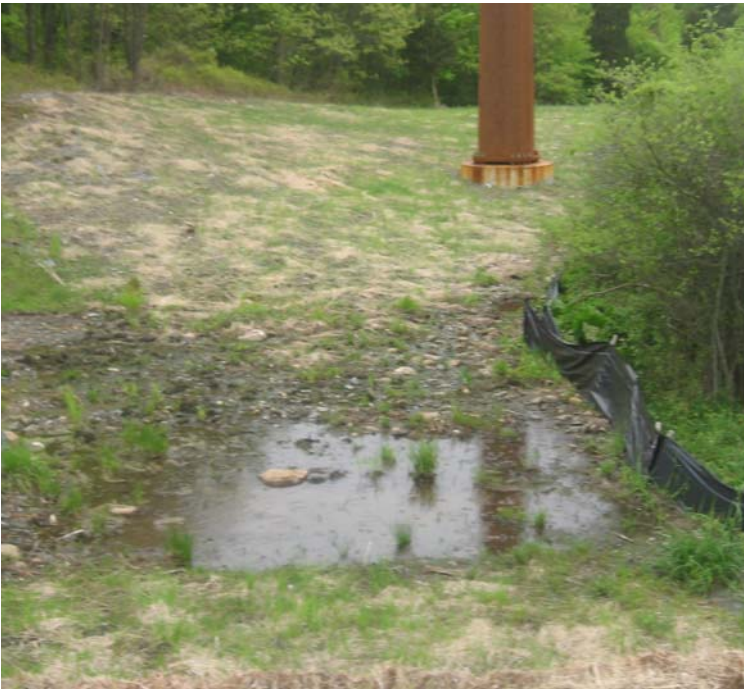
Litchfield Tpk (Bethany): A view of 115 kV restoration efforts at structure #3961.

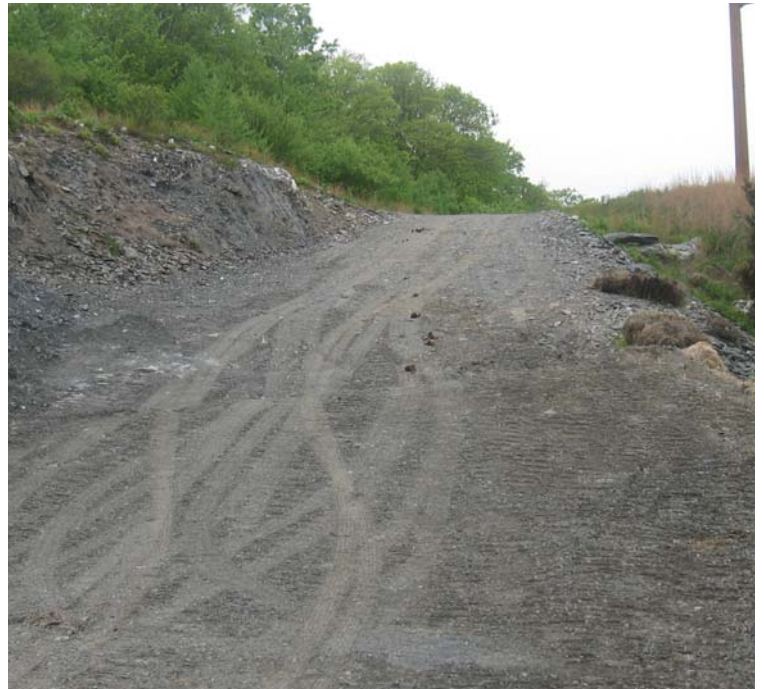
Litchfield Tpk: Access road controls (i.e waterbars) remain functional near structure #24148.

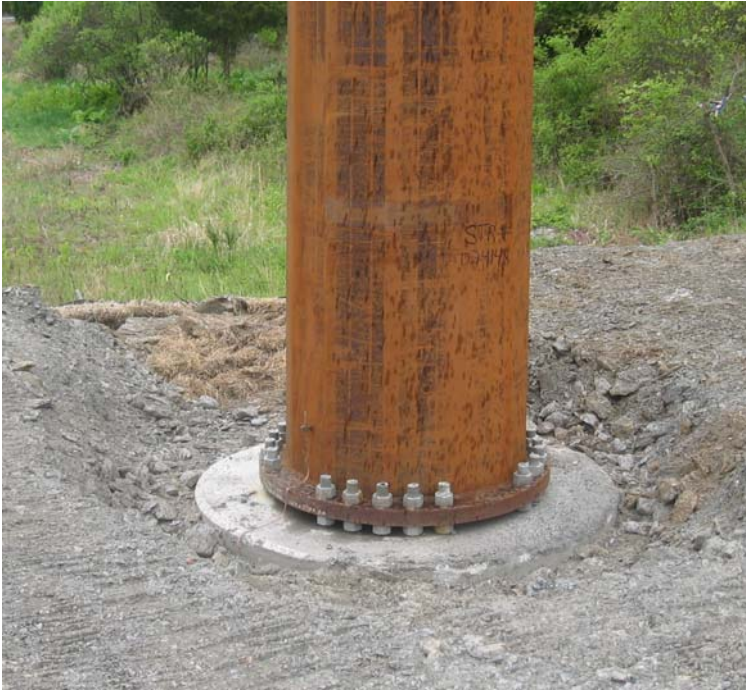
Litchfield Tpk: Stormwater controls have been installed at the base of structure #24148.

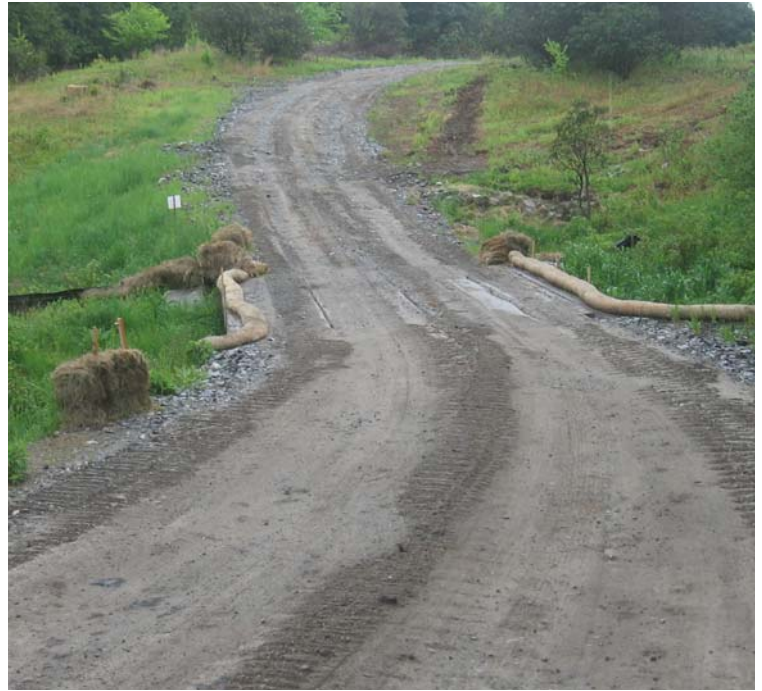
Litchfield Tpk: Access road controls (i.e waterbars) continue to function at the wetland crossing between structures #24152-153. Sediment continues to accumulate on the timber mat crossing here.

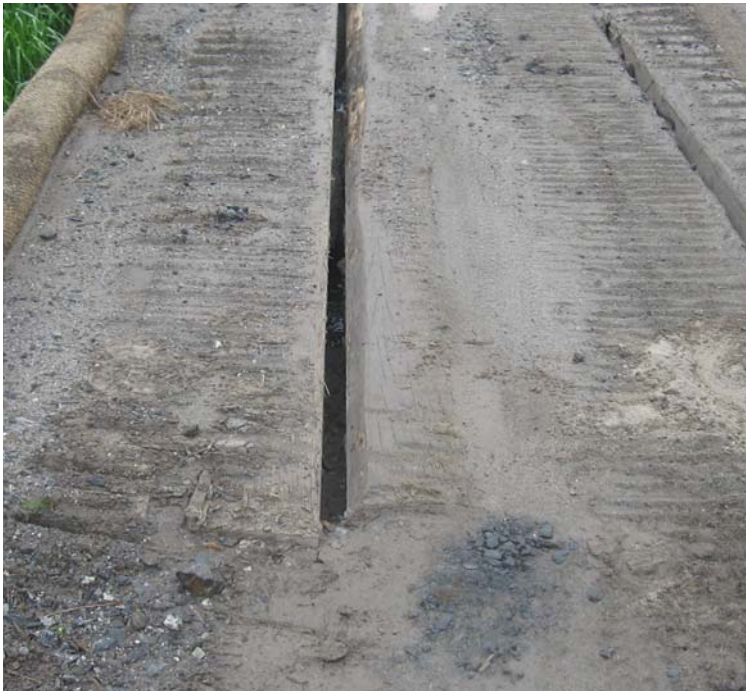
Litchfield Tpk: A view of sediment accumulated on the timber mat crossing between structures #24153-154.

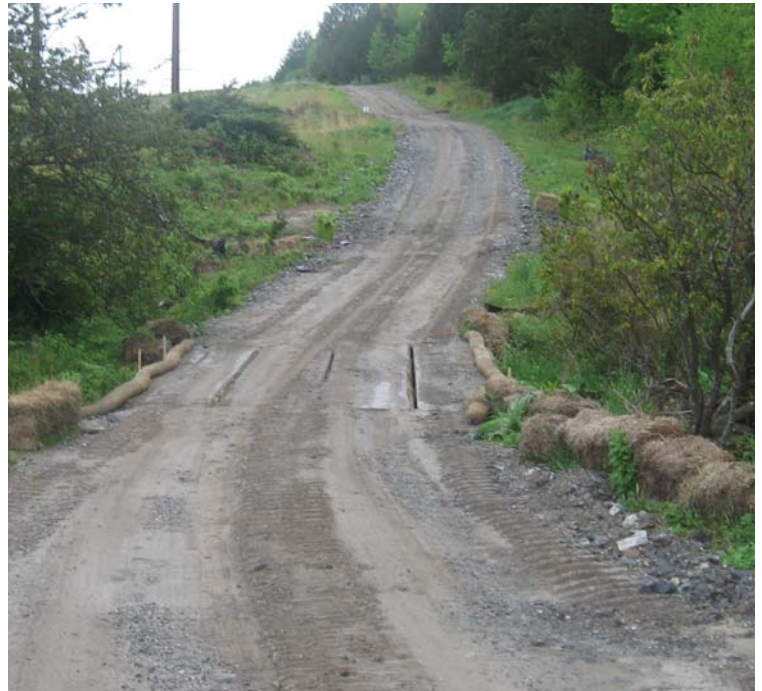
Litchfield Tpk: A view of the timber mat crossing between structures #24154-155. A culvert remains beneath the timber mats here, which allows for water flow.

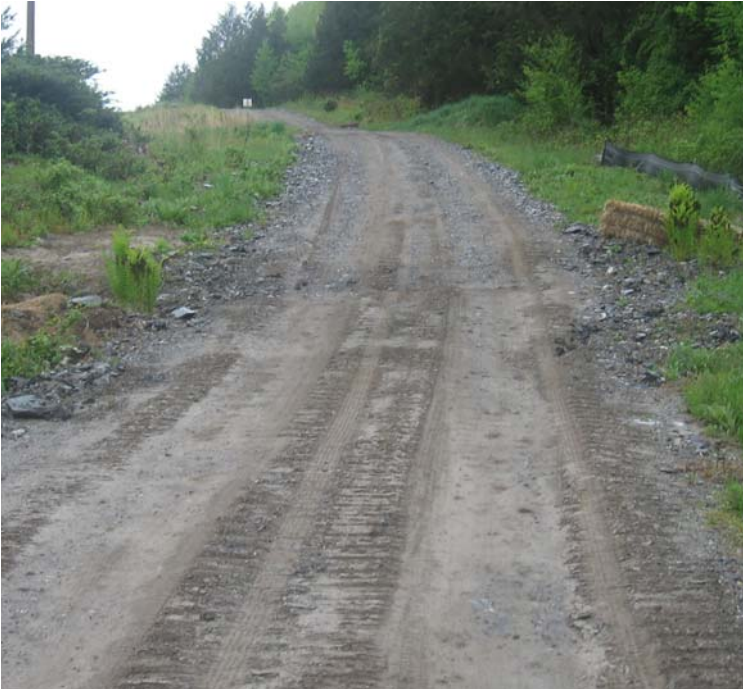
Litchfield Tpk: Access road controls (i.e waterbars) remain functional at the wetland crossing between structures #24154-155.

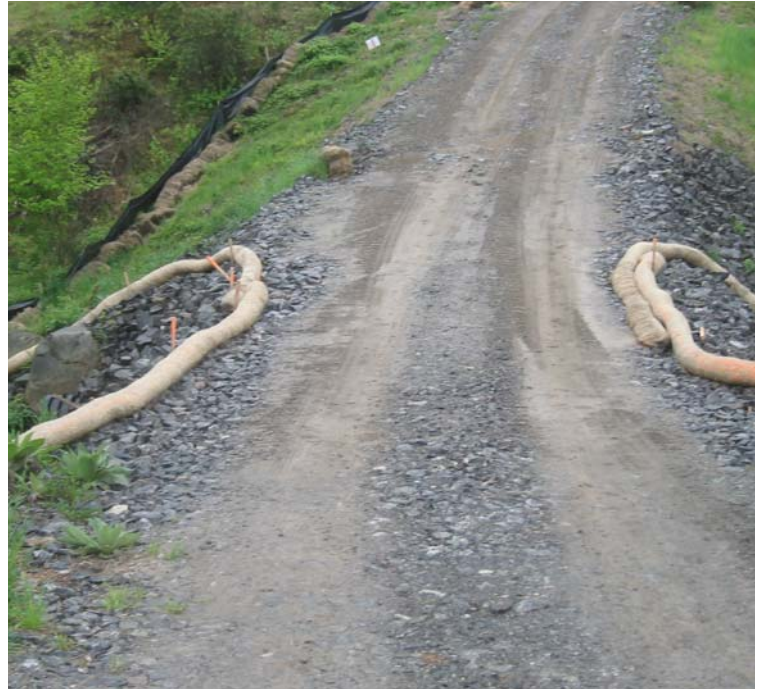
Litchfield Tpk: A view of the wetland crossing between structures #24156-157. Erosion controls remain functional.

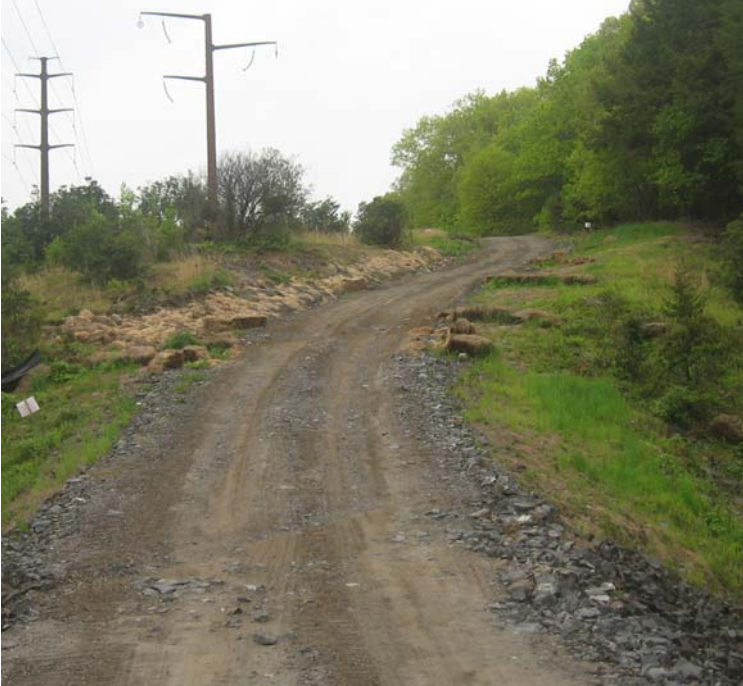
Litchfield Tpk: Access road controls remain functional near the wetland crossing between structures #24156-157.

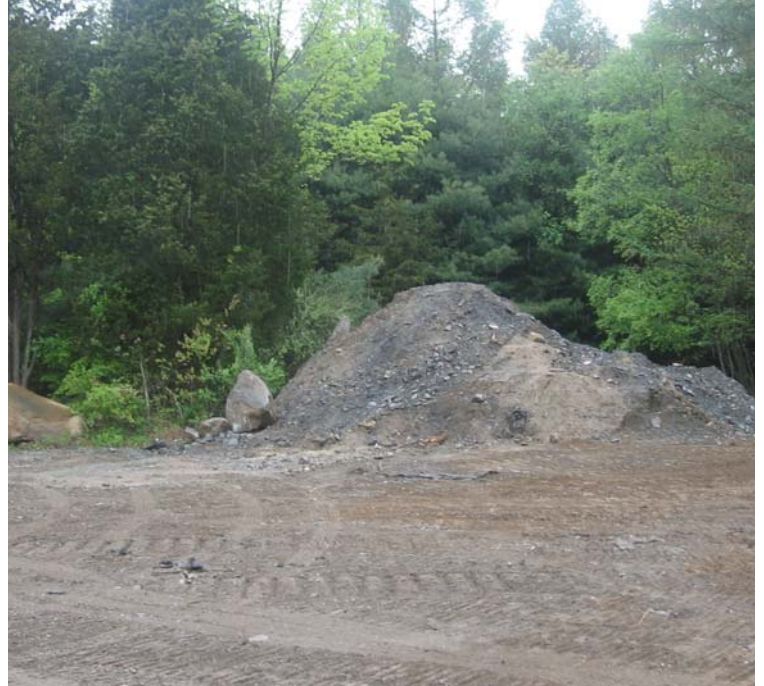
Hatfield Road north (Bethany): Spoil piles remain within upland portions of the ROW. Spoils in this area appear to be contained on site.

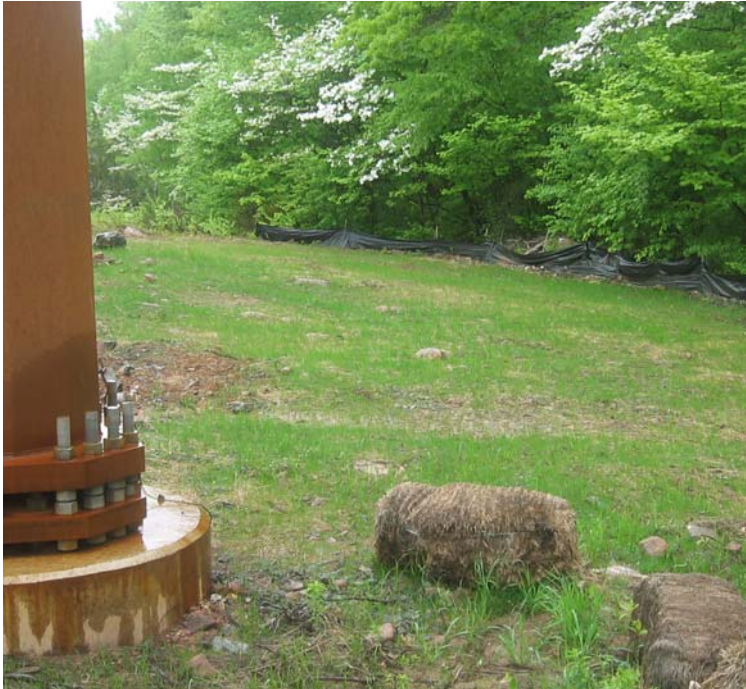
Tom Swamp Rd (Hamden): A view of 115 kV restoration efforts near structure #4002.

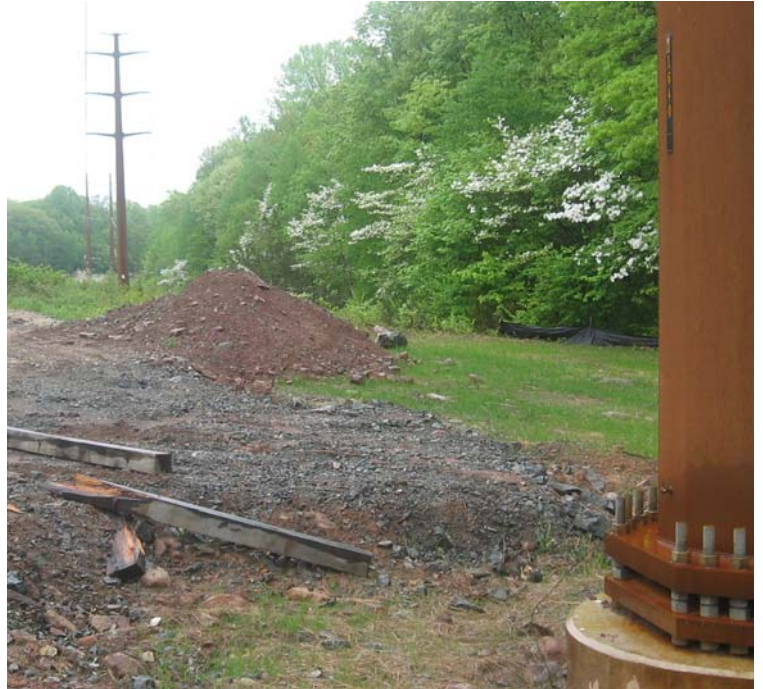
Tom Swamp Rd: Spoil piles remain within the ROW in this area. Spoils appear to be contained in upland portions of the site.

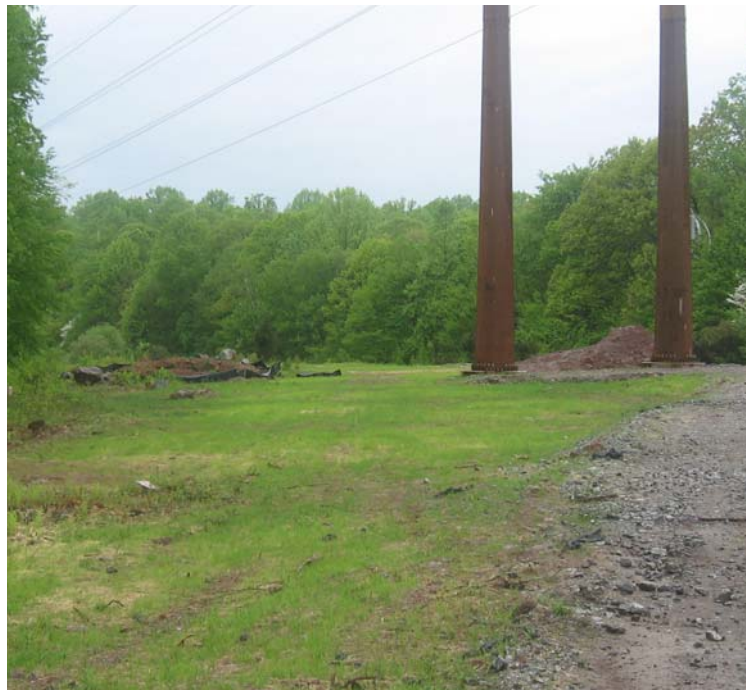
Brooksvale Ave (Hamden): A view of 115 kV restoration efforts near structure #4004. Spoils remain in upland portions of the ROW in this area. Spoils appear to be contained on site.
