Docket No. 272 – Development and Management Plan Inspection

Segment 2b Inspection

Date: May 30, 2008

Location: Segment 2b – Cheshire/Hamden Town Line to East Devon Substation

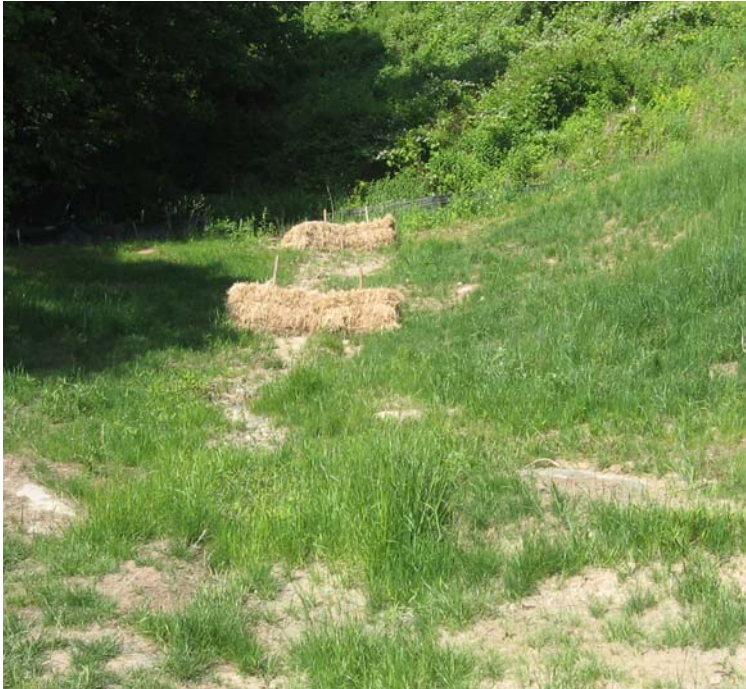
Wheelers Farm Rd (Milford): Grass growth was observed within the erosive gully near structure #3832.

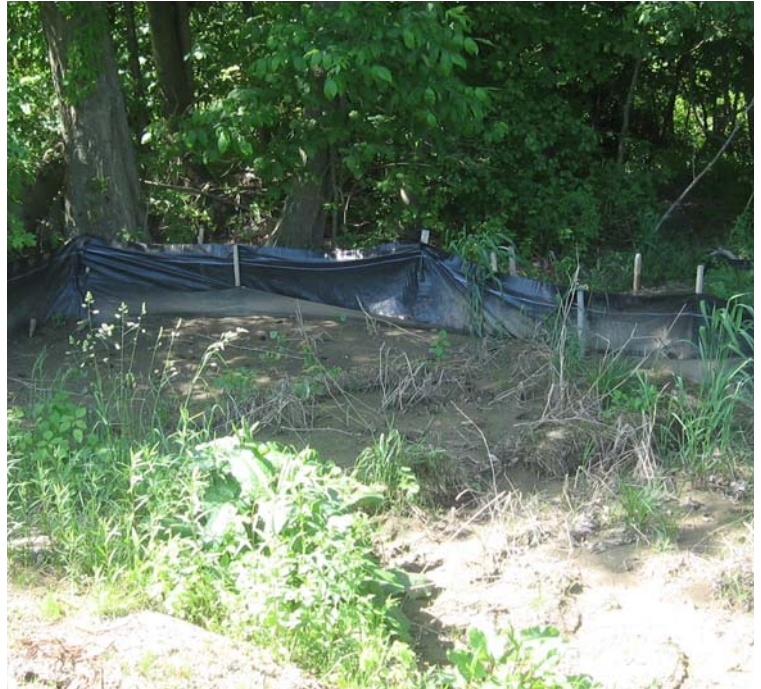
Wheelers Farm Rd: No further sediment accumulation has been observed within the controls near structure #3832.

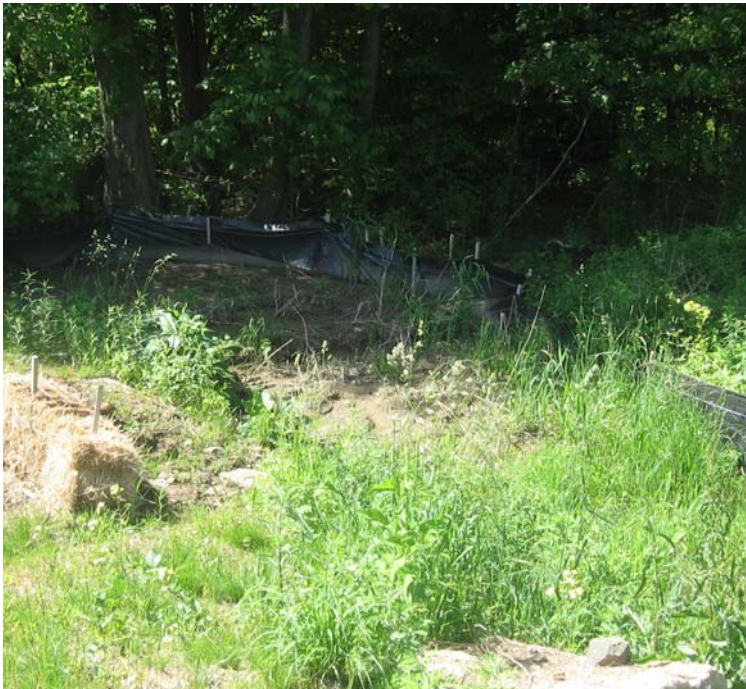
Wheelers Farm Rd: An additional view of the silt fence near structure #3832.

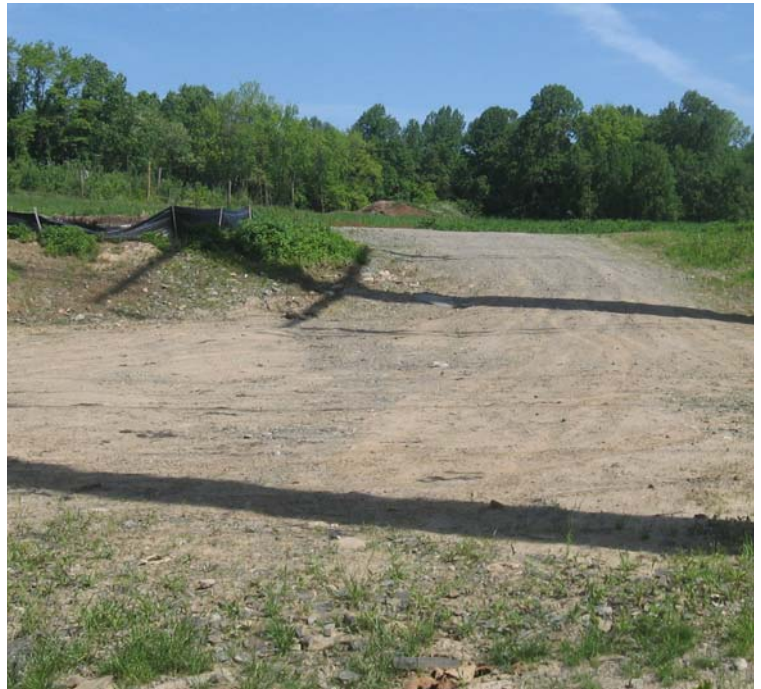
Wheelers Farm Rd: Ground water is no longer flowing across the access road and crane pad near structure #3832. However, stormwater continues to channelize within the ROW.

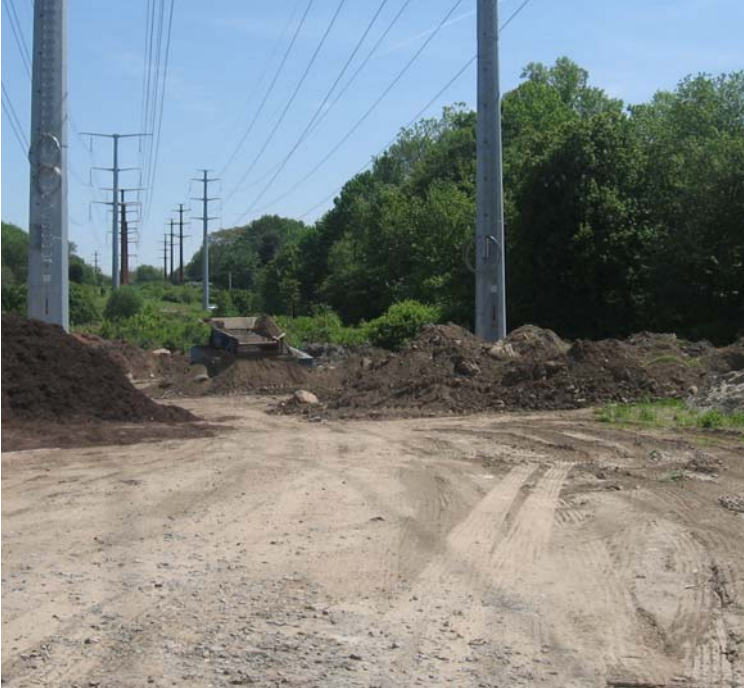
North St (Milford): A view of non-project related activity within the ROW near structure #3845/24032. This activity is within the wetland buffer.

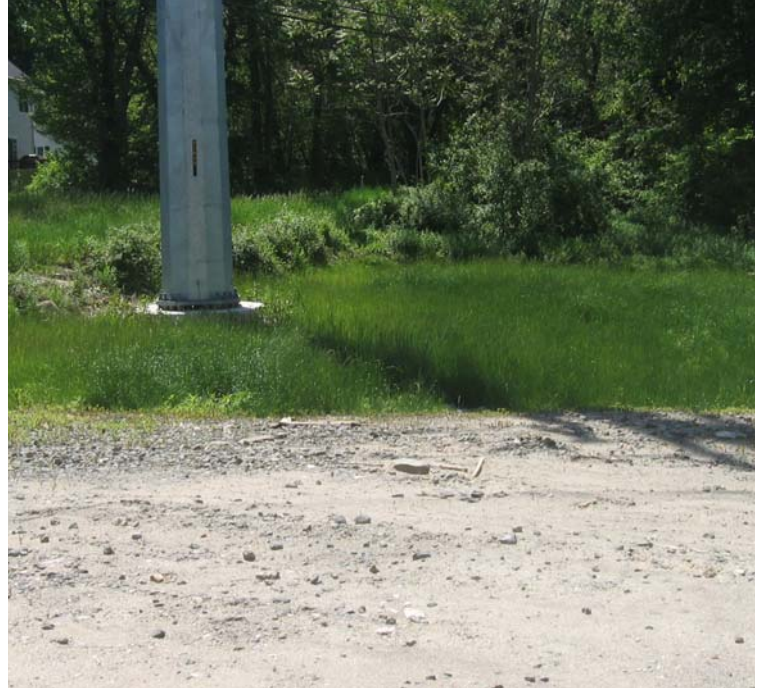
North St (south): A view of 115kV restoration efforts near structure #3844.

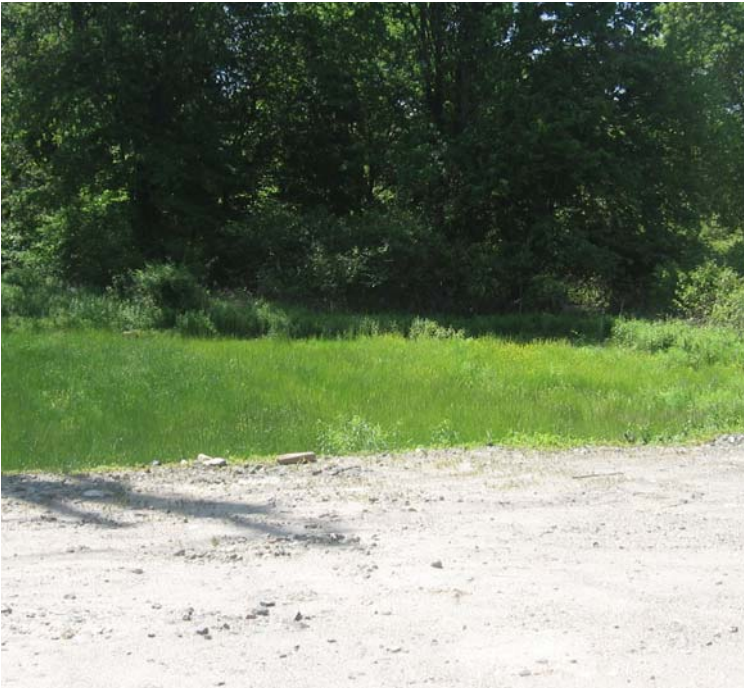
North St (south): An additional view of 115kV restoration efforts near structure #3844.

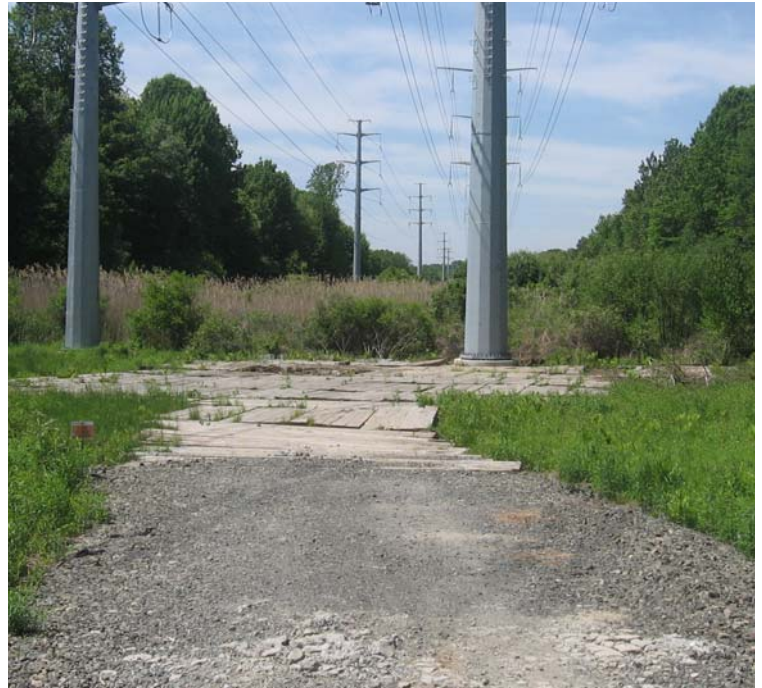
North St south: Timber mats remain within the wetland area here.

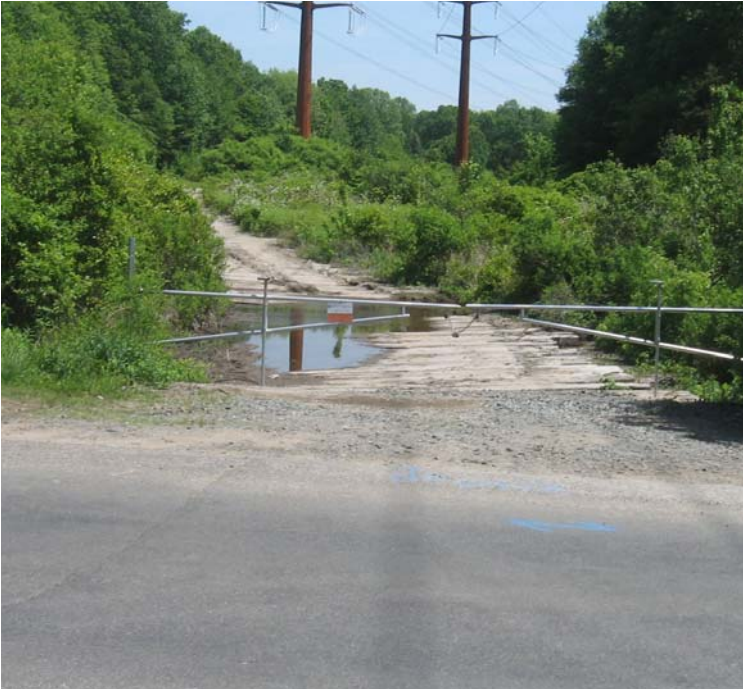
Pine Tree Dr (Orange): Timber mats remain within the wetland areas here.

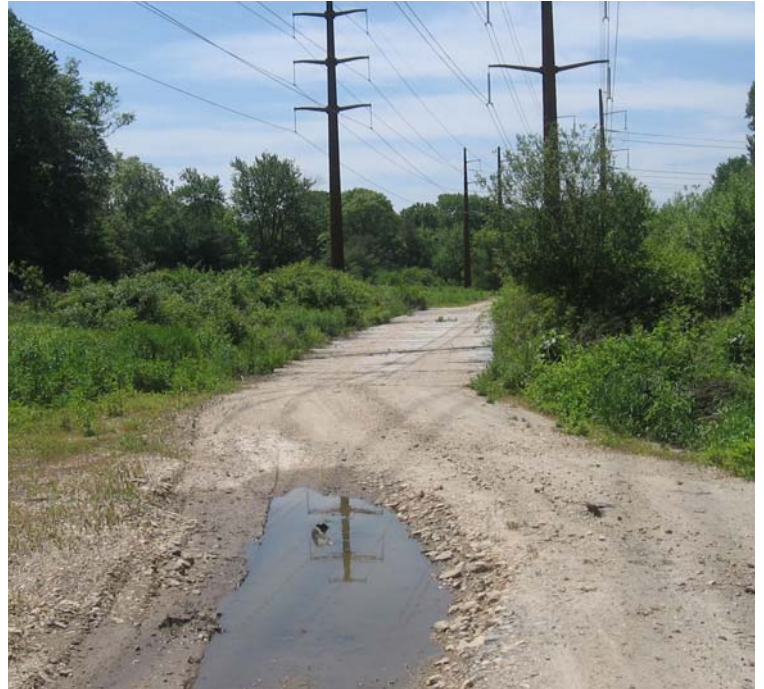
Sunset Dr (Orange): Timber mats remain within the wetland area here.

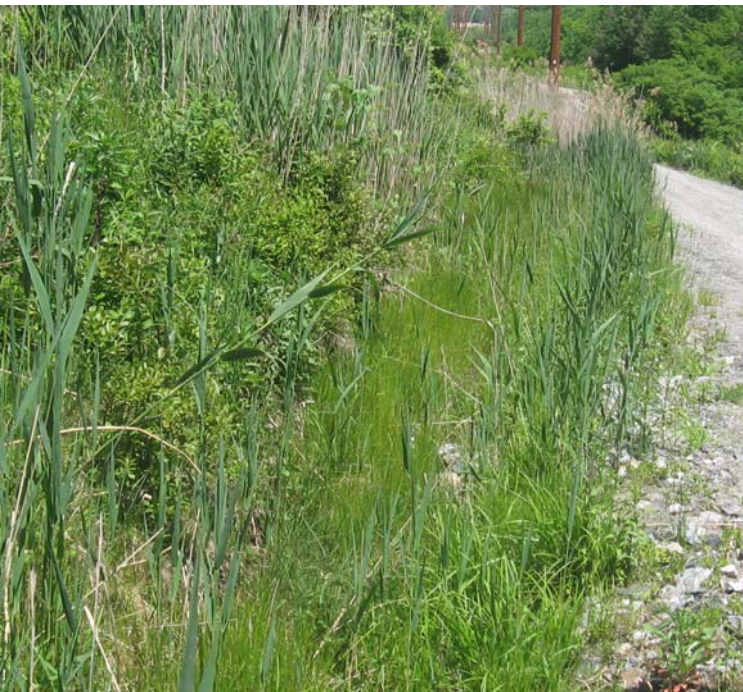
Gaylord Mtn Rd north (Hamden): Vegetative growth was observed within the trench located along the access road.

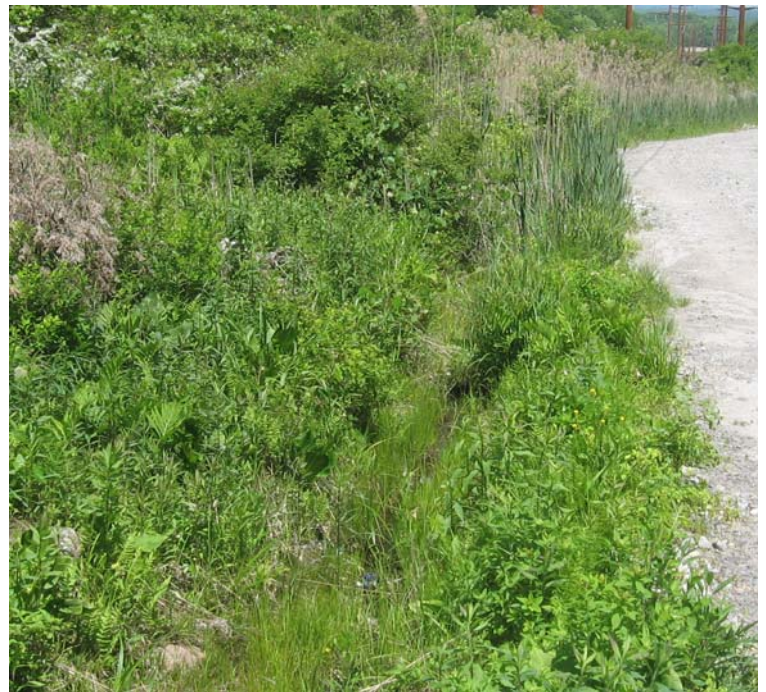
Gaylord Mtn Rd north: An additional view of the vegetative growth within the trench along the access road.

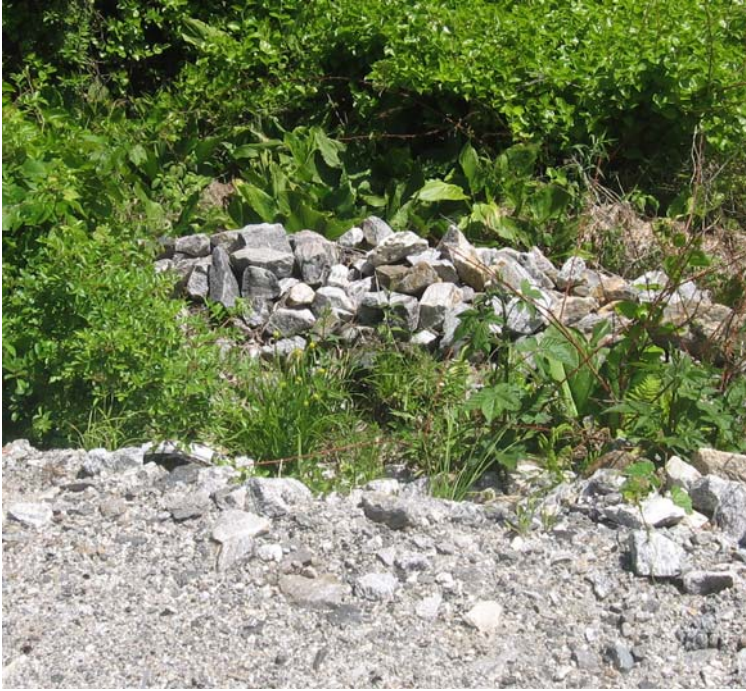
Gaylord Mtn Rd north: A view of the first culvert outlet and sediment basin along the access road. No sediment accumulation was noted here.

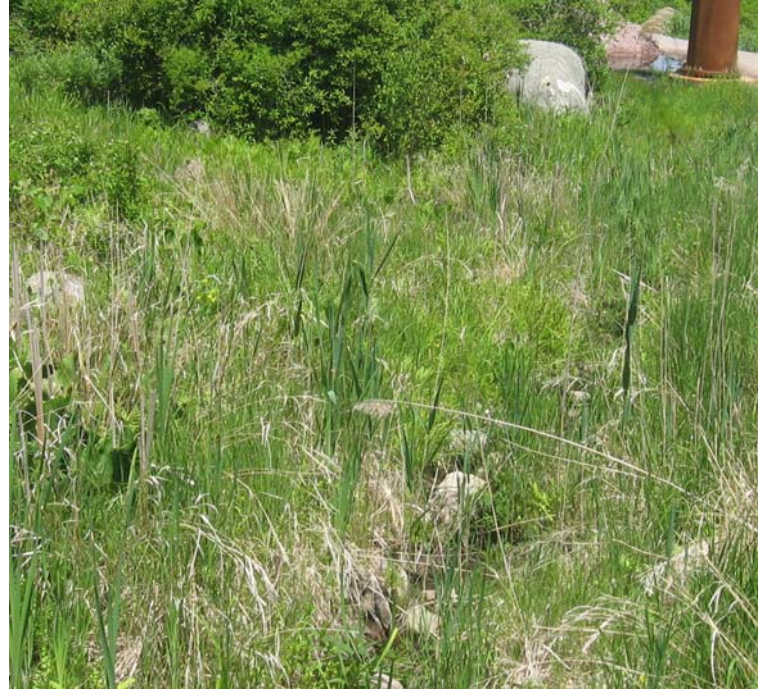
Gaylord Mtn Rd north: An additional view of the trench located along the access road. Vegetation growth has been noted.

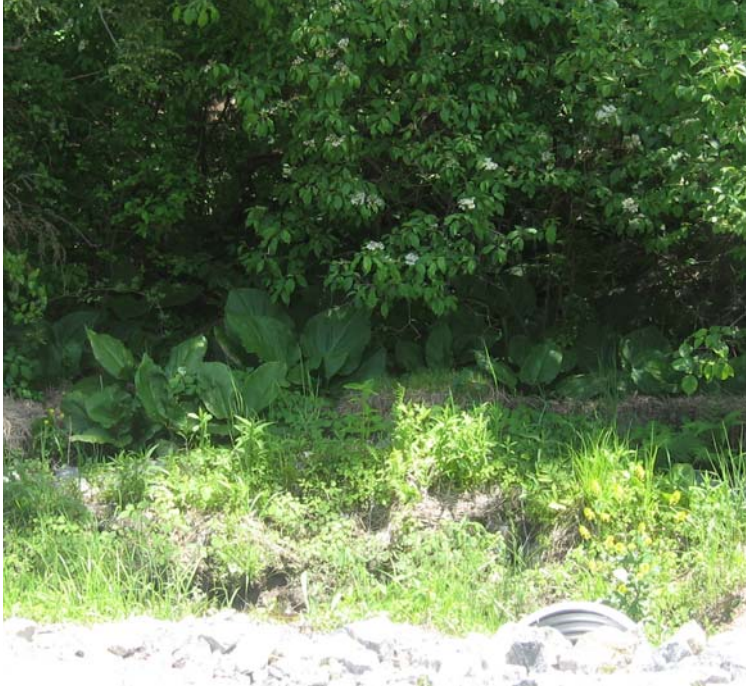
Gaylord Mtn Rd north: A view of the second culvert outlet and sediment basin located adjacent to the access road. Wetland vegetation has been noted in this area. Sediment has accumulated within the sediment basin.

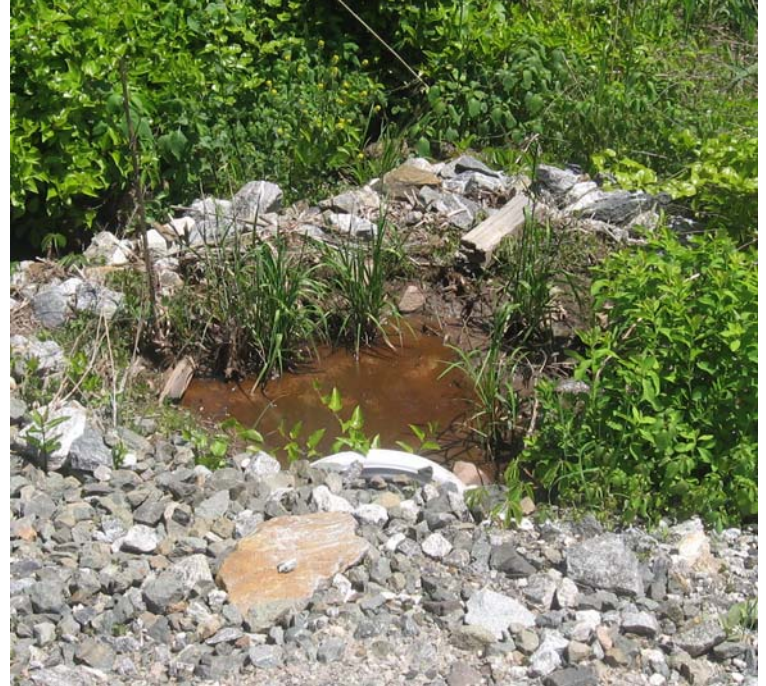
Gaylord Mtn Rd north: A view of the third culvert outlet and sediment basin located adjacent to the access road. Sediment accumulation has been noted within the basin here.
