**Docket No. 272 – Development and Management Plan Inspection**

**Segment 2b Inspection**

**Date:** June 6, 2008

**Location:** Segment 2b – Cheshire/Hamden Town Line to East Devon Substation

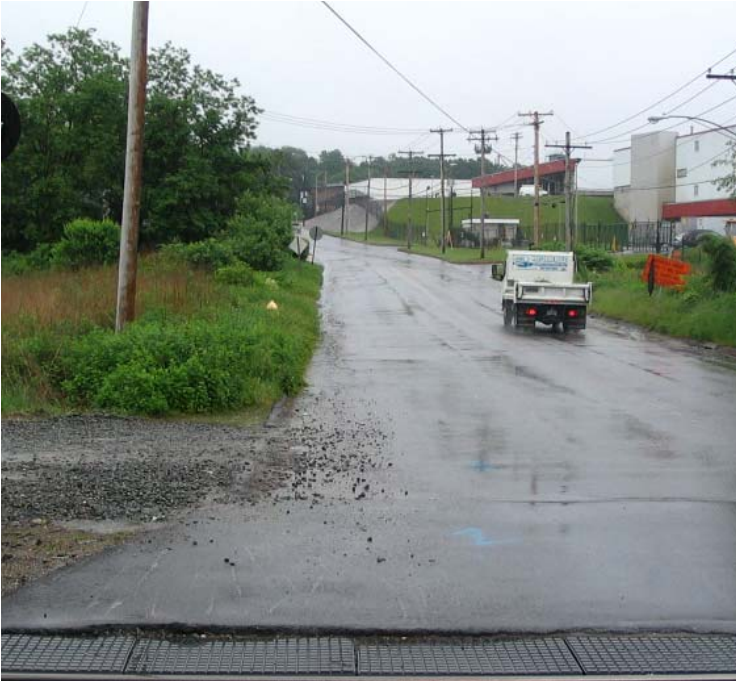
Caswell St (Milford): View of the northern access road entrance. Some sediment tracking was observed on Caswell St this week.

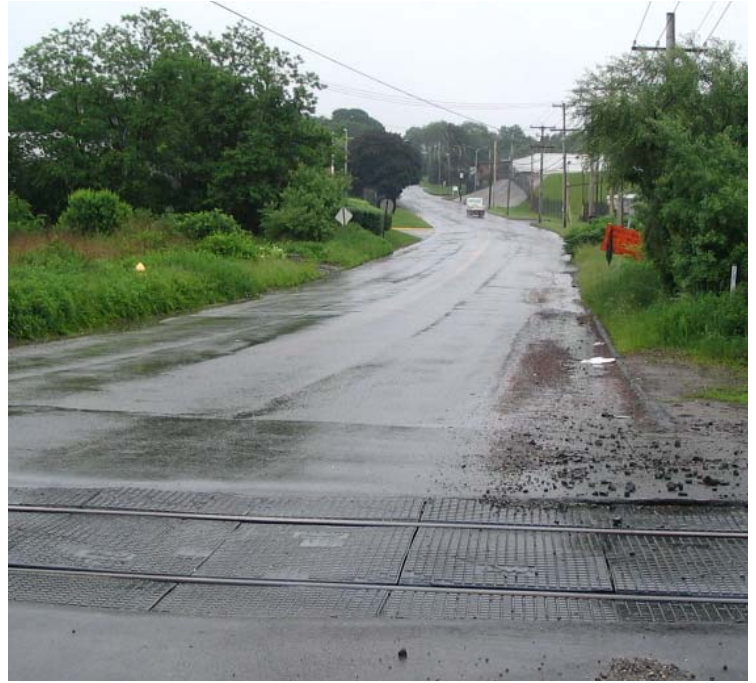
Caswell St: Sediment tracking was observed at the southern access off Caswell St.

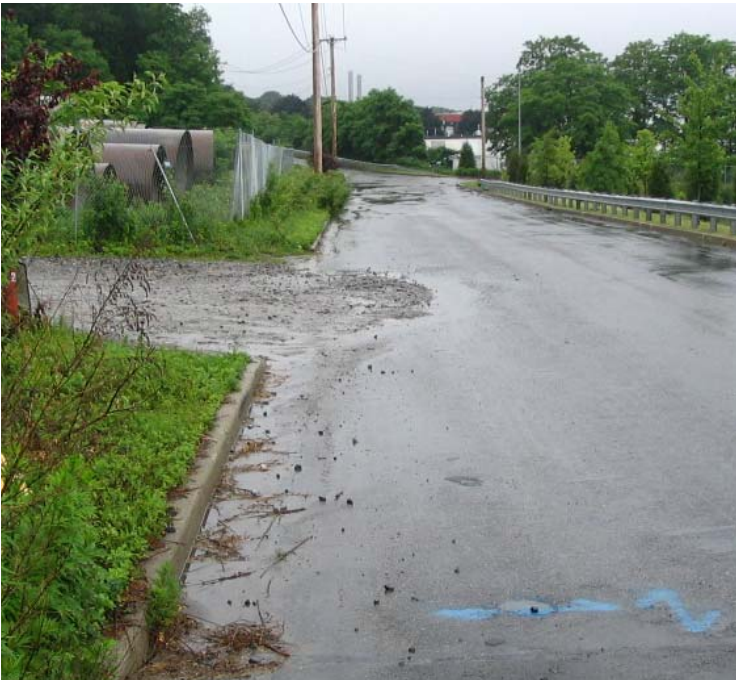
Shelland St (Milford): Some sediment tracking was observed at the storage yard entrance on Shelland St.

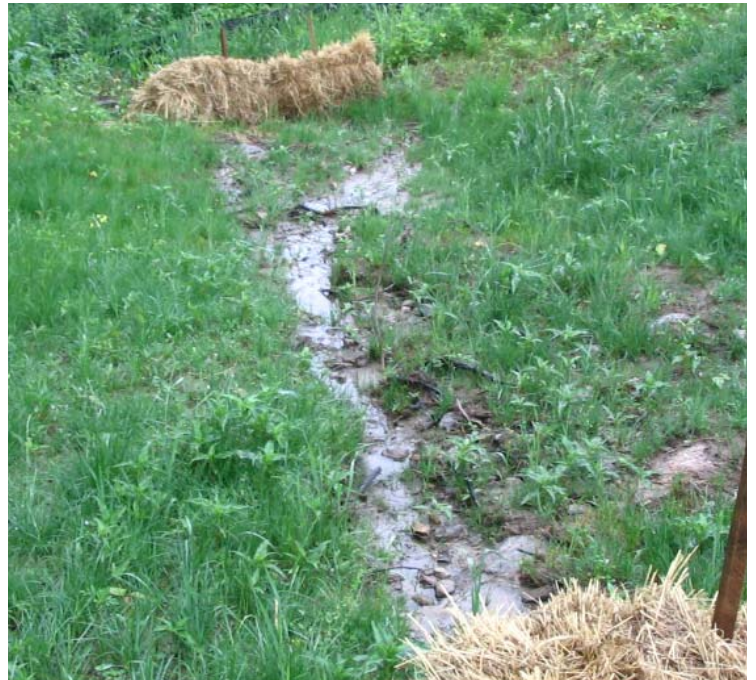
Ground water is no longer breaking through and flowing across the access road and crane pad near structure #3832, but channelized flow continues within the ROW. 5/30-6/6/08	Continue to monitor and add maintain controls as necessary. 6/6/08	Needs attention/evaluation
Eisenhower Park	Excess sediment from foundation drilling was observed on wetland timber mats in this section. 1/24-6/6/08	Remove excess sediment from timber mat pads and add controls as necessary. See Wetland Section. 6/6/08	Needs attention when feasible
Orange, CT	Silt fence is in need of repair near structure #24067. 3/12-6/6/08	Repair/add controls as necessary. 6/6/08	Needs attention when feasible
Dogwood Rd			
Dogburn Rd	Access road controls are still in need of repair and waterbars are no longer functional near structure #24077. 6/6/08	Continue to monitor and repair/add controls as necessary. 6/6/08	Needs evaluation/attention

Wheelers Farm Rd (Milford): Channelized flow was observed near structure #3832. Controls remain functional in this area.

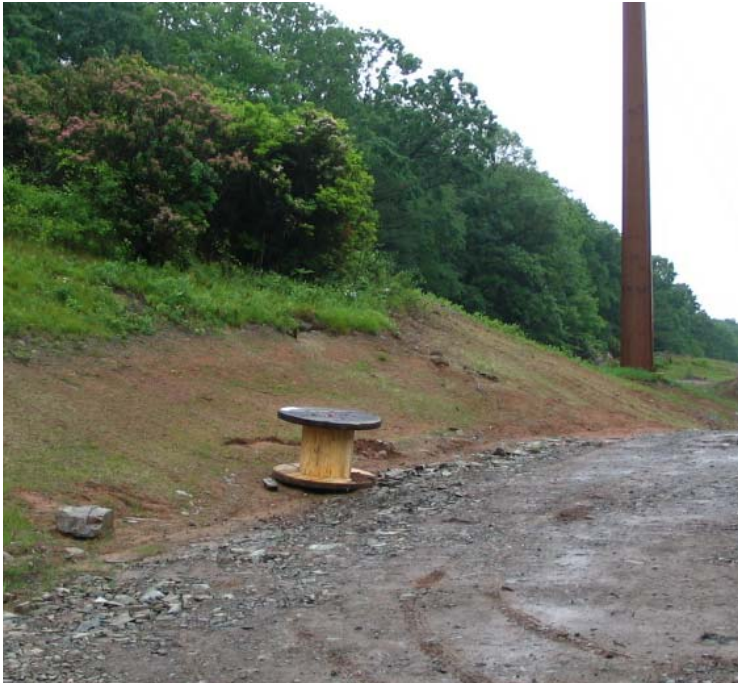
Rt 34 (Orange): Vegetation growth has been observed along the slope near structure #3887.

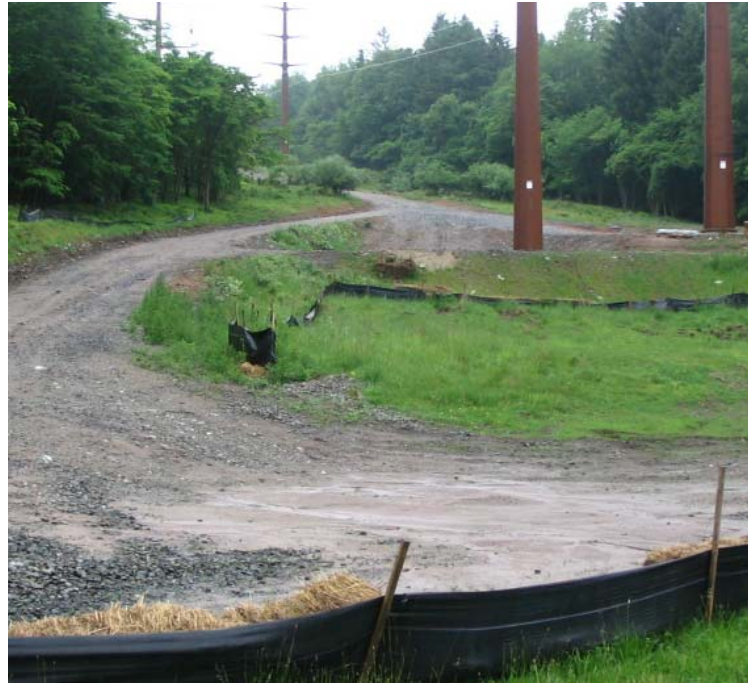
Dogburn Rd (Orange): A view of the access road near structures #3890/24077. Sediment accumulation was observed against the silt fence controls above Maltby Lake.

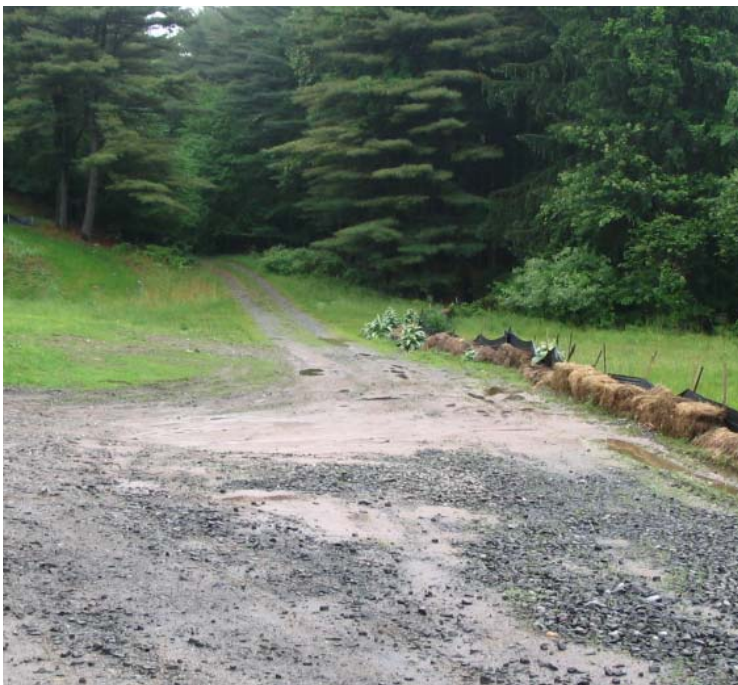
Dogburn Rd: An additional view of sediment accumulation within the access road near structures #3890/24077. Silt fence controls remain functional in this area.

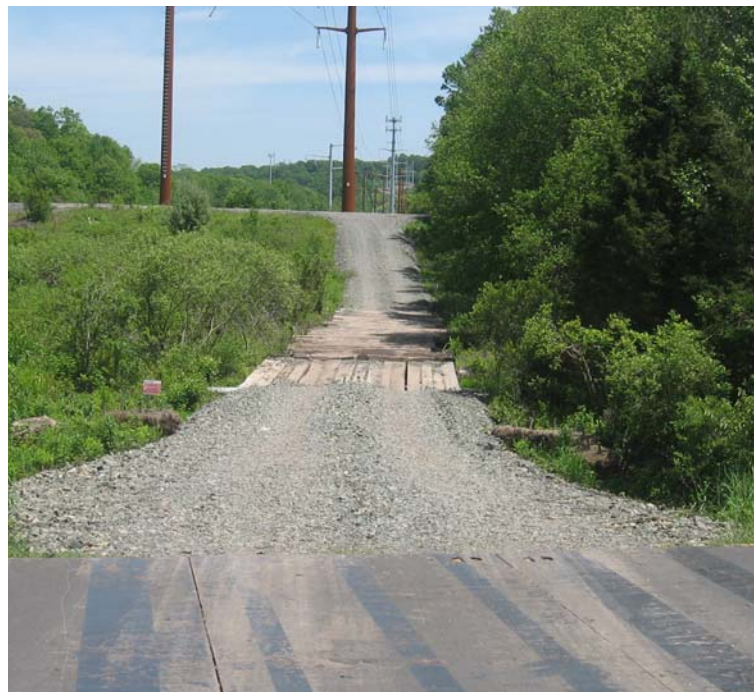
Brooksvale Ave north (Hamden): The wetland timber mat crossing remains in this area.

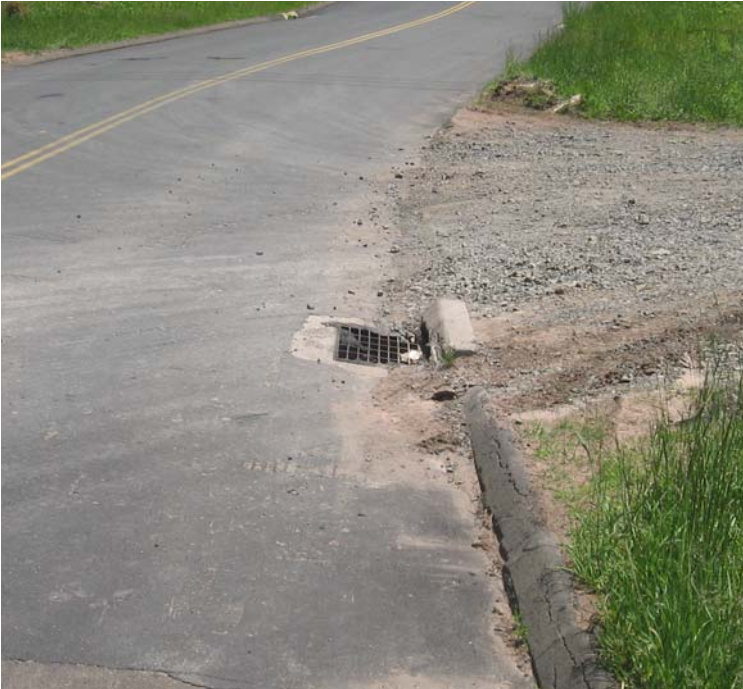
Old Ln (Hamden): No catch basin protection has been provided here.

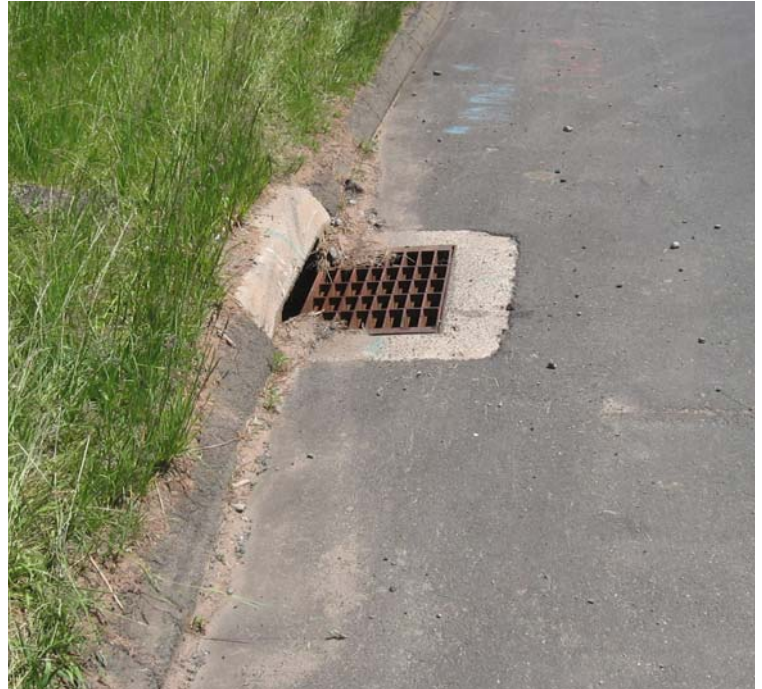
Old Ln: No protection has been provided for the catch basin located on the west bound side of Old Ln.

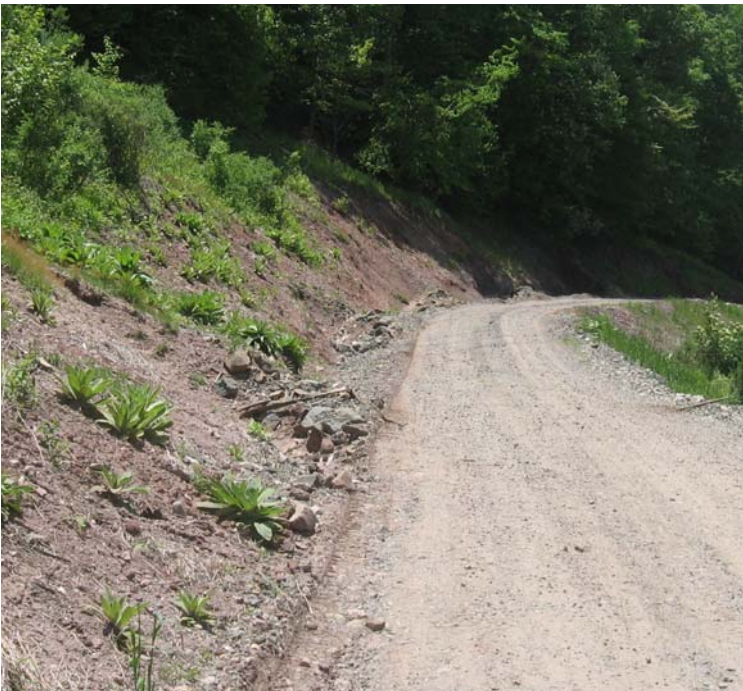
Old Ln: Access road controls remain functional on the slope in this area.

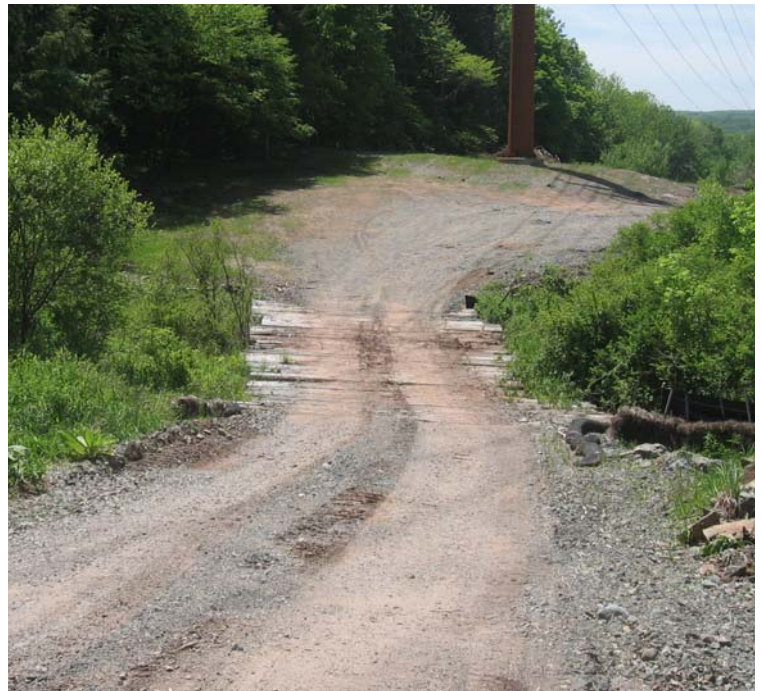
Old Ln: A view of the access road controls located at the base of the slope. Wetland timber mats remain in this area.
