Docket No. 272 – Development and Management Plan Inspection

Segment 2b Inspection

Date: June 12, 2008

Location: Segment 2b – Cheshire/Hamden Town Line to East Devon Substation

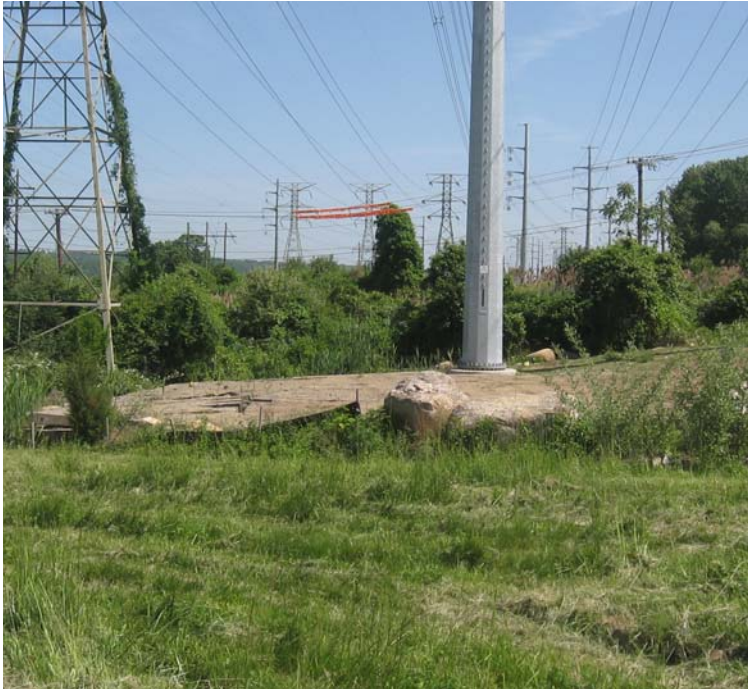
Naugatuck Ave (Milford): Wetland timber mats remain in the wetland area near structure #3804.

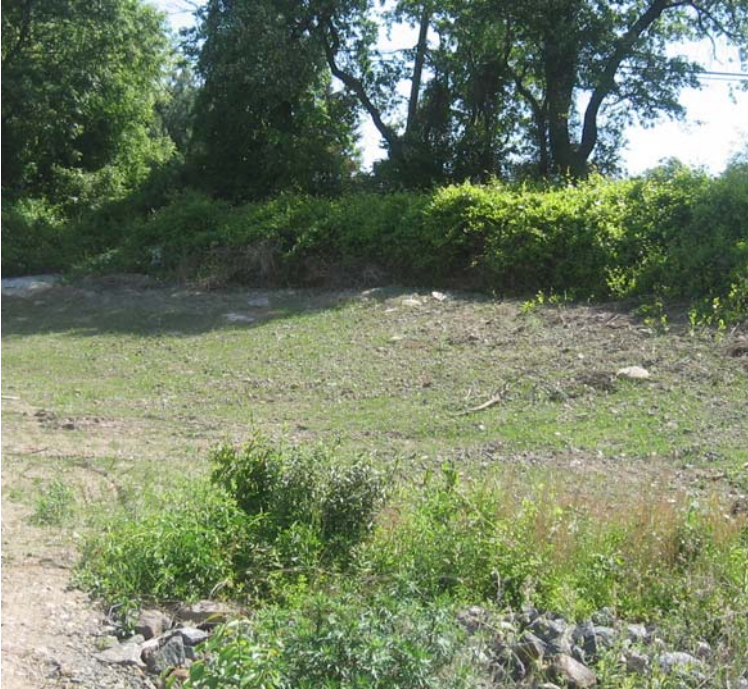
Naugatuck Ave: A view of 115 kV restoration efforts near structure #3804. Vegetative growth has been observed here.

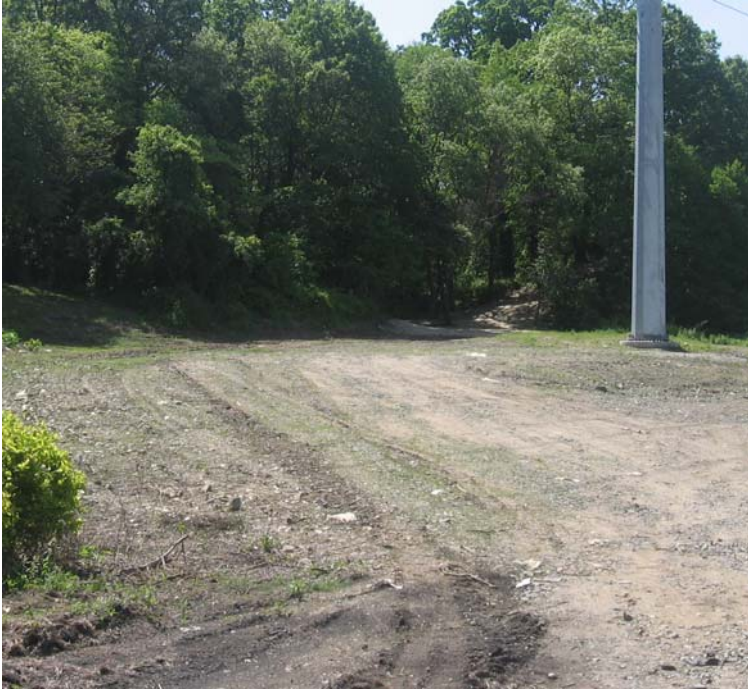
Naugatuck Ave: A view of 115kV restoration efforts near structure #3802. Some vegetative growth has been observed.

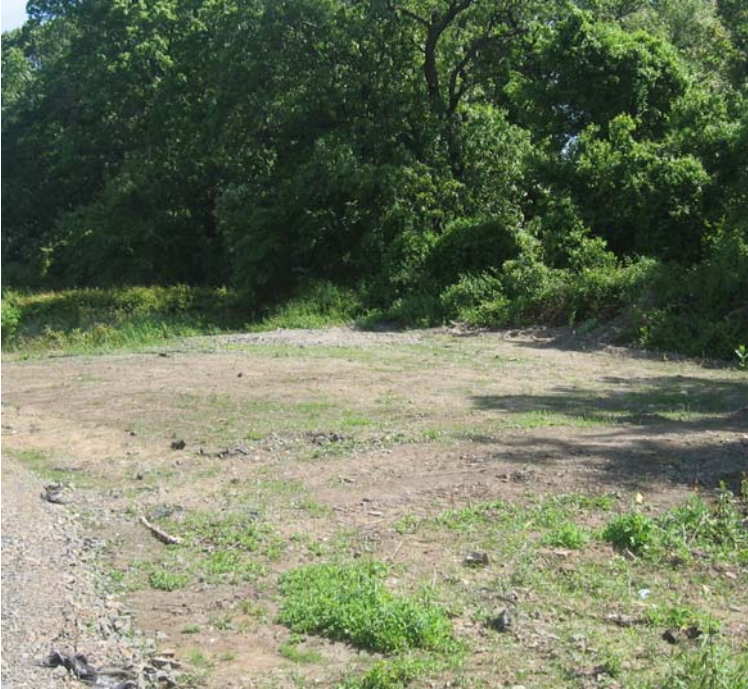
Naugatuck Ave: A view of 115kV restoration efforts near structure #3803. Some vegetative growth has been observed.

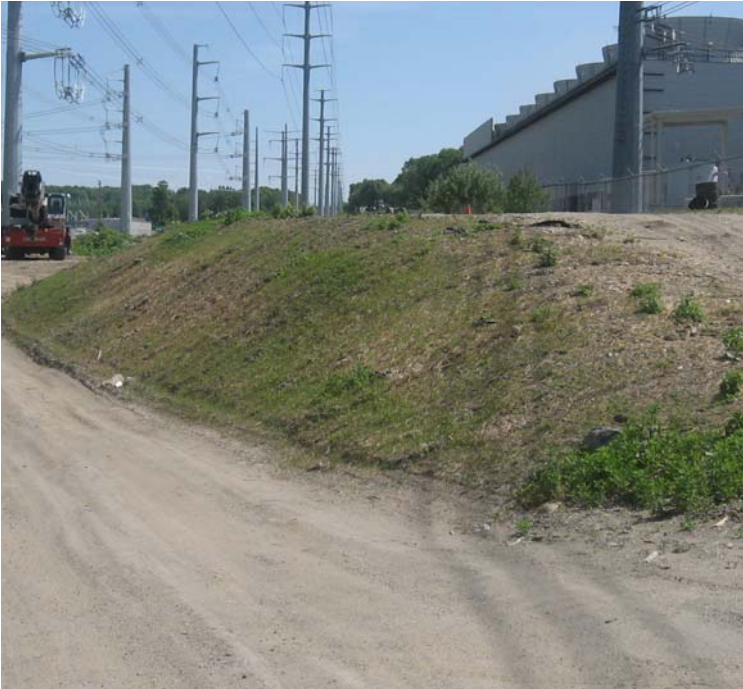
Caswell St (Milford): Vegetative growth has been noted and soils appear stable along the slope near structure #3887.

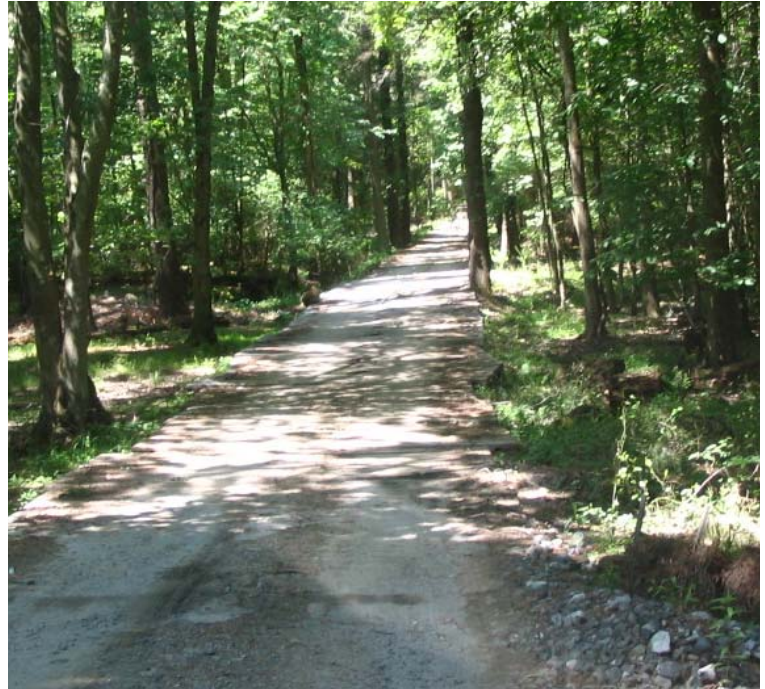
Clearview Ln (Woodbridge): The timber mat crossing remains in the wetland here.

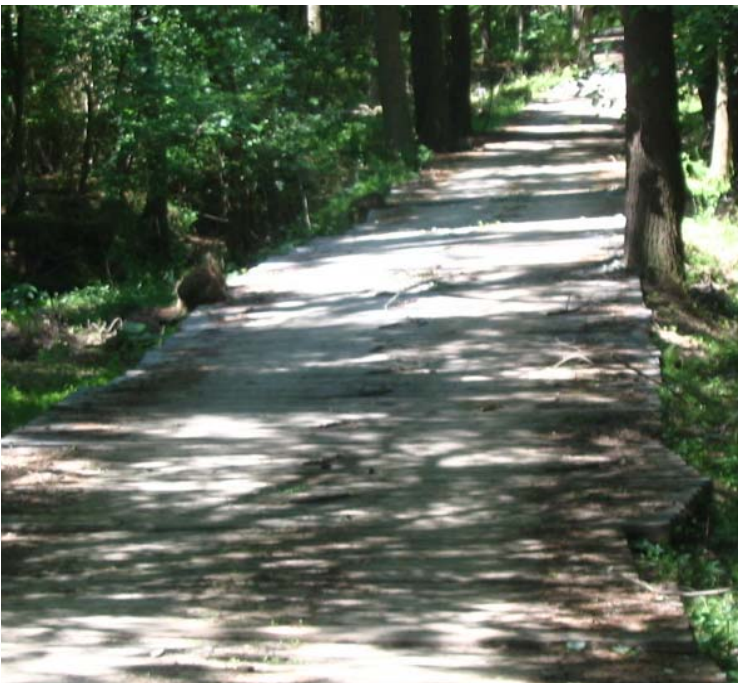
Clearview Ln: An additional view of the timber mats used to cross wetland #138.

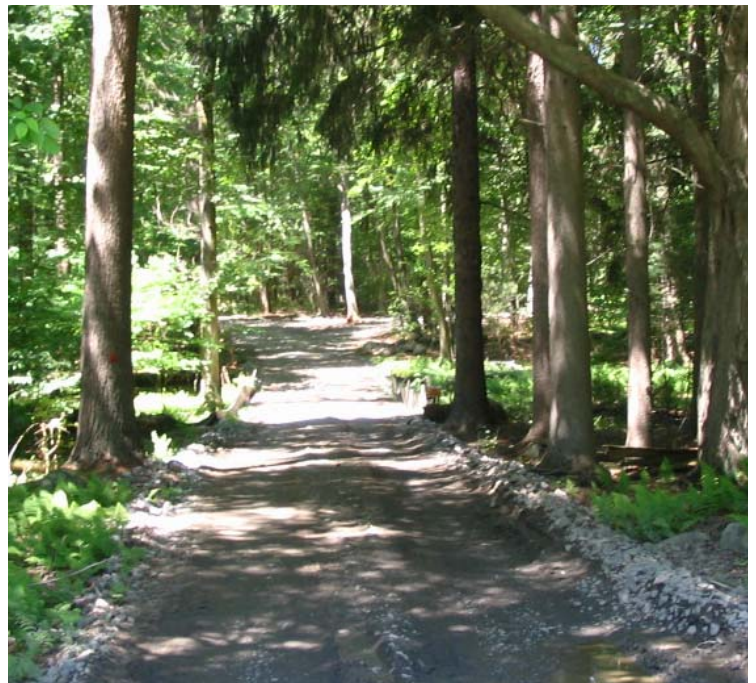
Clearview Ln: Timber mats remain in place at the stream crossing in this area.

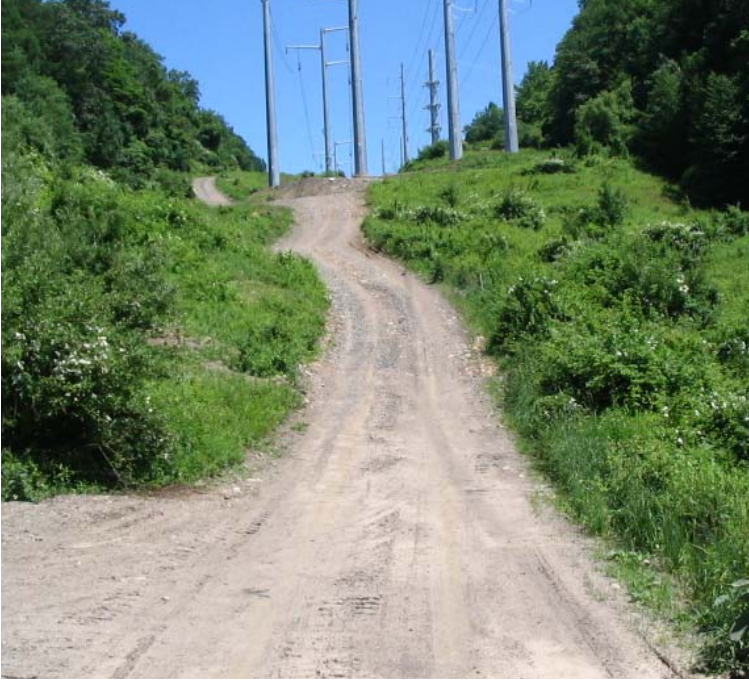
Glen Dam (Woodbridge): The access road, located on a steep slope, remains stable and stormwater controls remain functional.

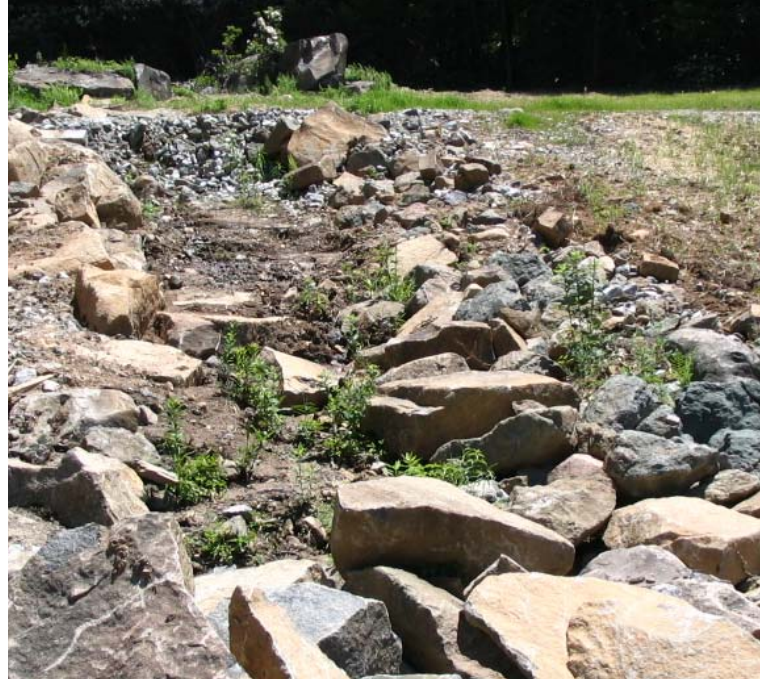
Downs Rd (Bethany): Rip-rap controls continue to function near structure #3982.

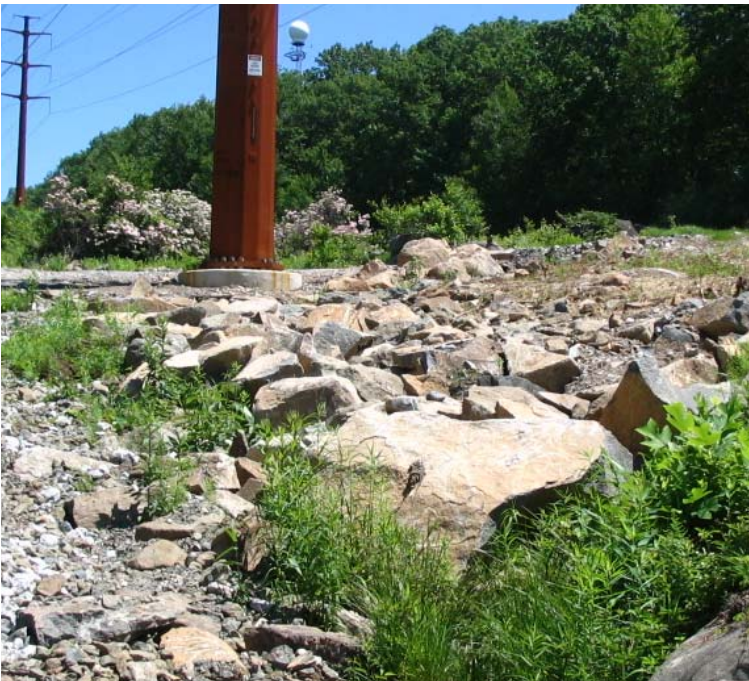
Downs Rd: An additional view of the rip-rap controls near structure #3982. There is a culvert inlet here that collects runoff from the eastern side of the access road.

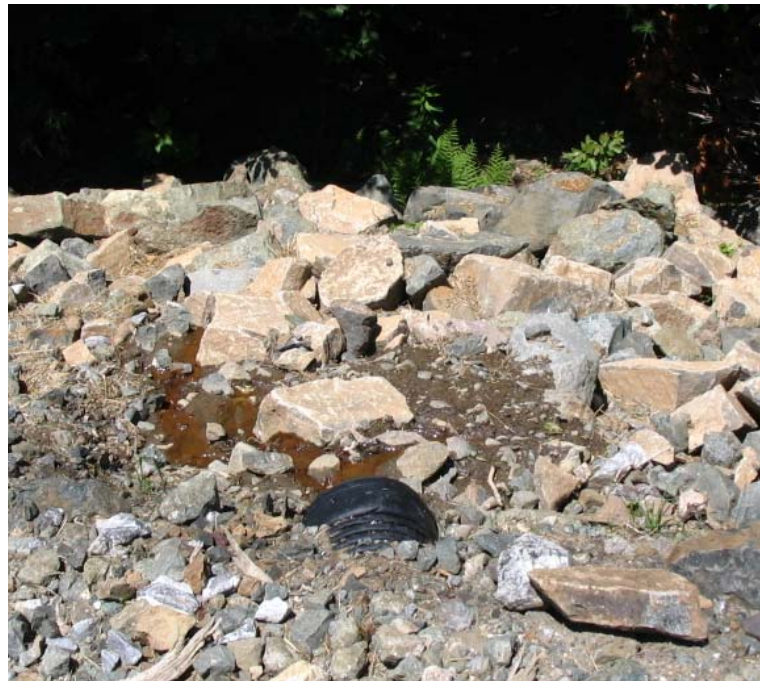
Downs Rd: A view of the culvert outlet and rip-rap controls located on the western side of the access road near structure #3982.
