Docket No. 272 – Development and Management Plan Inspection

Segment 2b Inspection

Date: June 19, 2008

Location: Segment 2b – Cheshire/Hamden Town Line to East Devon Substation

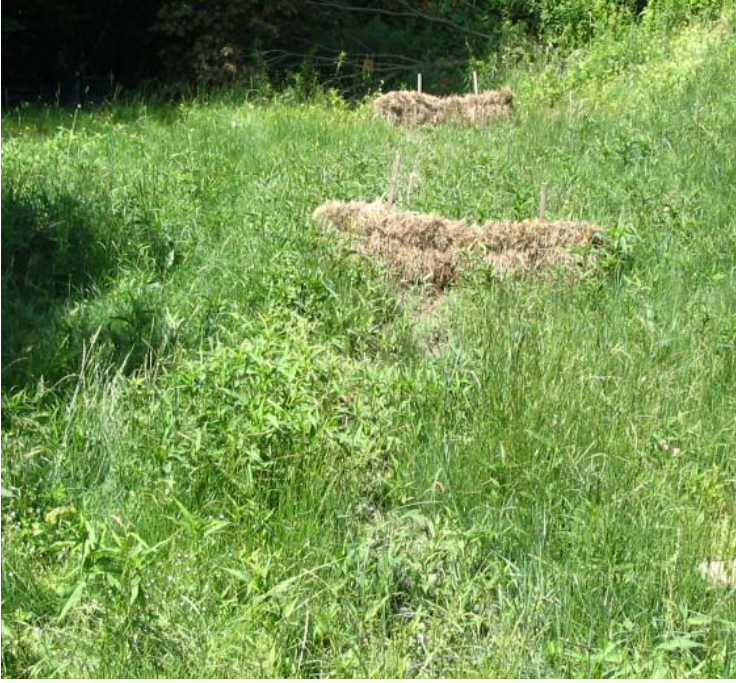
Wheelers Farm Rd (Milford): Vegetation covers approximately 80-85% of the restored area near structure #3832. However, channelized flow from stormwater runoff continues here. Controls remain functional.

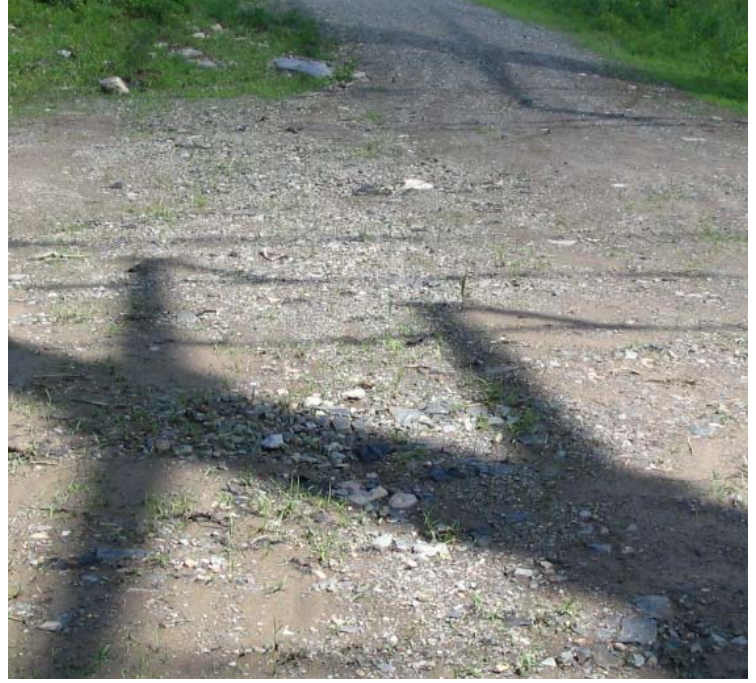
Wheelers Farm Rd: Stormwater flows across the crane pad resulting in channelized flow near structure #3832.

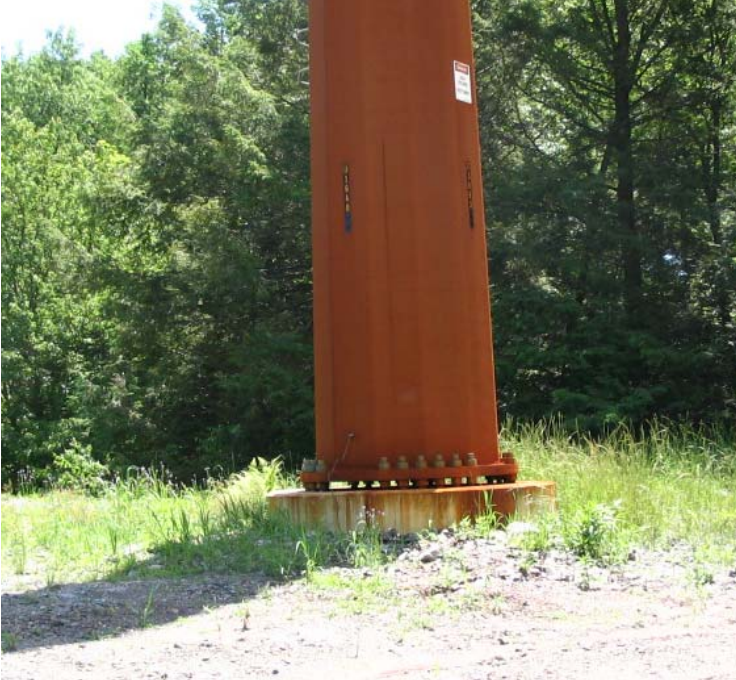
Lambert Rd (Orange): A view of 115kV restoration efforts near Structure #3863. Some vegetative growth has been observed.

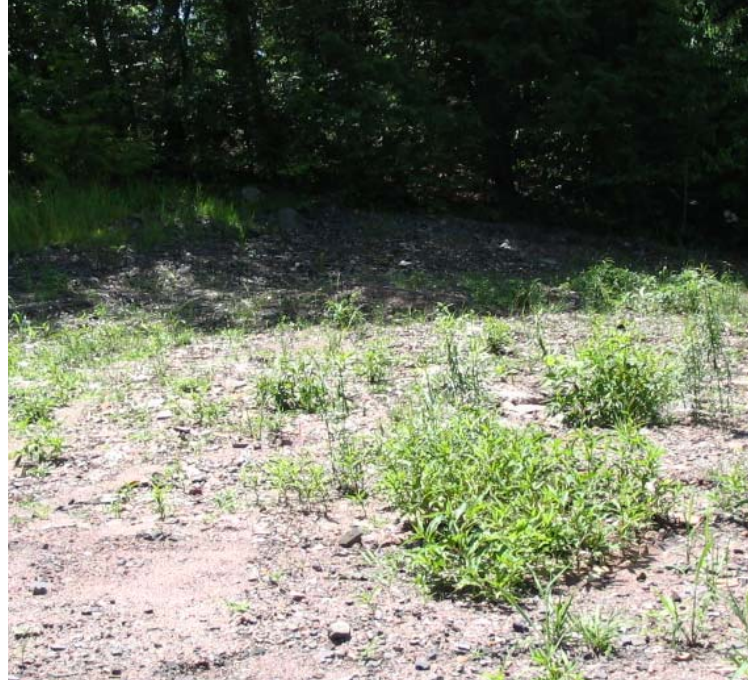
Lambert Rd: A view of 115kV restoration efforts near structure #3863. Some vegetative growth has been observed.

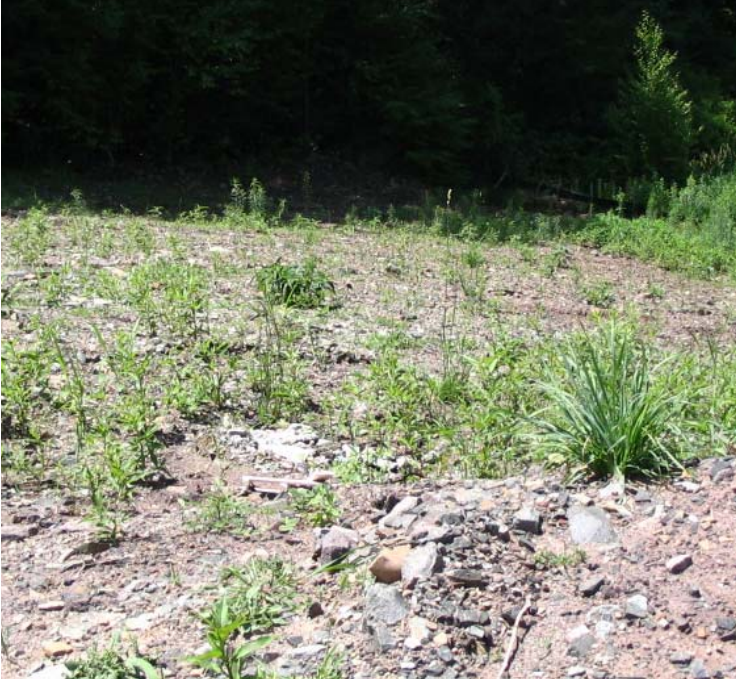
Lambert Rd: Vegetative growth has been noted and soils appear stable along the slope near structure #3863.

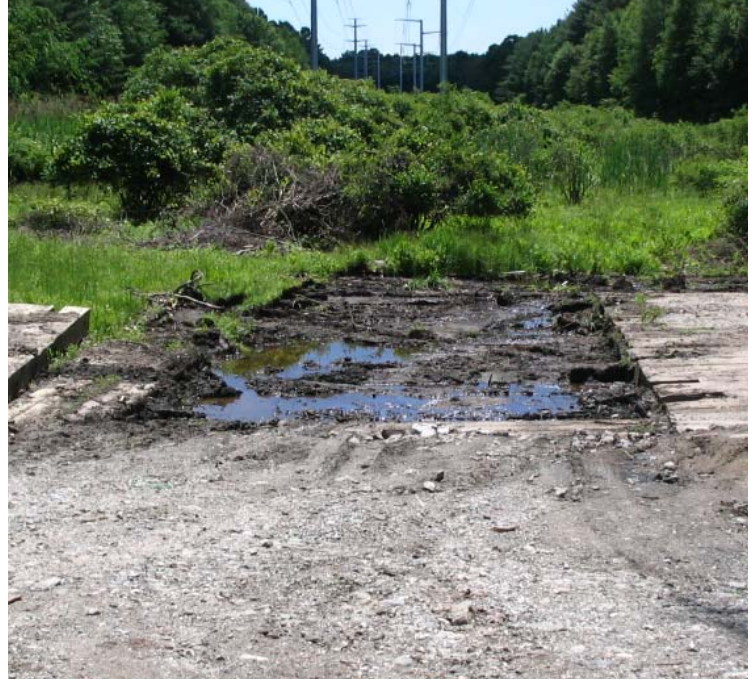
Clearview Ln (Woodbridge): Timber mat removal and 115/345 kV restoration efforts have begun in this area.

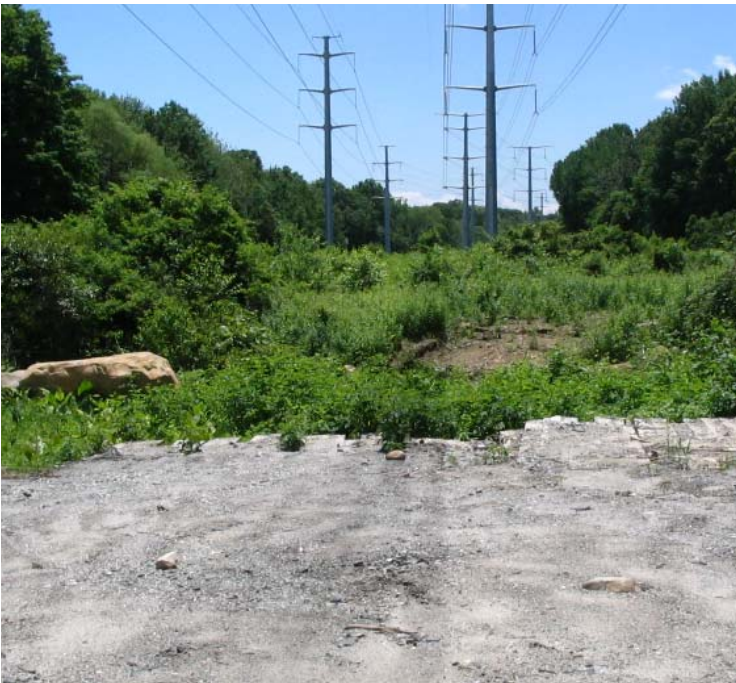
Rimmon Rd (Woodbridge): Vegetative growth has been noted and soils appear stable where timber mats were used to cross a stream near structure #3918.

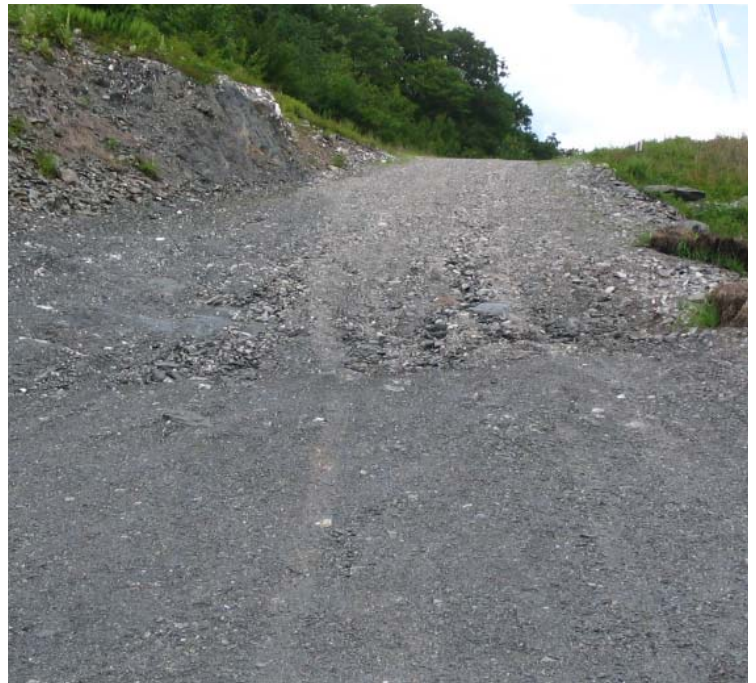
Litchfield Turnpike (Bethany): The waterbar near structure #24148 remains functional.

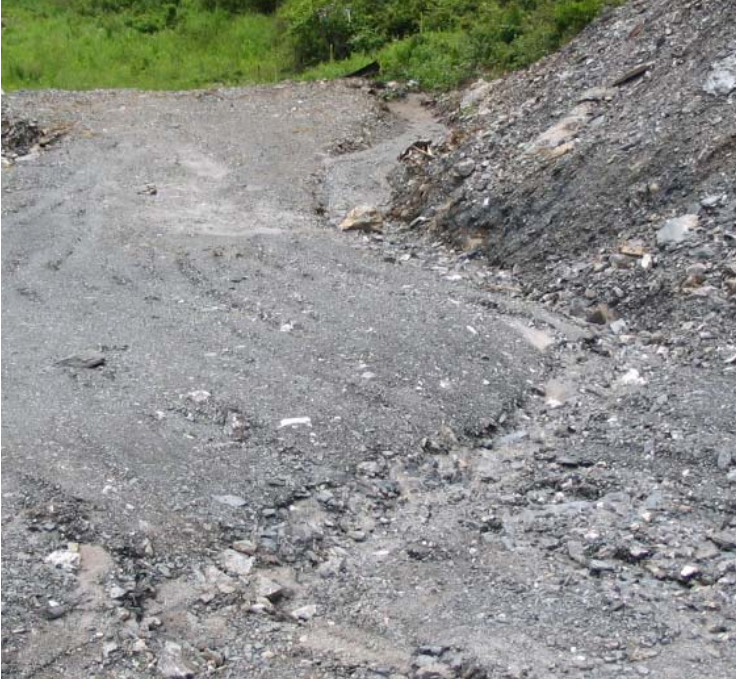
Litchfield Turnpike: An additional view of the waterbar and sediment basin near structure #24148.

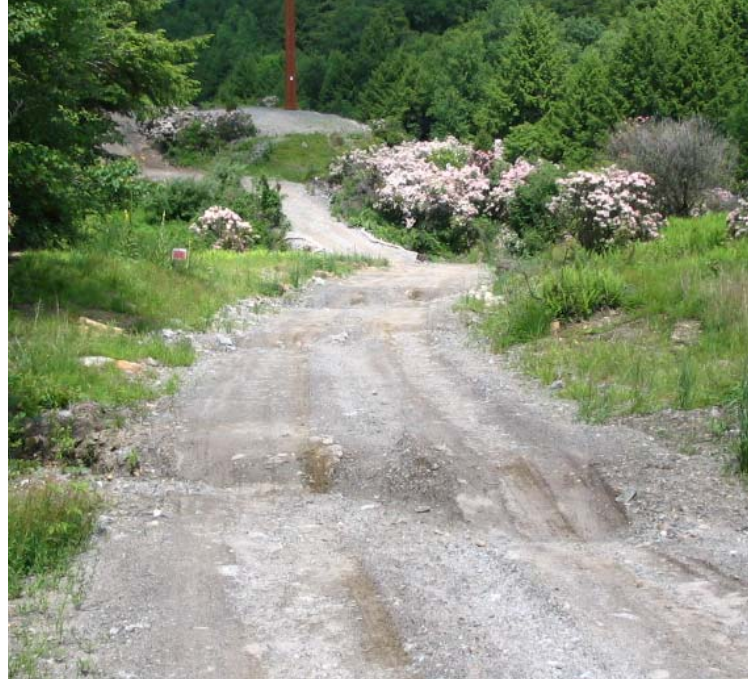
Litchfield Turnpike: Waterbars and sediment basins remain functional within the access road in this area.

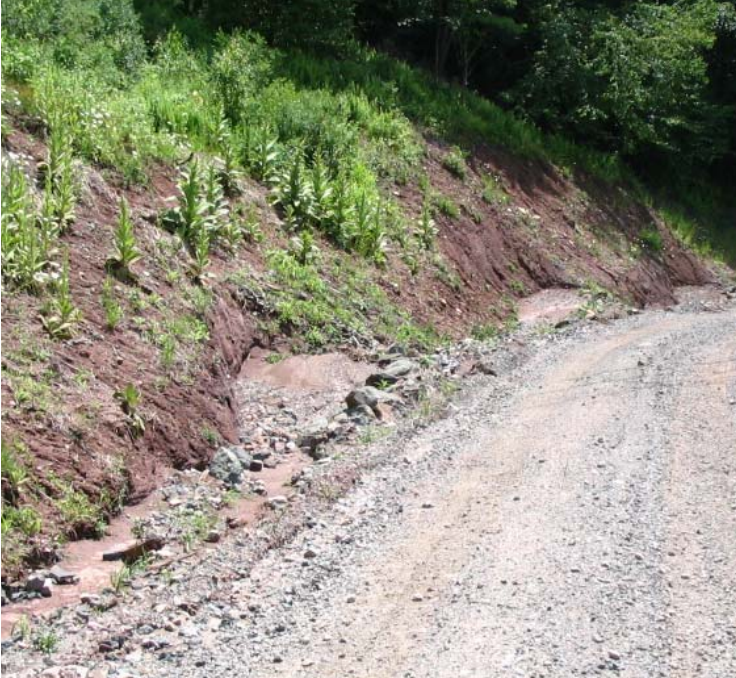
Old Ln (Hamden): Access road controls continue to help control stormwater runoff in this area. Sediment basins need attention here.

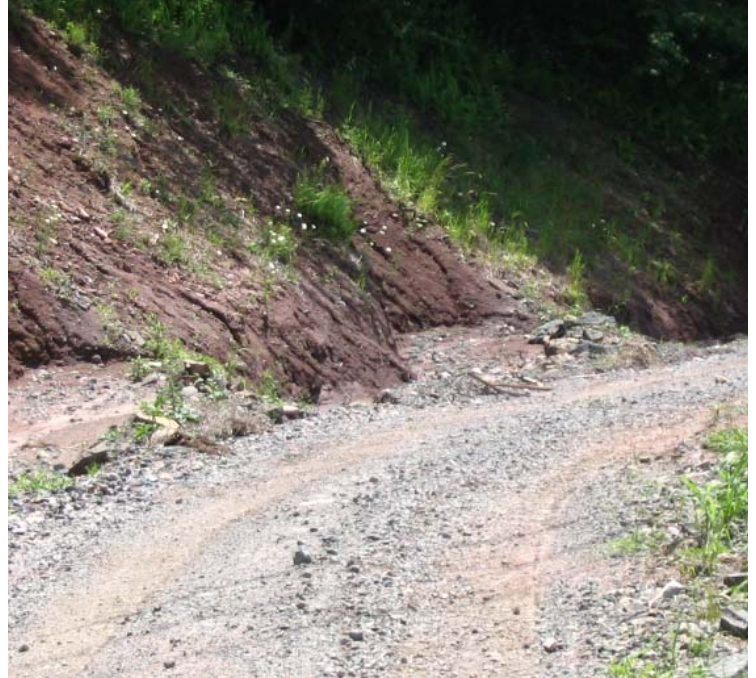
Old Ln: Sediment basins along the access road need attention.
