**Docket No. 272 – Development and Management Plan Inspection**

**Segment 2b Inspection**

**Date:** June 26, 2008

**Location:** Segment 2b – Cheshire/Hamden Town Line to East Devon Substation

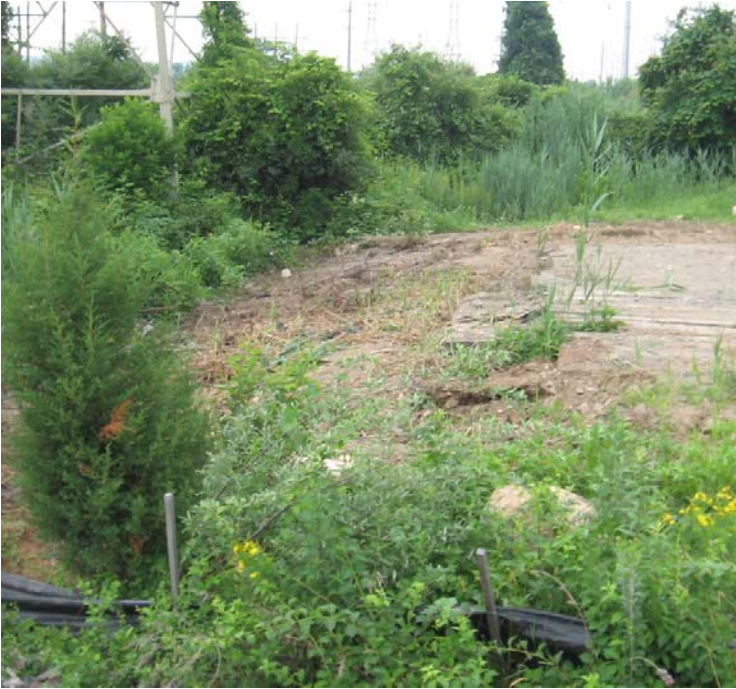
Naugatuck Ave (Milford): Wetland mats have been removed from the wetland near structure #24483. Mats remain in the uplands adjacent to the wetland.

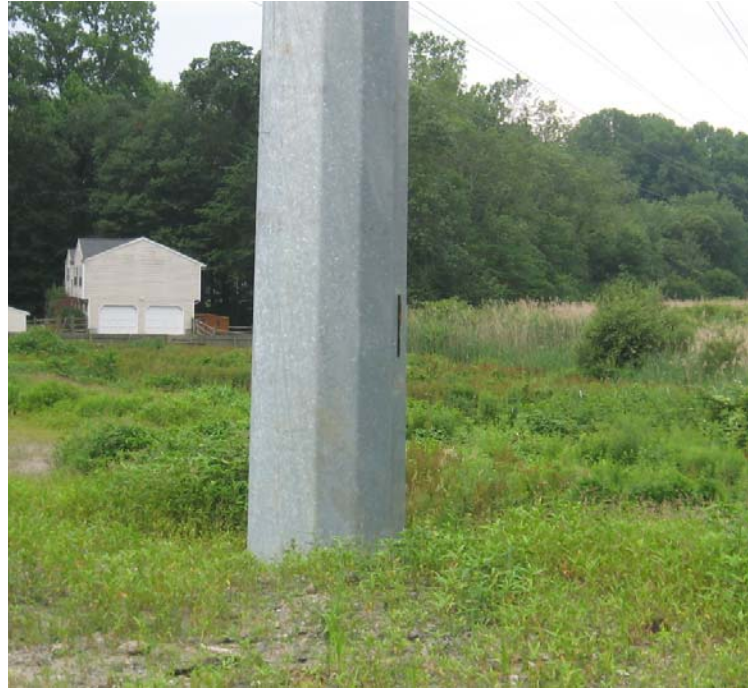
Oronoque Rd: A view of vegetative growth and 115 kV restoration efforts.

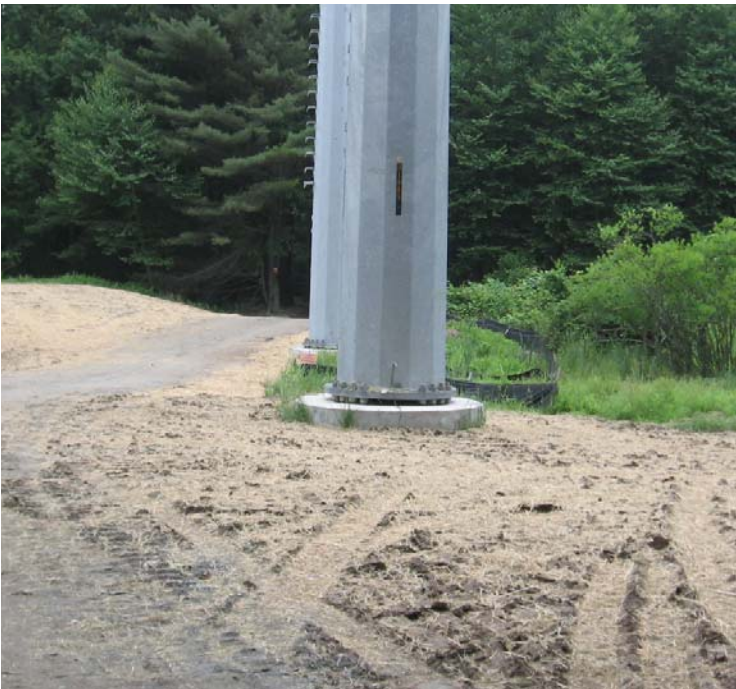
Clearview Ln (Woodbridge): A view of 115/345 kV restoration efforts. The access road has been returned to the original grade, and exposed soils have been temporarily stabilized with mulch.

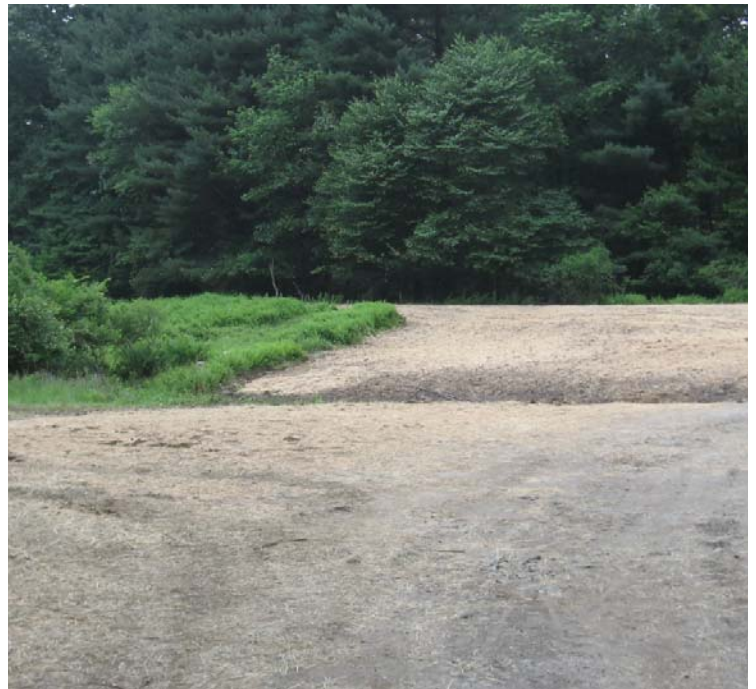
Clearview Ln: Wetland timber mats have been removed from the wetland near structure #3903/24090. Exposed upland soils have been temporarily stabilized with mulch.

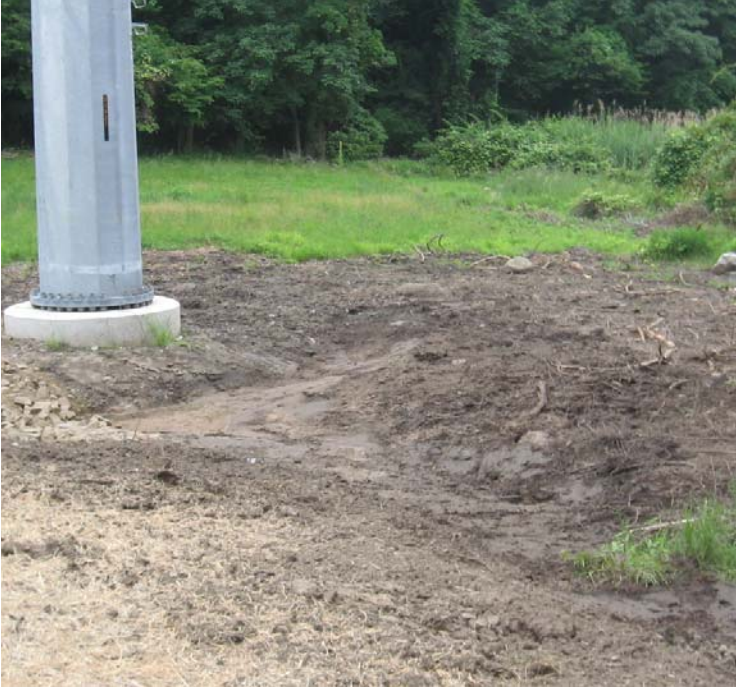
Clearview Ln: Wetland timber mats have been removed from the Wetland and soils have been graded near structure #24091.

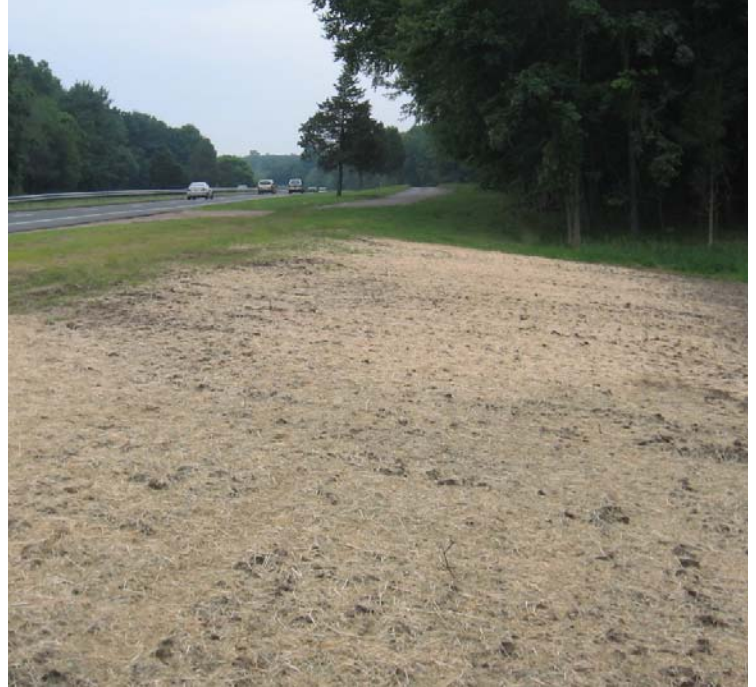
Clearview Ln: Exposed upland soils have been graded and temporarily stabilized with mulch.

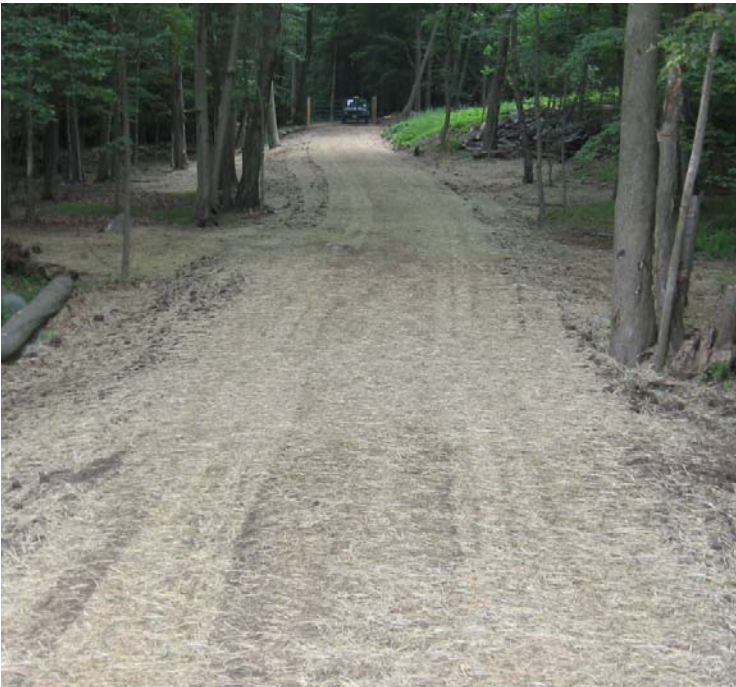
Clearview Ln: Upland access roads have been graded to the original grade and temporarily stabilized with mulch.

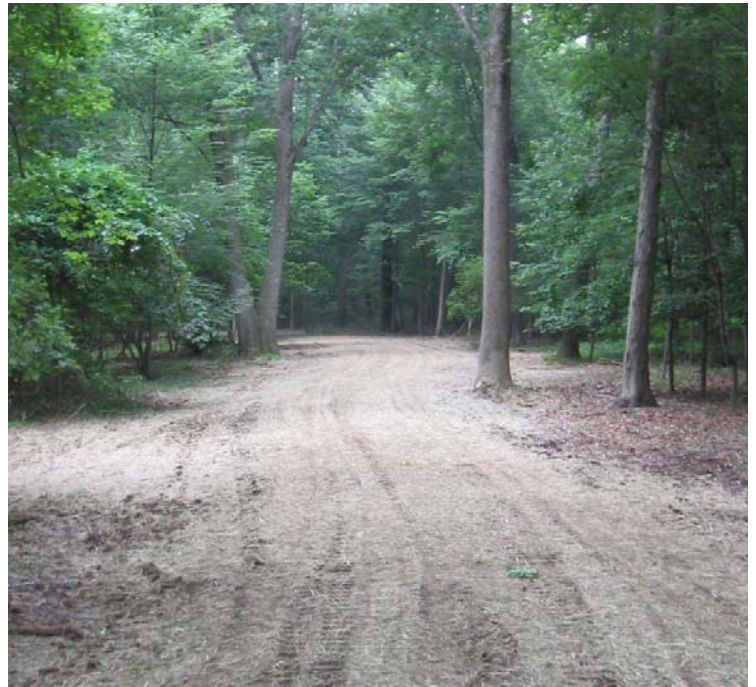
Clearview Ln: An additional view of upland access road restoration efforts.

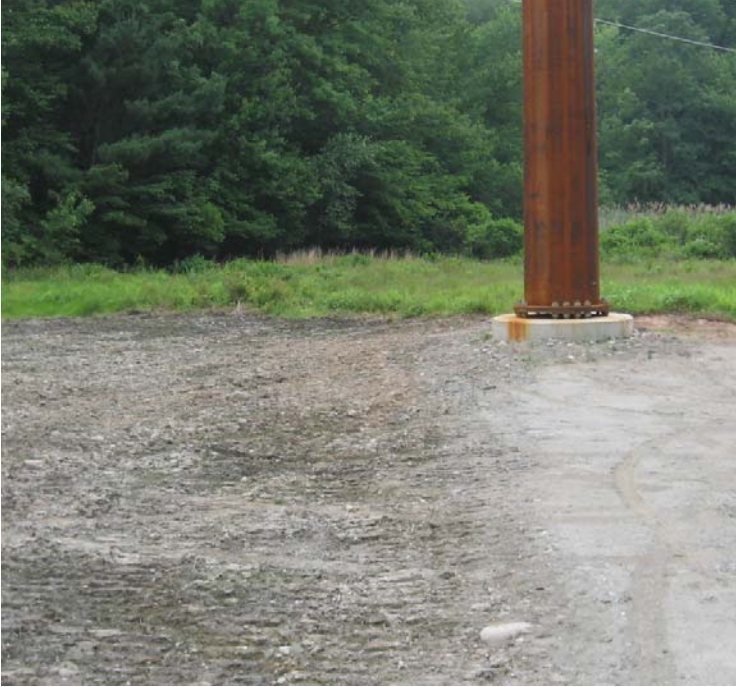
Clearview Ln: The stone crane pad was removed and soils were graded in the wetland area near structure #24086.

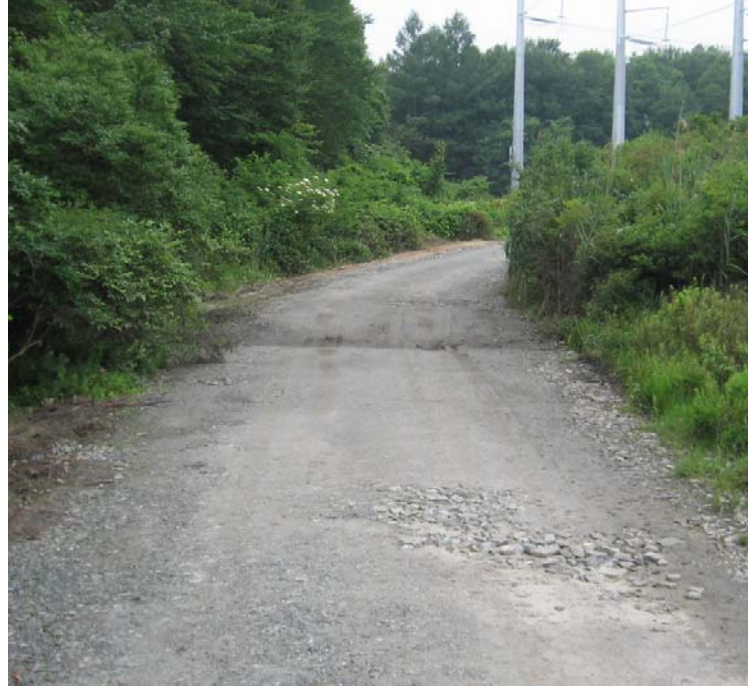
Clearview Ln: The access road to structures #3899/24086 is located within a wetland. The road has been graded and a waterbar was installed to allow water flow.

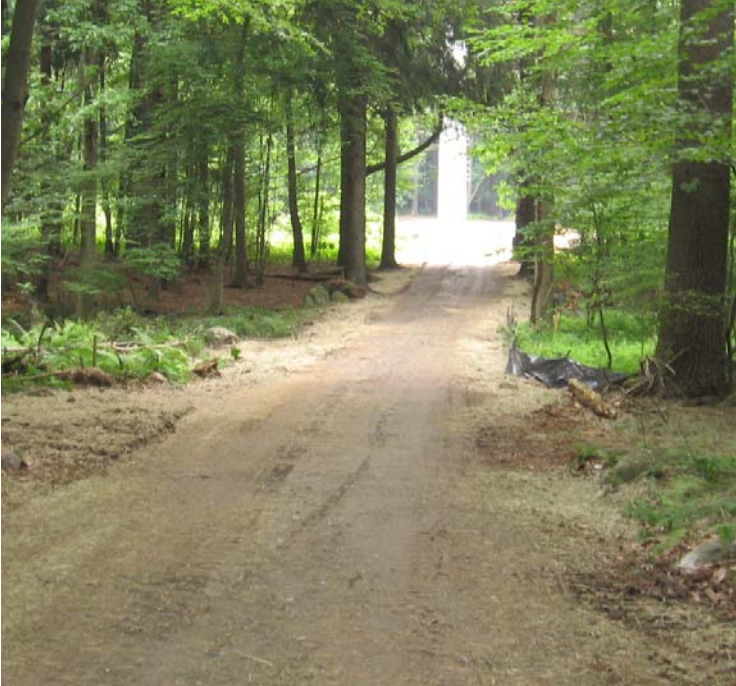
Clearview Ln: Wetland timber mats have been removed from the wetland crossing near structure#24090.

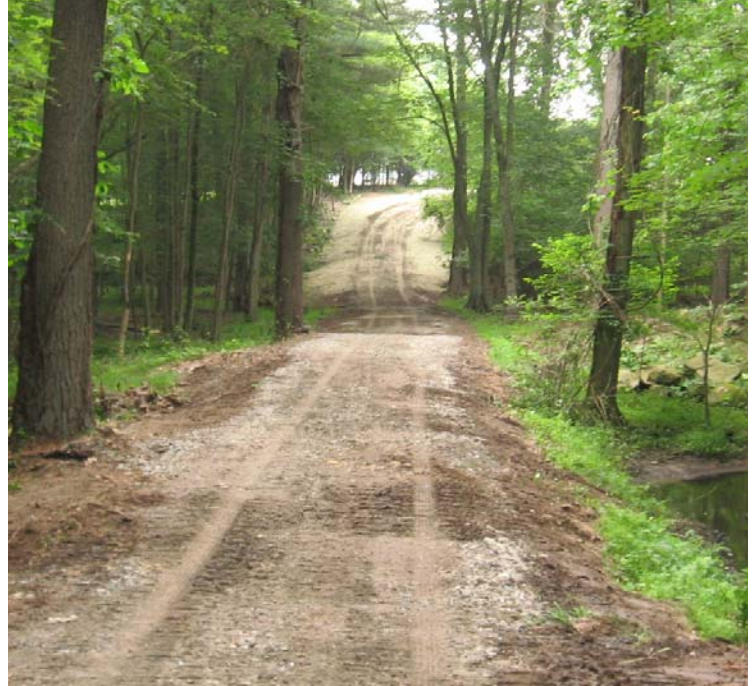
Clearview Ln: Wetland timber mats have been removed from the access road off Clearview Lane. The existing road has been graded.

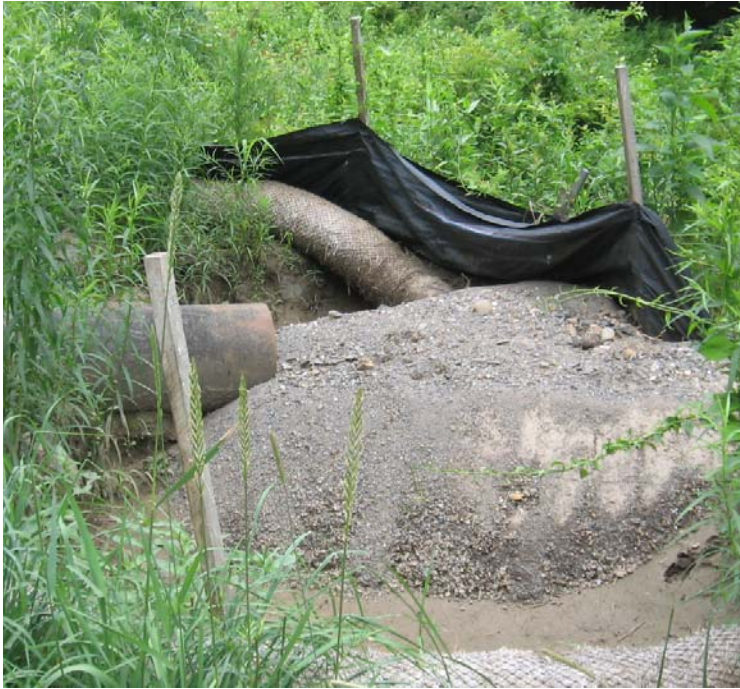
Glen Dam (Woodbridge): The sediment basin near structure #3950 is no longer functional.

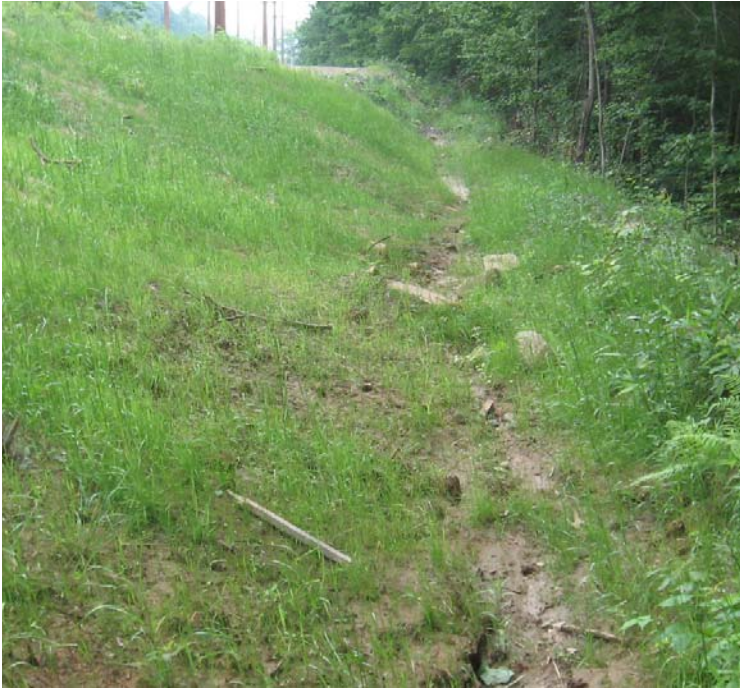
Gaylord Mtn Rd (Hamden): Vegetative growth has been noted in the swale located along the perimeter of the ROW.

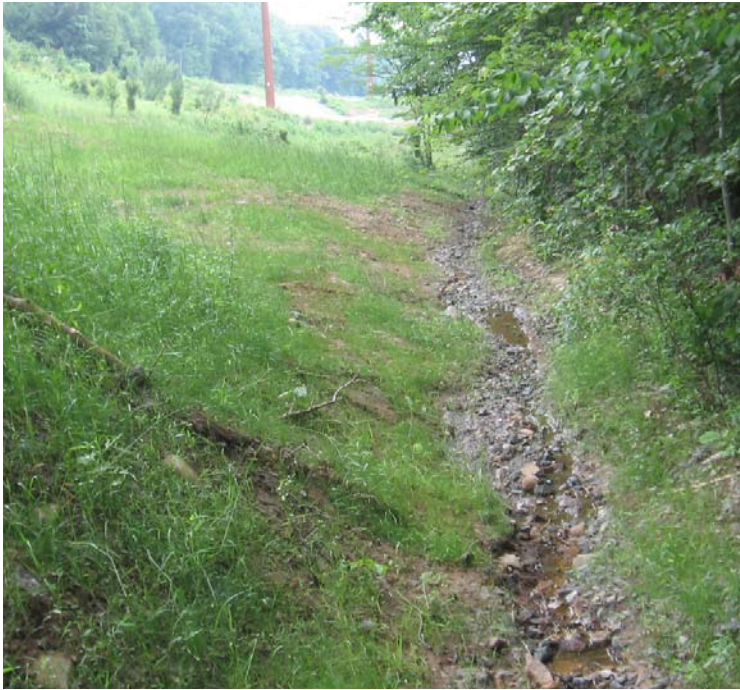
Gaylord Mtn Rd: An additional view of the vegetative swale.

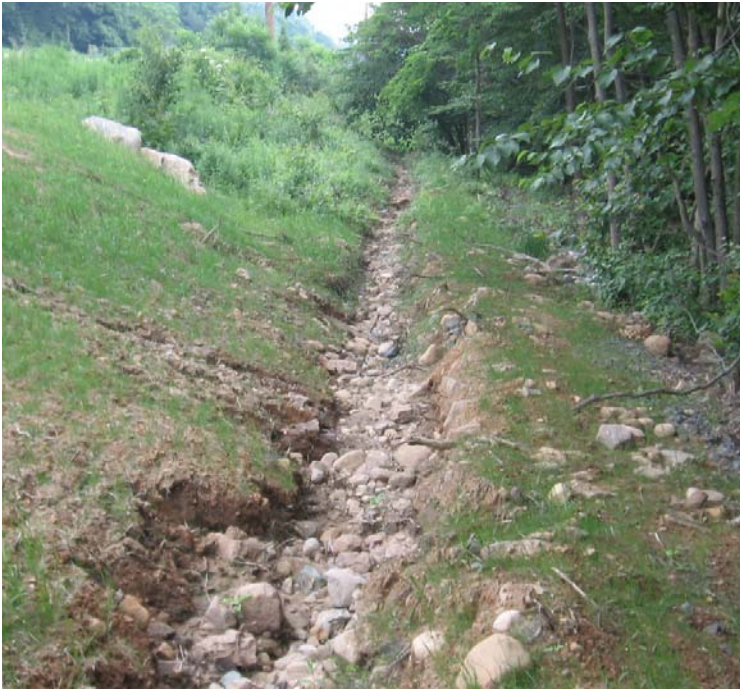
Gaylord Mtn Rd: View of the erosive gully located in the vegetative swale.
