Docket No. 272 – Development and Management Plan Inspection

Segment 2b Inspection

Date: July 1, 2008

Location: Segment 2b – Cheshire/Hamden Town Line to East Devon Substation

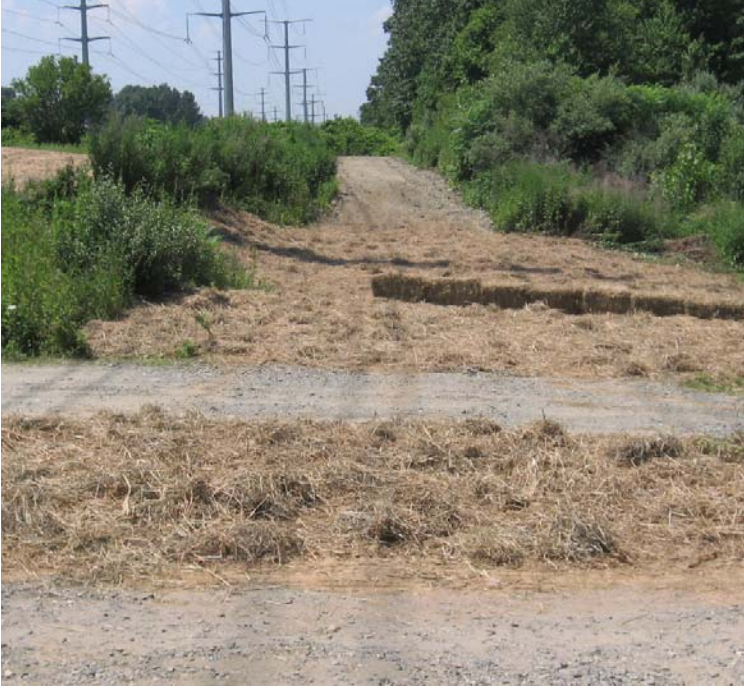
Oronoque Rd (Milford): A view of 345 kV restoration efforts.

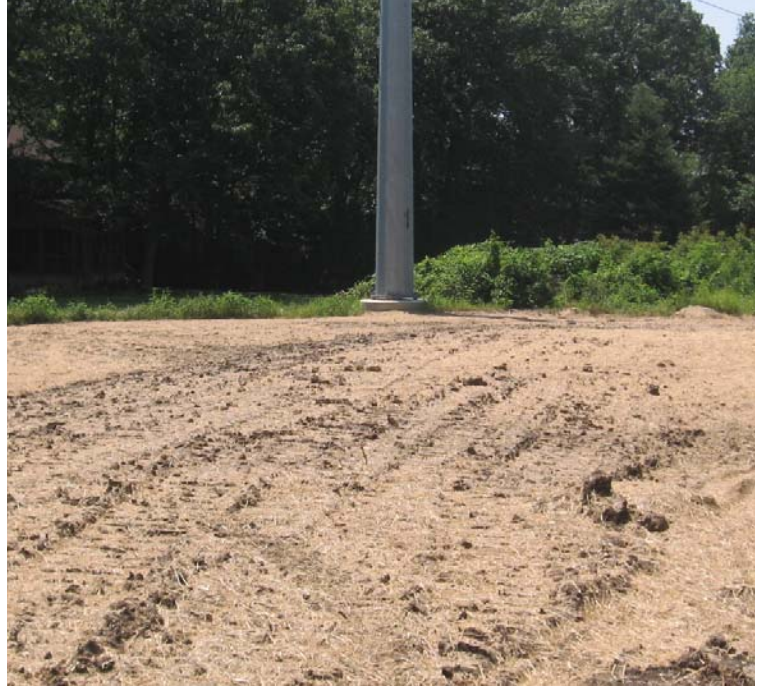
Oronoque Rd: Crane pads have been removed and exposed soils have been temporarily stabilized with mulch.

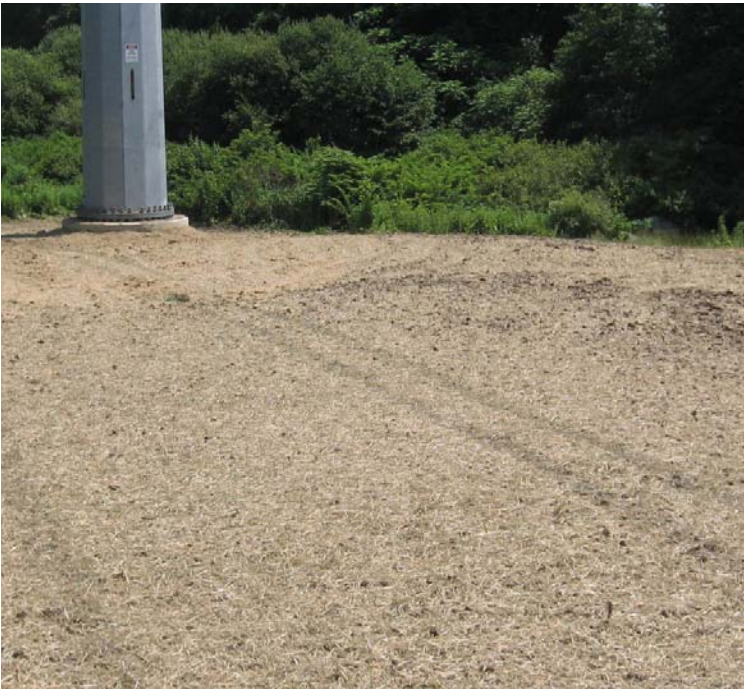
Oronoque Rd: Crane pads have been removed and exposed soils have been temporarily stabilized with mulch near structure # 24008.

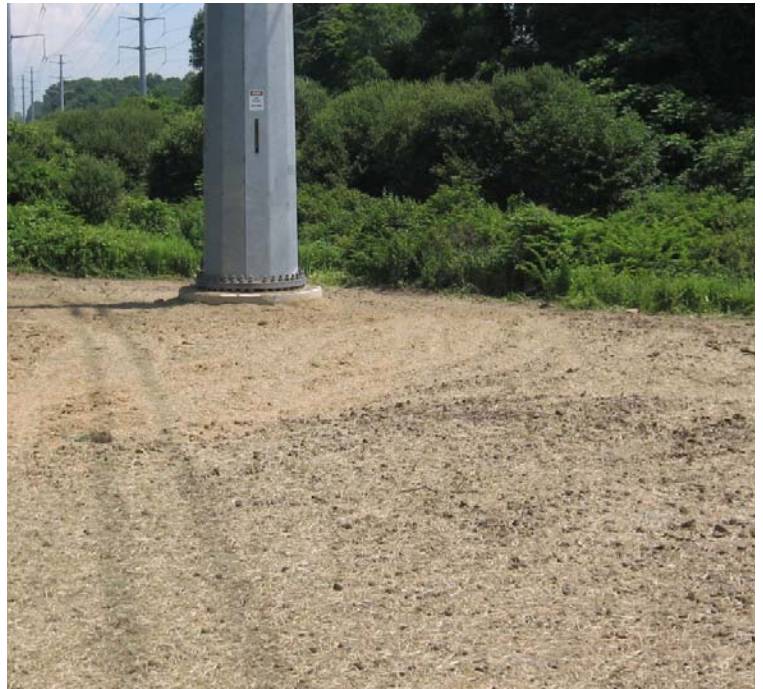
Oronoque Rd: An additional view of restoration efforts near structure #24008.
