Docket No. 272 – Development and Management Plan Inspection

Segment 2b Inspection

Date: July 11, 2008

Location: Segment 2b – Cheshire/Hamden Town Line to East Devon Substation

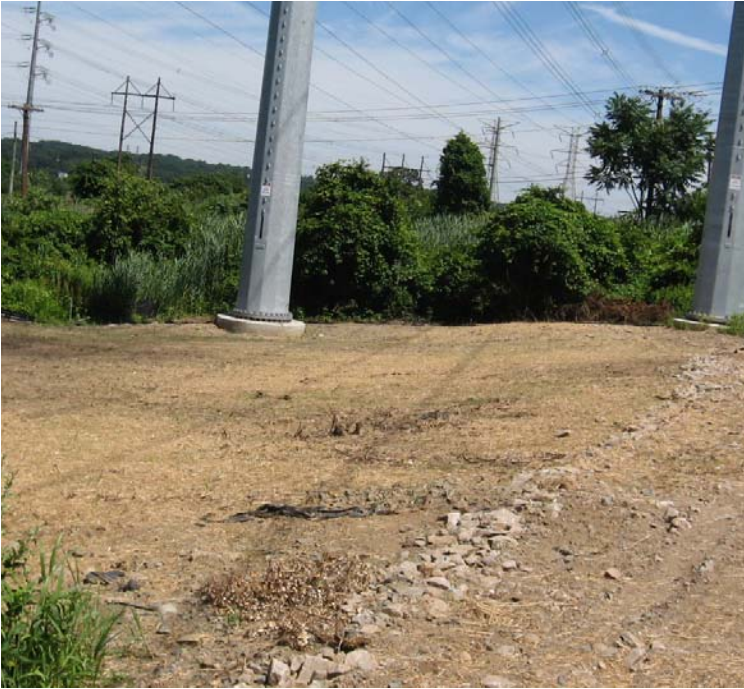
Naugatuck Rd (Milford): A view of 345 kV restoration efforts.

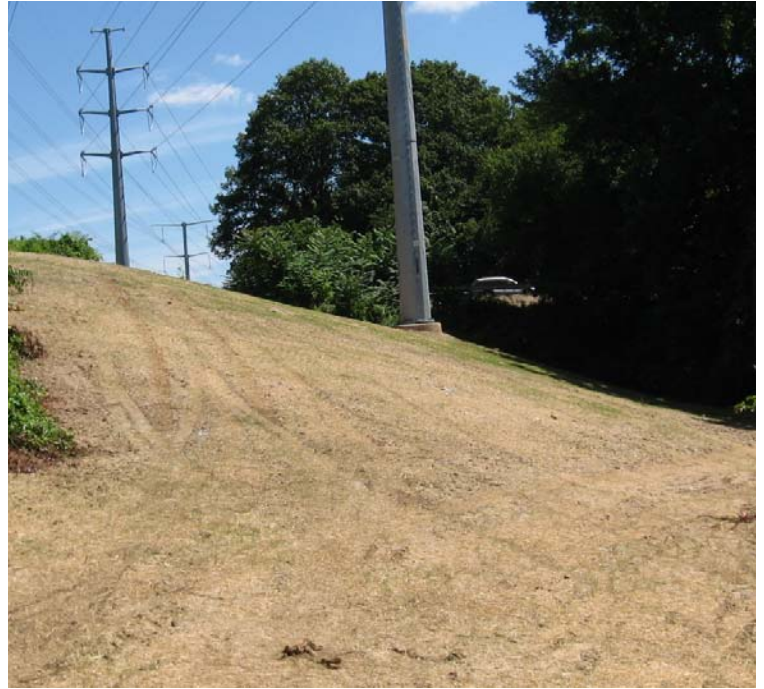
Lexington Way: Crane pads have been removed and exposed soils have been temporarily stabilized with mulch. Silt fence remains along the wetland boundary.

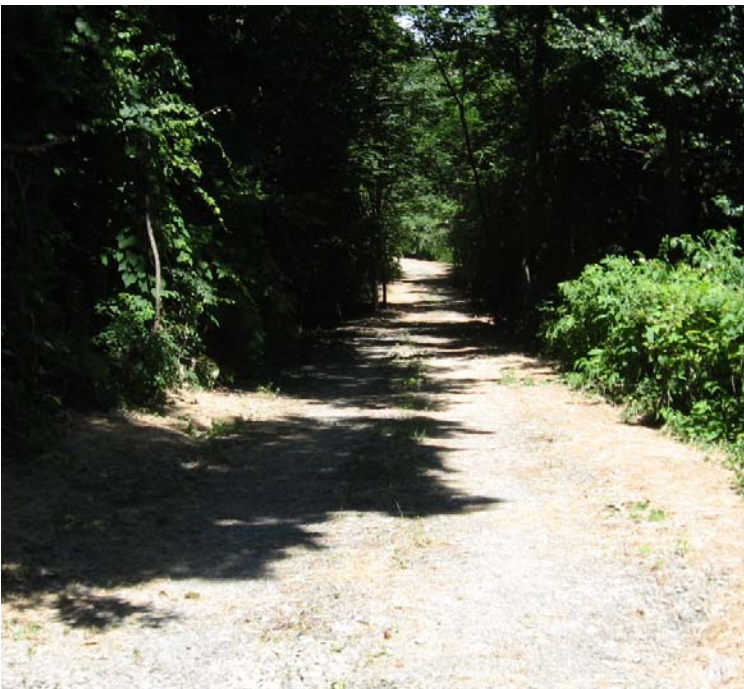
East Rutland: The access road to structures # 3827/24014 remains. Exposed soils have been graded and temporarily stabilized with mulch.

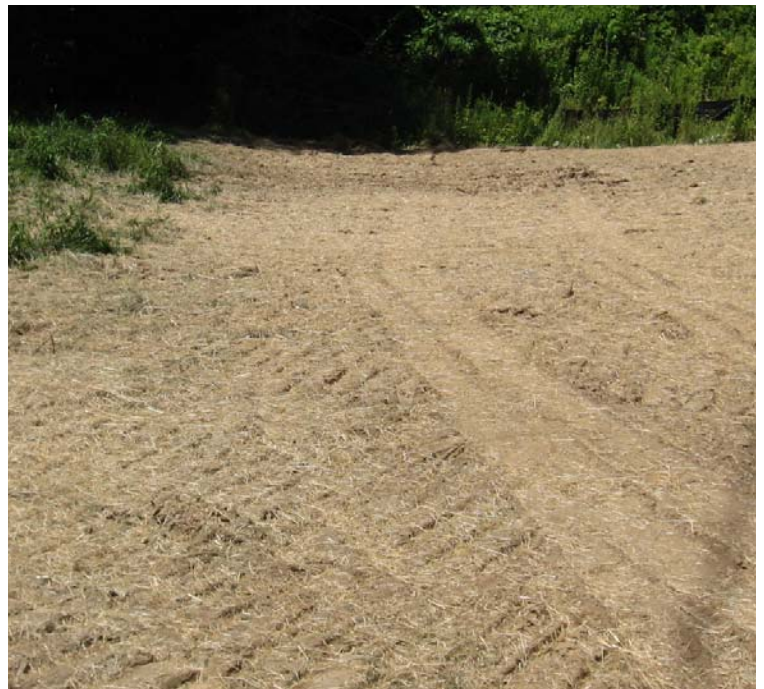
Wheelers Farm Rd: The crane pad near structure # 3832/24019 has been reclaimed and soils have been graded and mulched. The erosive gully in this area has been graded. Silt fence protection remains.
