Docket No. 272 – Development and Management Plan Inspection

Segment 2b Inspection

Date: July 25, 2008

Location: Segment 2b – Cheshire/Hamden Town Line to East Devon Substation

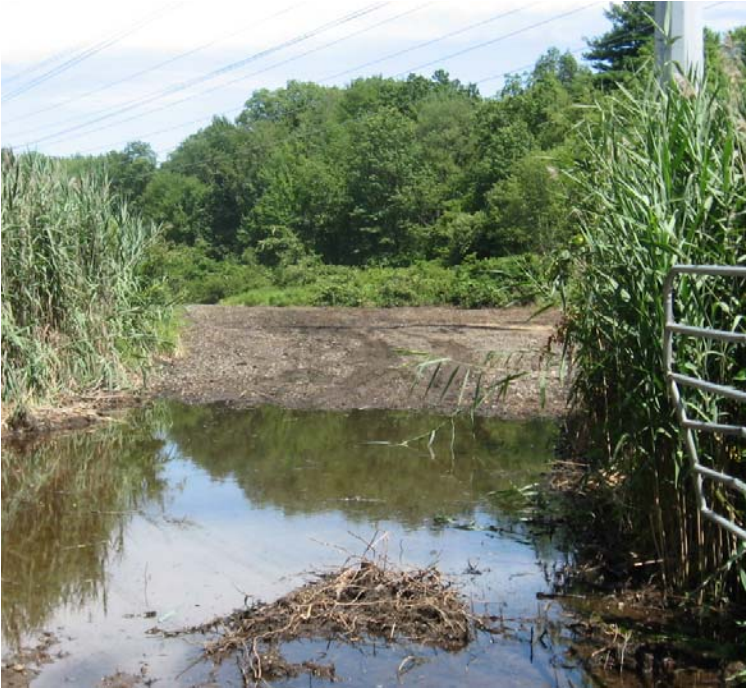
West River St (Milford): The access road has been restored to the original grade.

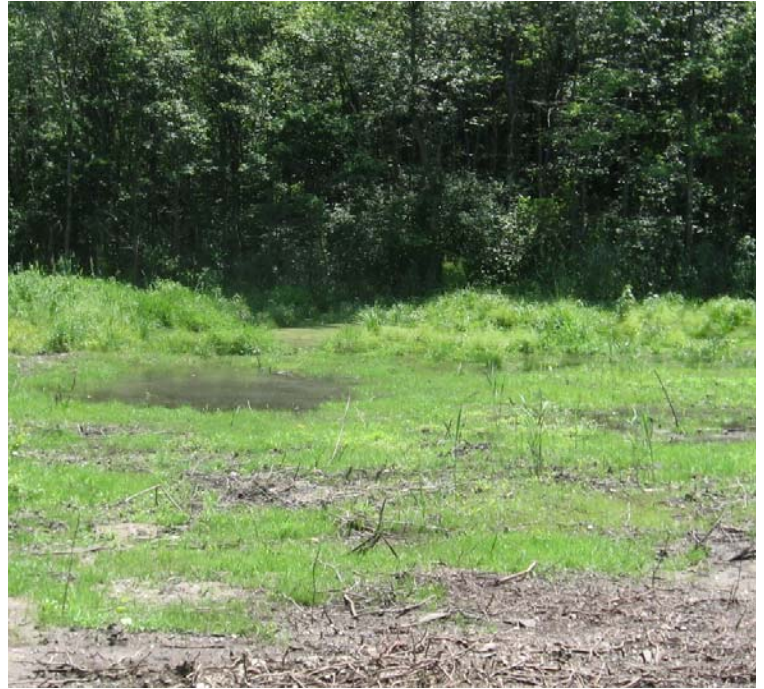
West River St: Wetland timber mats have been removed from the wetland near structure # 3836/24023.

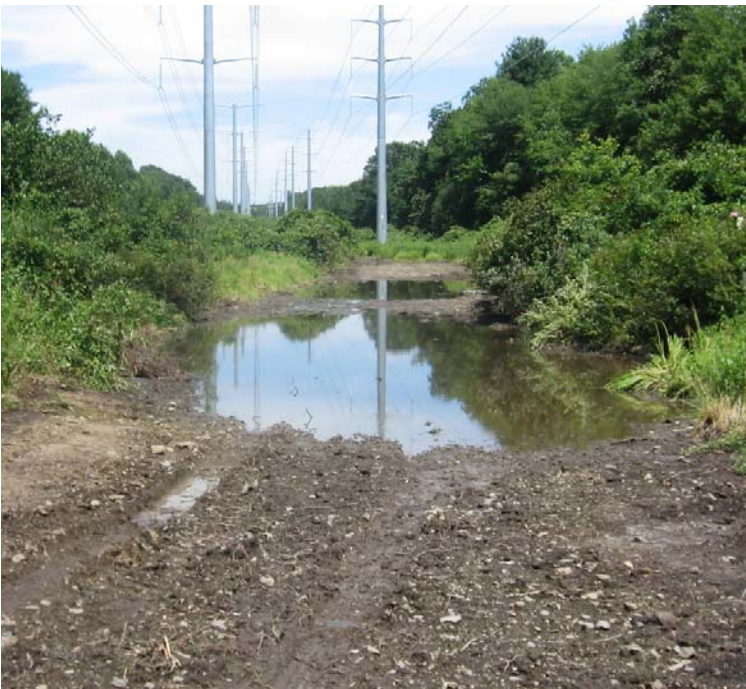
West River St: An additional view of where the access road has been returned to the original grade.

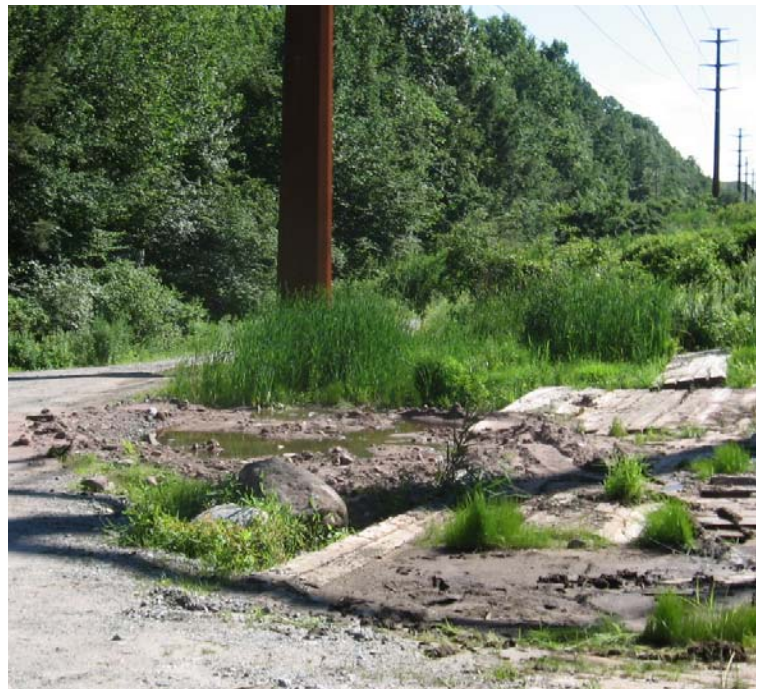
Gaylord Mtn Rd (Hamden): The spoil pile has been removed from the wetland near structure # 3992.
