Docket No. 272 – Development and Management Plan Inspection

The Connecticut Light and Power Company Certificate of Environmental Compatibility and Public Need for the construction of a new 345-kV electric transmission line and associated facilities between Scovill Rock Switching Station in Middletown and Norwalk Substation in Norwalk, Connecticut, including reconstruction of portions of existing 115-kV and 345-kV electric transmission line, the construction of Beseck Switching Station in Wallingford, East Devon Substation in Milford, (and Singer Substation in Bridgeport), modifications at Scovill Rock Switching Station and Norwalk Substation, and the reconfiguration of certain interconnections.

Segment 2b Inspection

Date: August 22, 2008

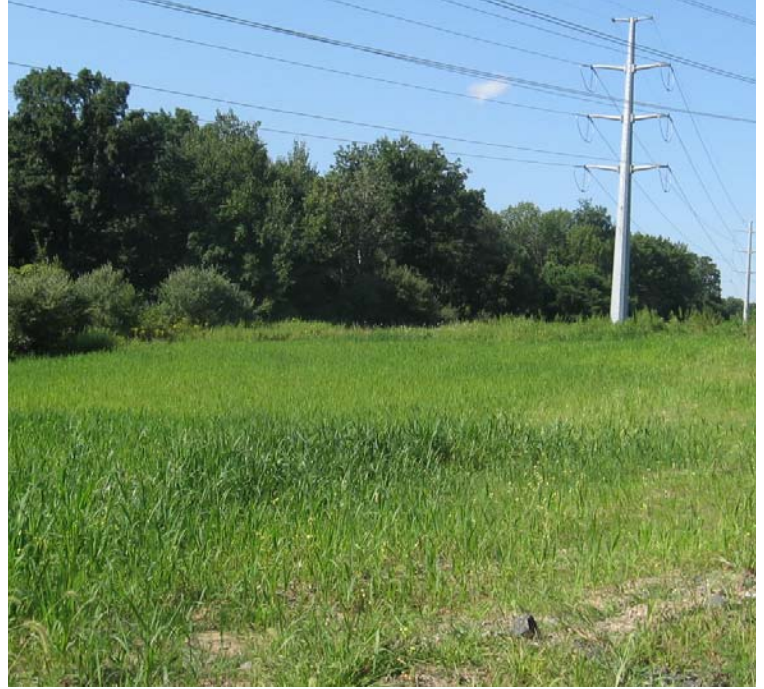
Wheelers Farm Rd: Vegetation covers approx. 70-80% of this former wire-pulling site.

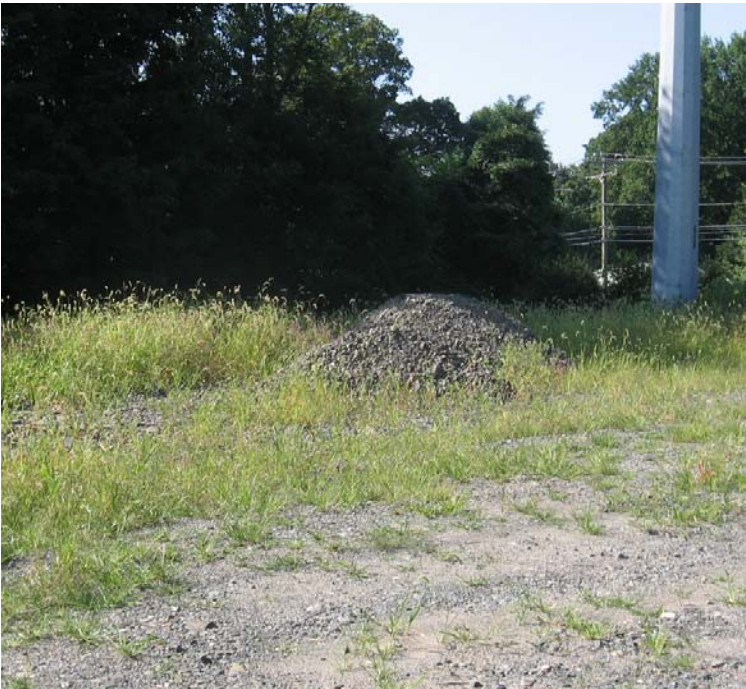
Wheelers Farm Rd: A spoil pile remains in the ROW near structure #3830.

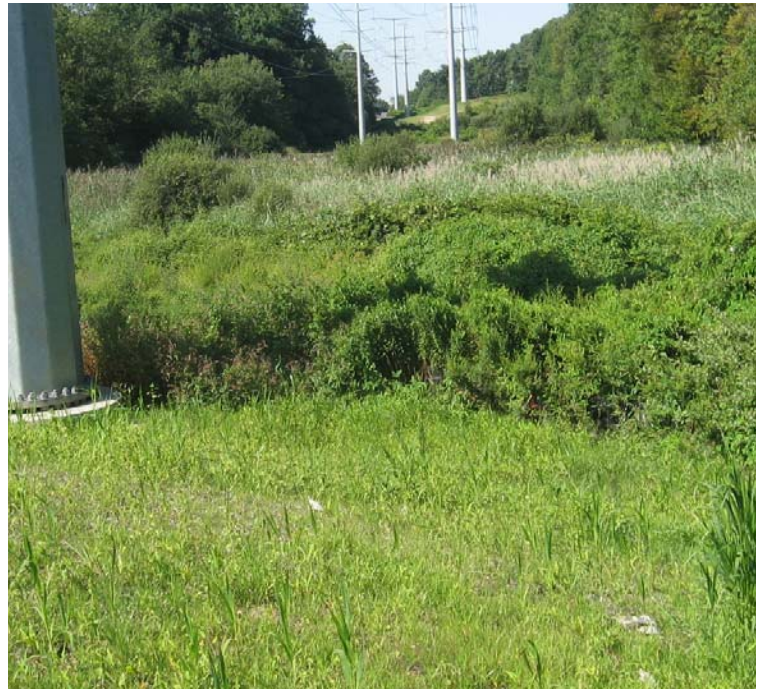
Wheelers Farm Rd: Vegetation covers approx. 70-80% of the former crane pad location at structure #24016 .

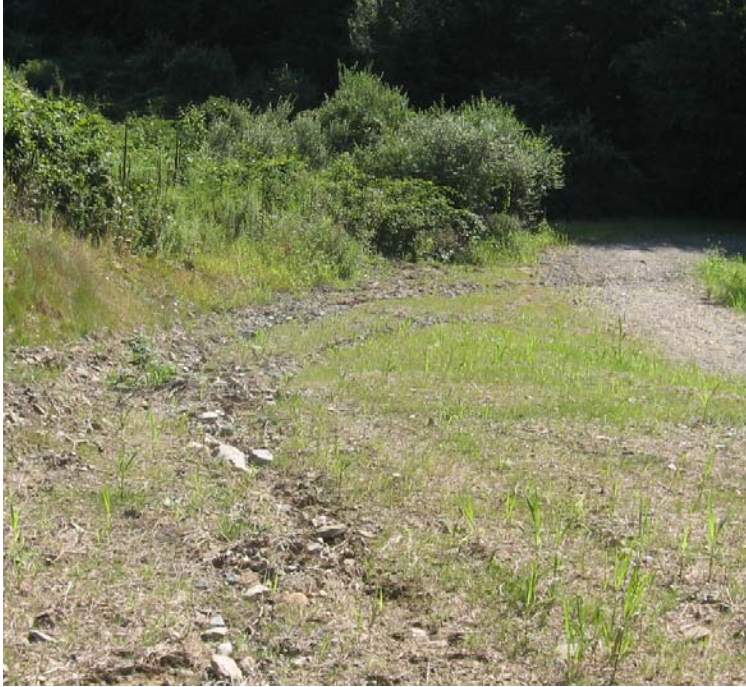
East Rutland (Milford): Some scouring is evident on the slope of the former crane pad.

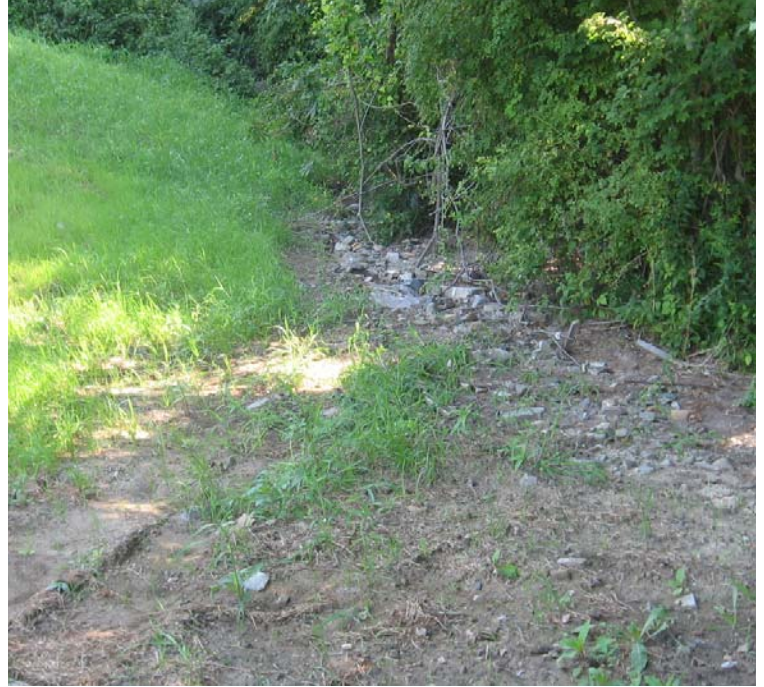
Lexington Way (Milford): Stormwater runoff flowing from a culvert beneath Hwy 15 is causing scouring/channelized flow along the perimeter of the ROW here.

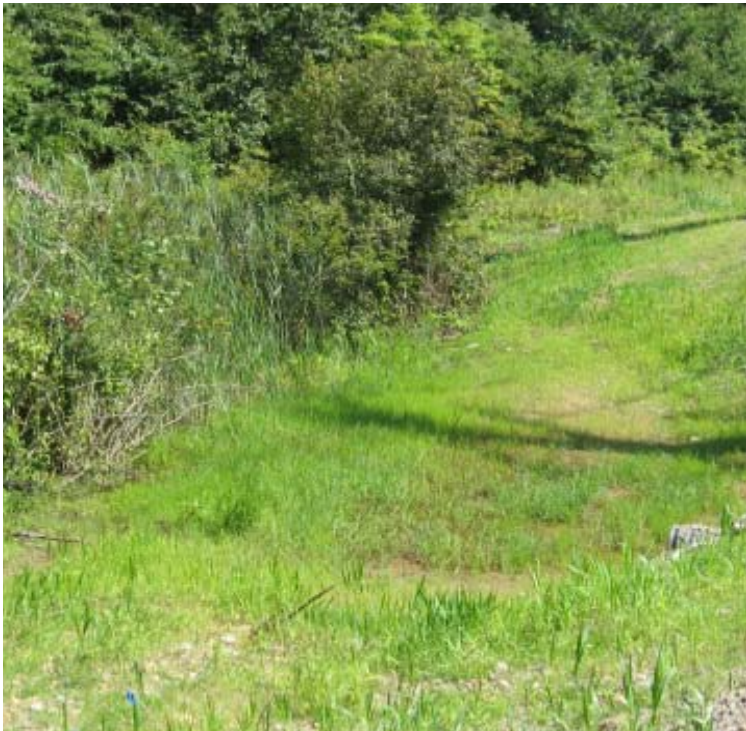
Fresh Meadow Ln (Milford): A view of wetland restoration efforts near structure # 24022.

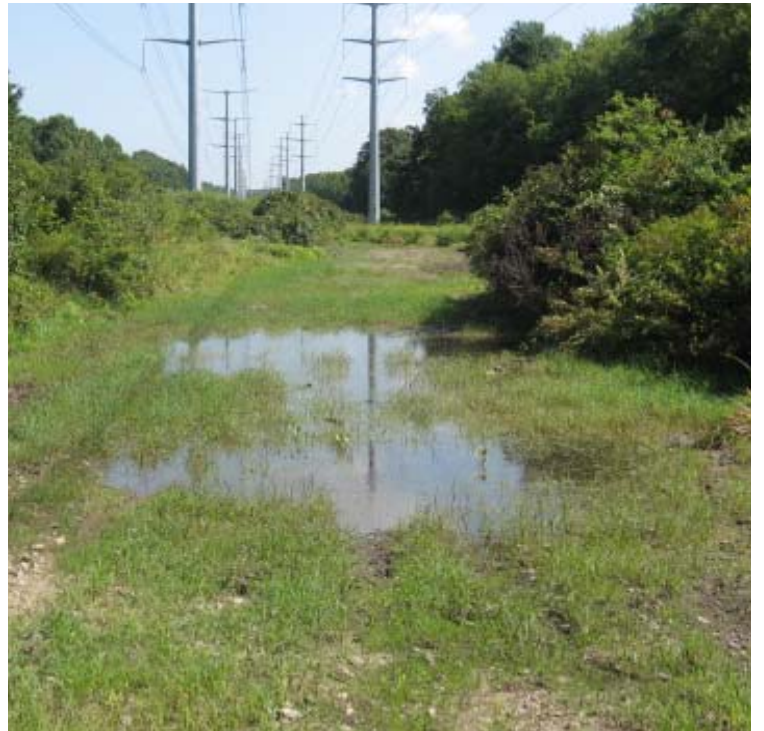
West River Street	Access road has been returned to the original grade. Vegetation growth has been noted this week, but exposed soils remain. 8/22/08	Continue to monitor. See EC Section. 8/22/08	Needs attention

West River St (Milford): Vegetative growth has been noted in some areas of the reclaimed access road.

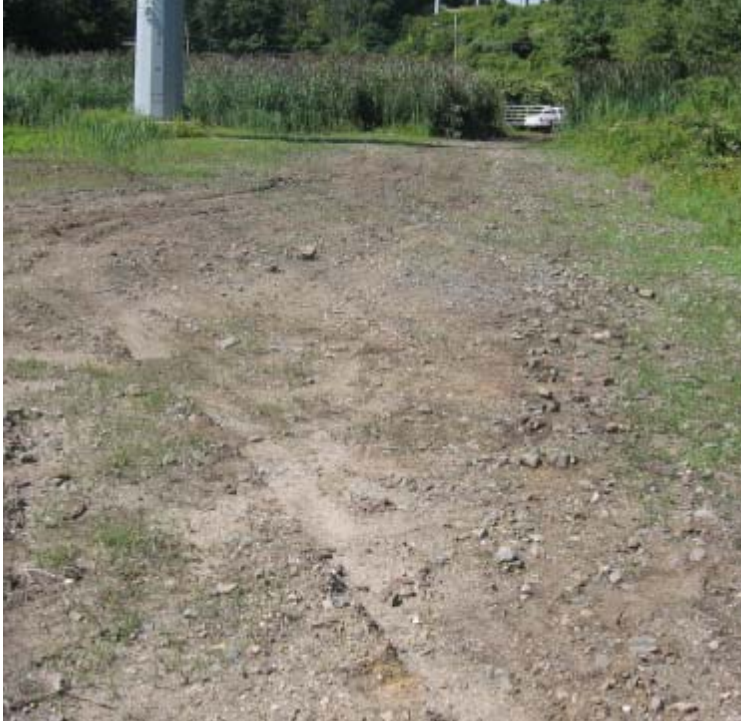
West River St: Exposed soils remain in this area.

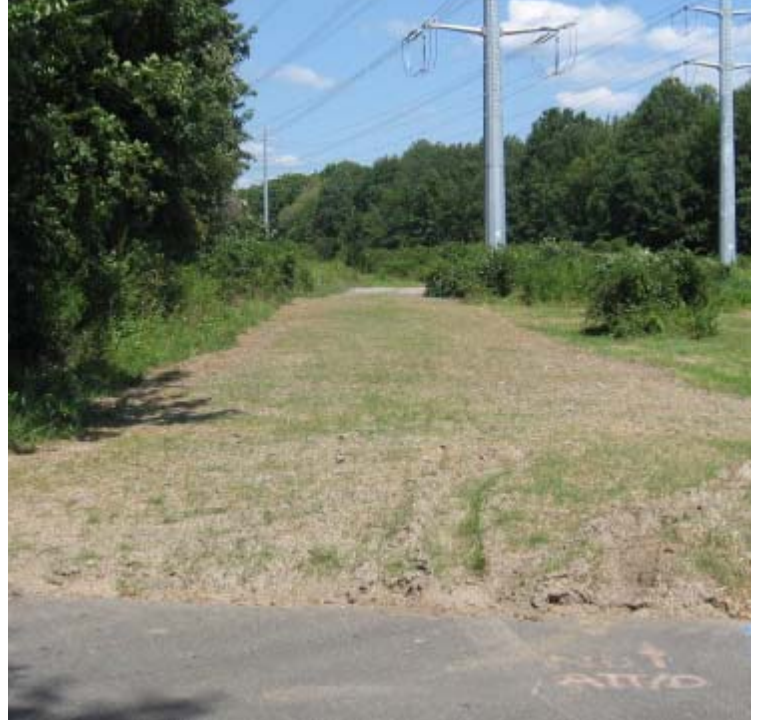
Manville Rd (Woodbridge): A portion of the access road has been restored. The remaining portion is permanent and will remain in the wetland, as permitted.

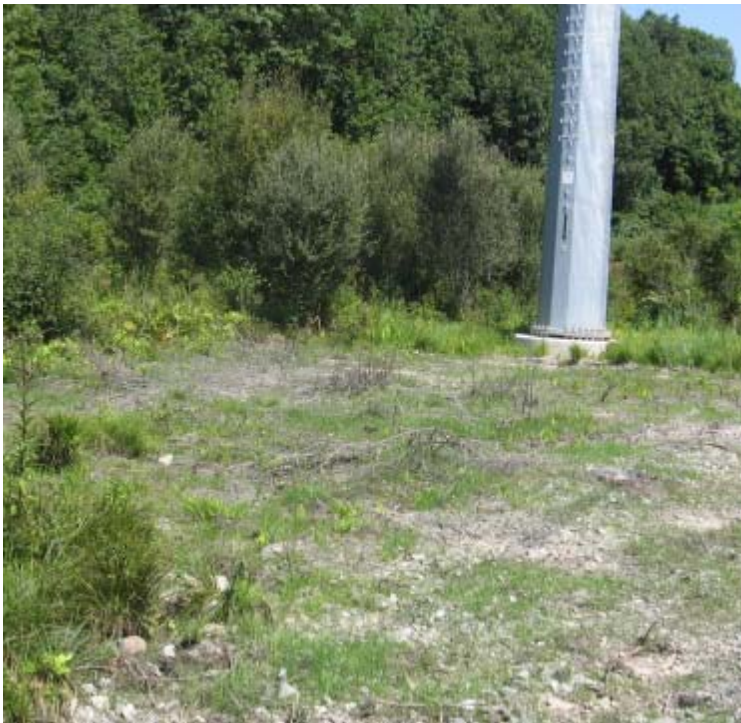
B'Nai Jacob (Woodbridge): A view of crane pad reclamation.

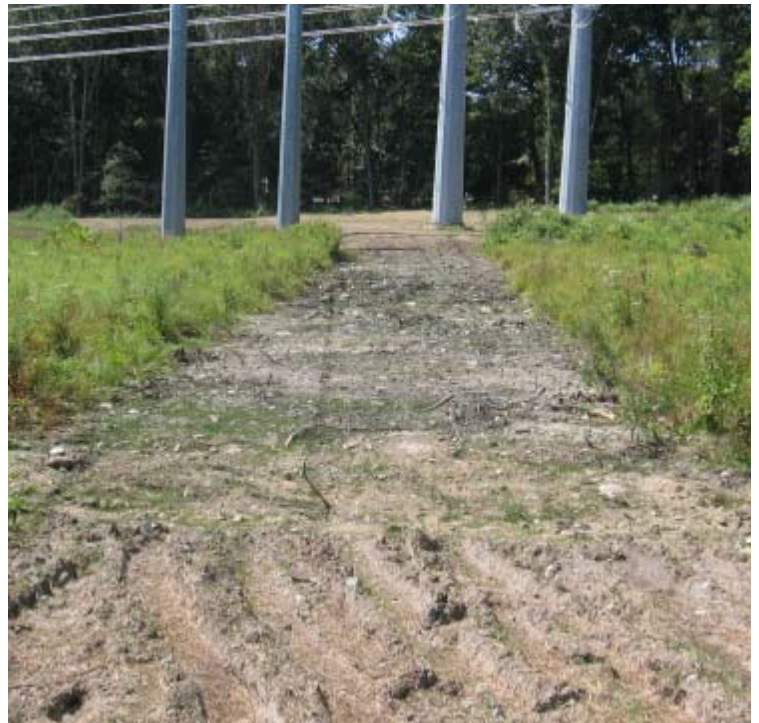
B'Nai Jacob: The access road has been removed from the wetland here.
