Docket No. 272 – Development and Management Plan Inspection

Segment 2b Inspection

Date: August 29, 2008

Location: Segment 2b – Cheshire/Hamden Town Line to East Devon Substation

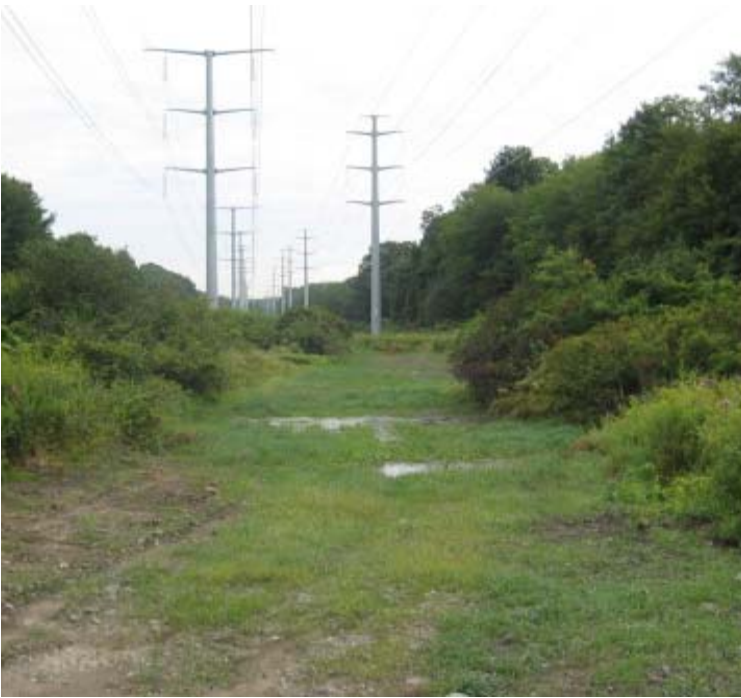
West River St (Milford): A view of vegetation growth where the access road was removed.

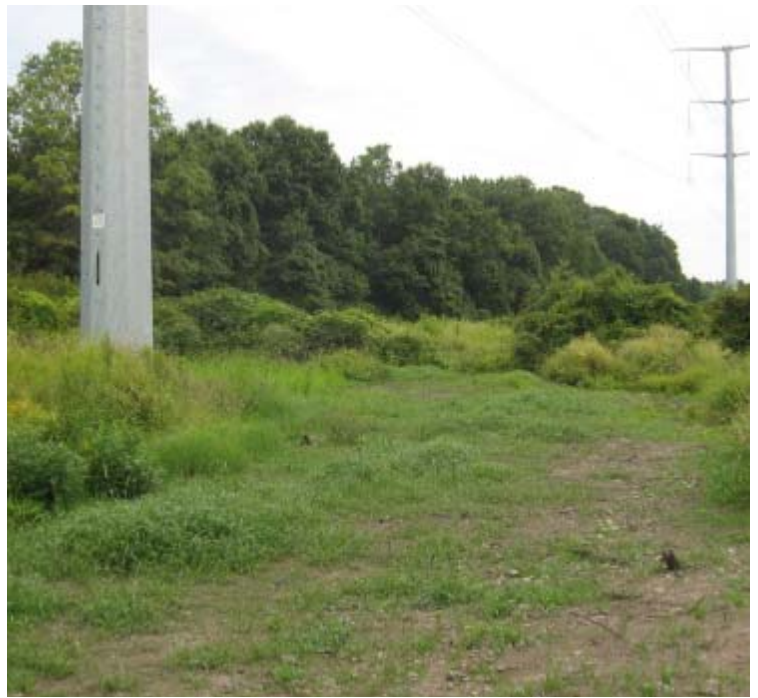
West River St: Vegetation covers approx. 70-80% of this former crane pad. Exposed soils remain where the access road was removed.

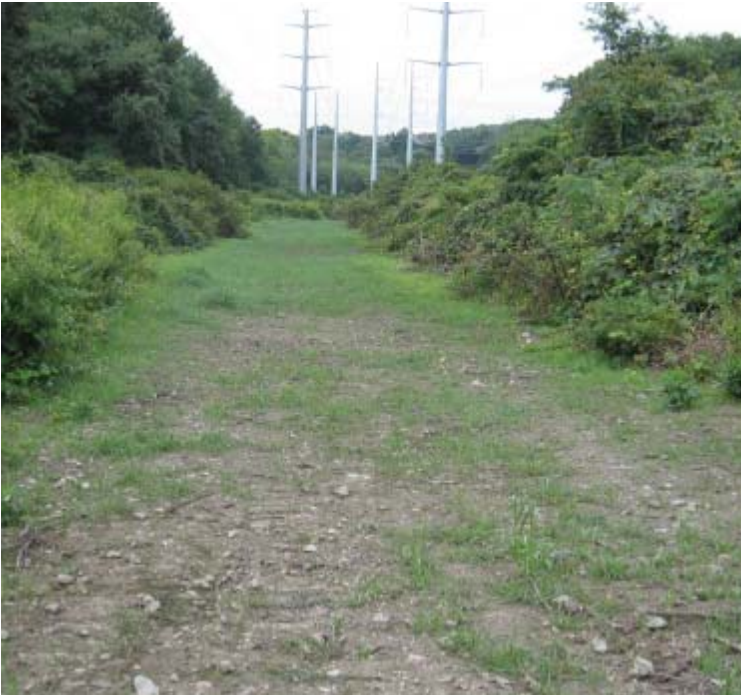
West River St: View of the former access road location.

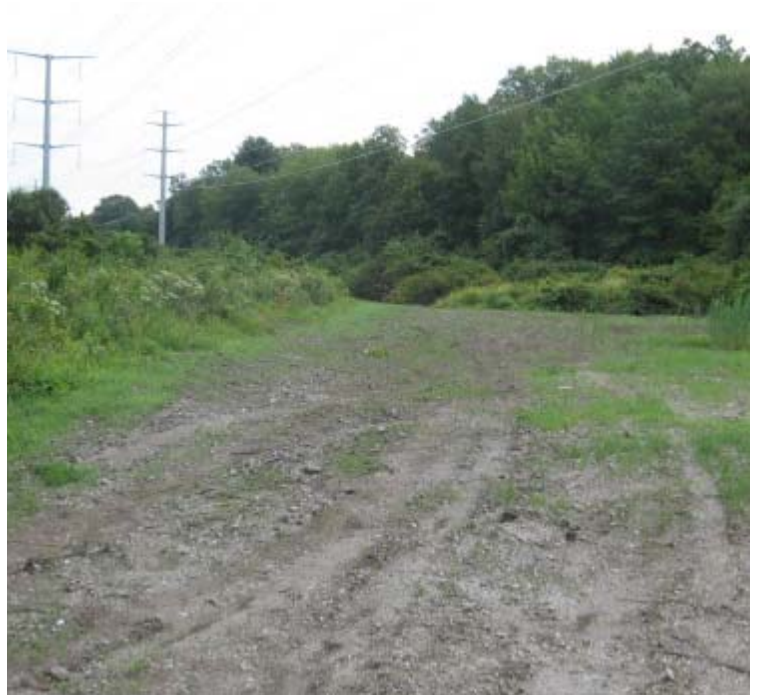
West River St: Exposed soils remain in the upland portion of the ROW where the access road was removed.

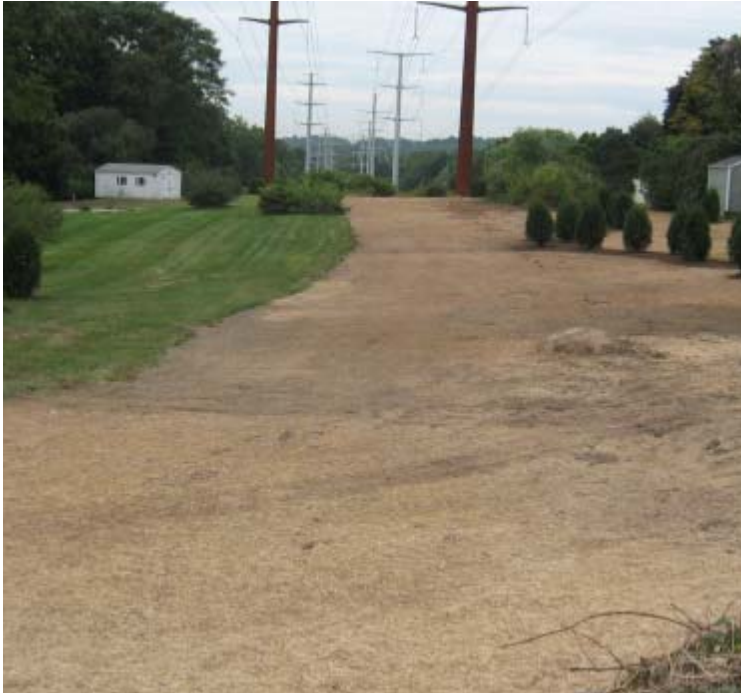
Ridge Rd (Orange): A view of restoration efforts in this area.

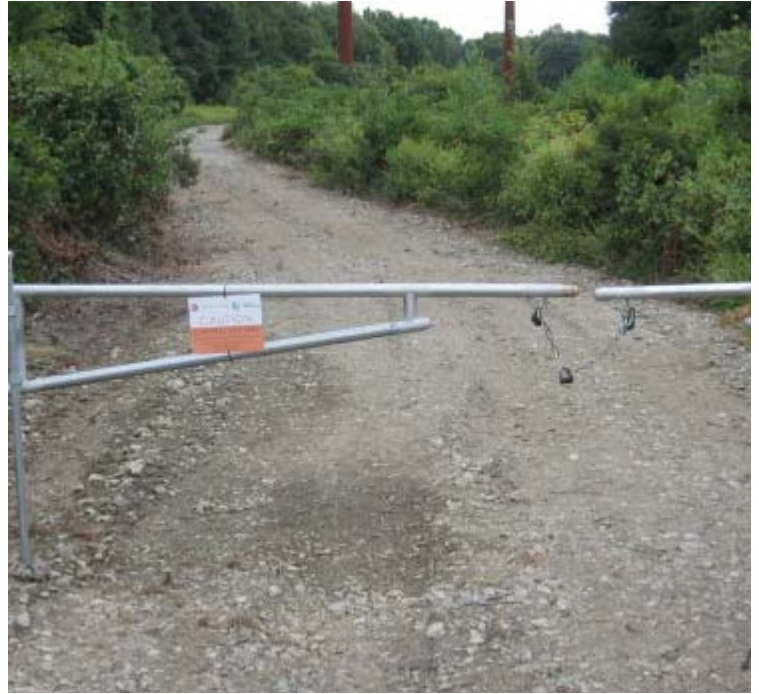
Pine Tree Dr (Orange): A permanent stone access Rd has been installed in the wetland here, as permitted.

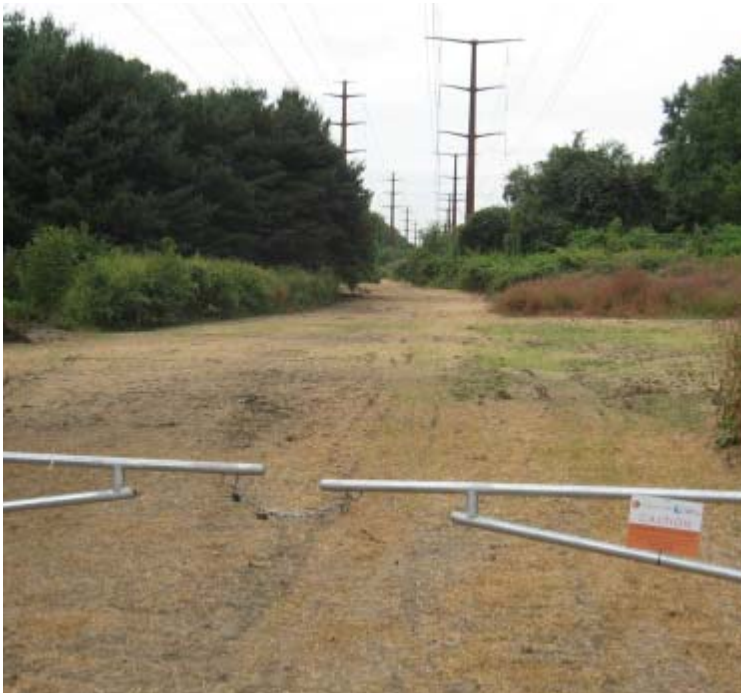
Orange Center Rd (Orange): A view of restoration efforts in this area.

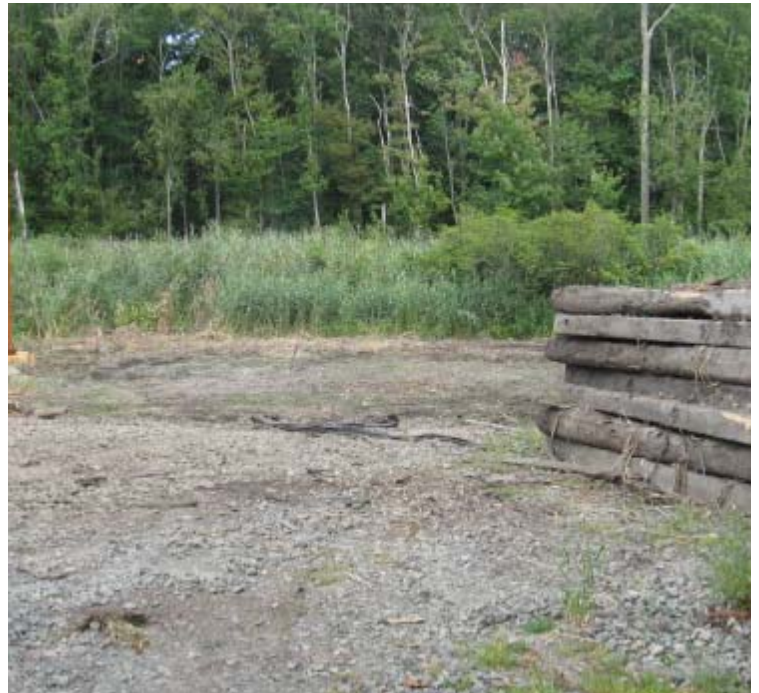
Hunting Hill Rd (Orange): Timber mats have been removed from the wetland here.

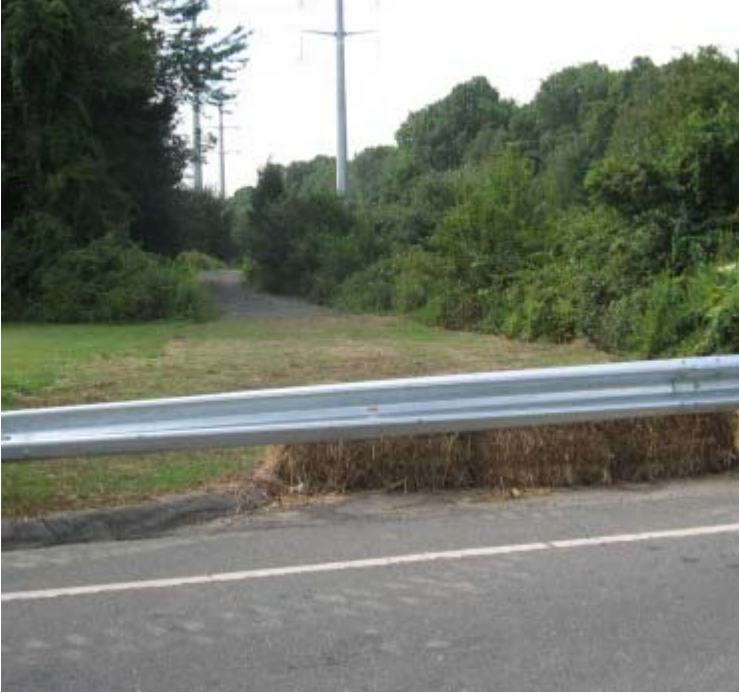
Ansonia Rd (Woodbridge): A view of restoration efforts in this area. The access road remains in the wetland as permitted.

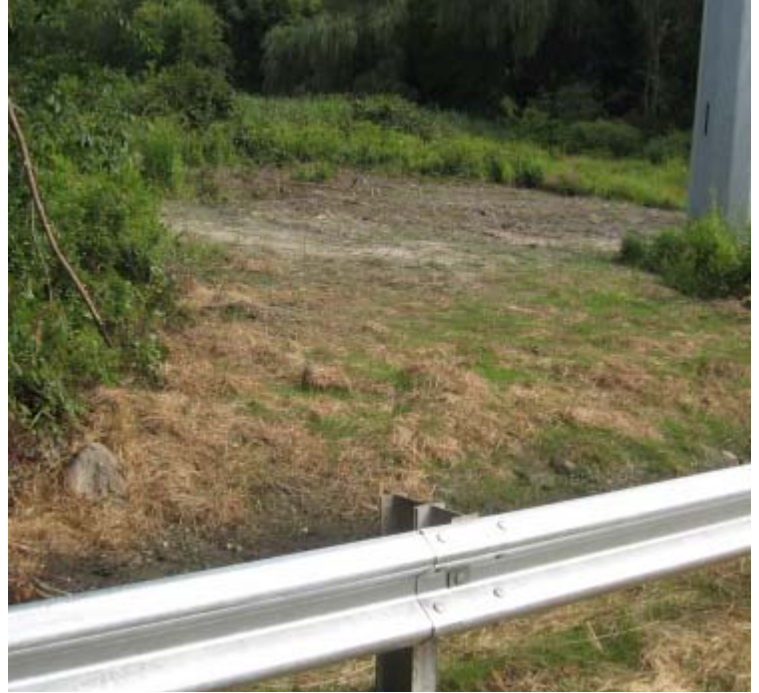
Ansonia Rd: Additional view of restoration efforts.

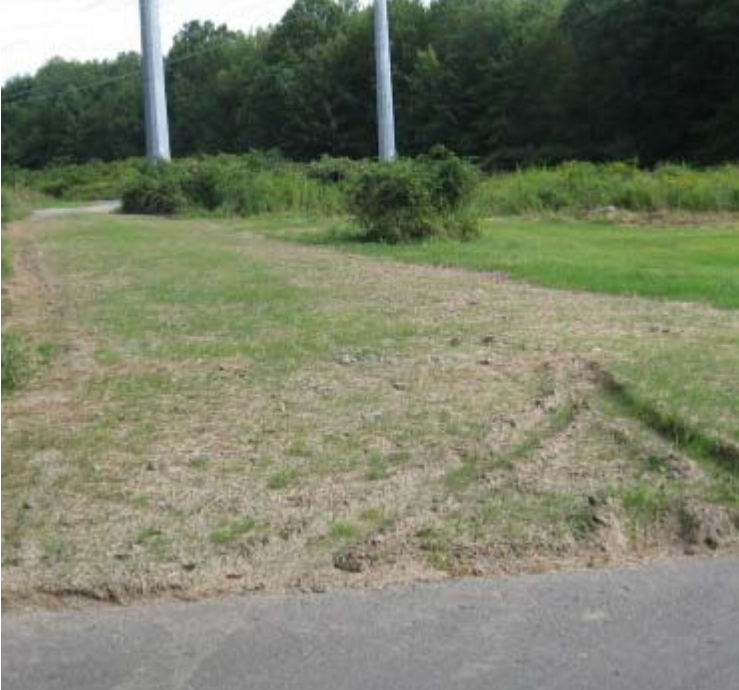
Manville Rd (Woodbridge): A view of restoration efforts here.

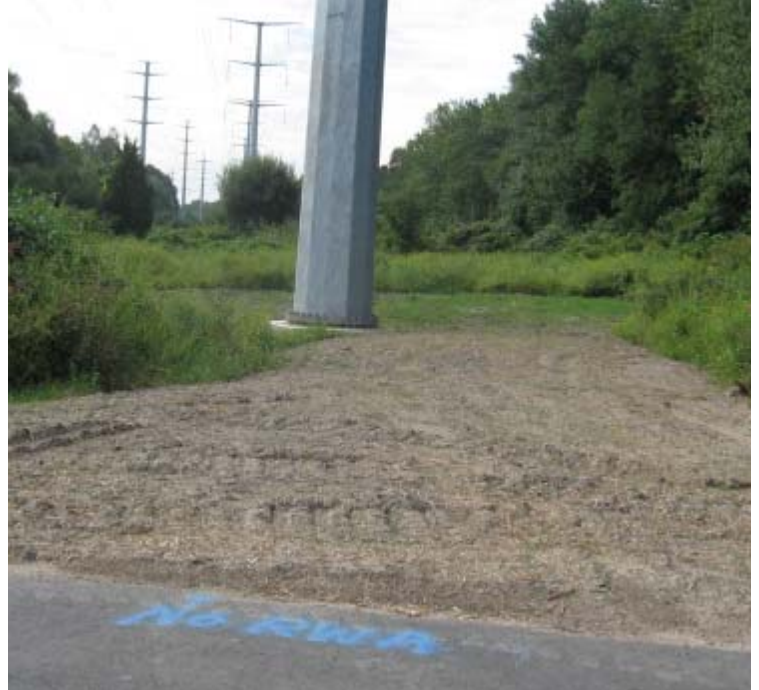
Manville Rd: The access road remains in the wetland here, as permitted. The stone access has been covered with hay mulch and seeded with loam.
