Docket No. 272 – Development and Management Plan Inspection

Segment 2b Inspection

Date: September 5, 2008

Location: Segment 2b – Cheshire/Hamden Town Line to East Devon Substation

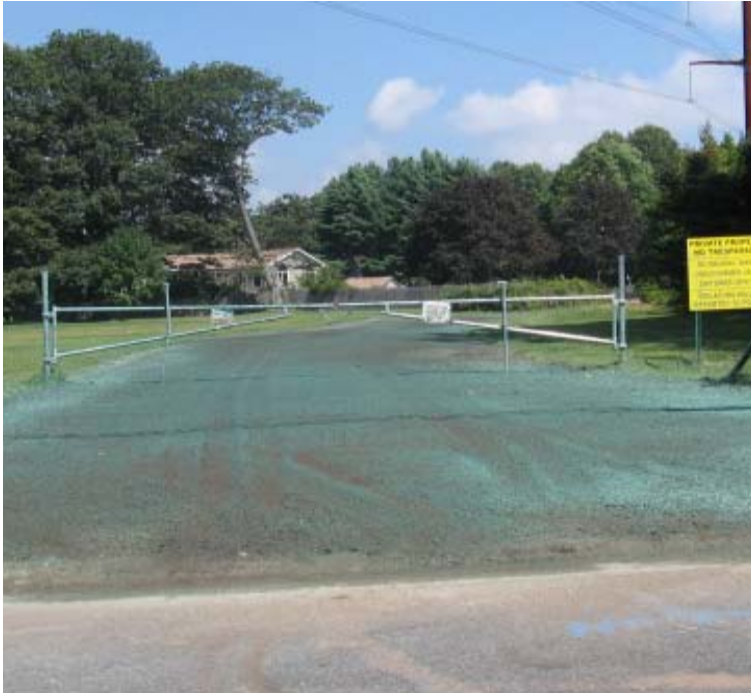
Treat Ln (Orange): View of restoration efforts. Hydro-seed was applied here.

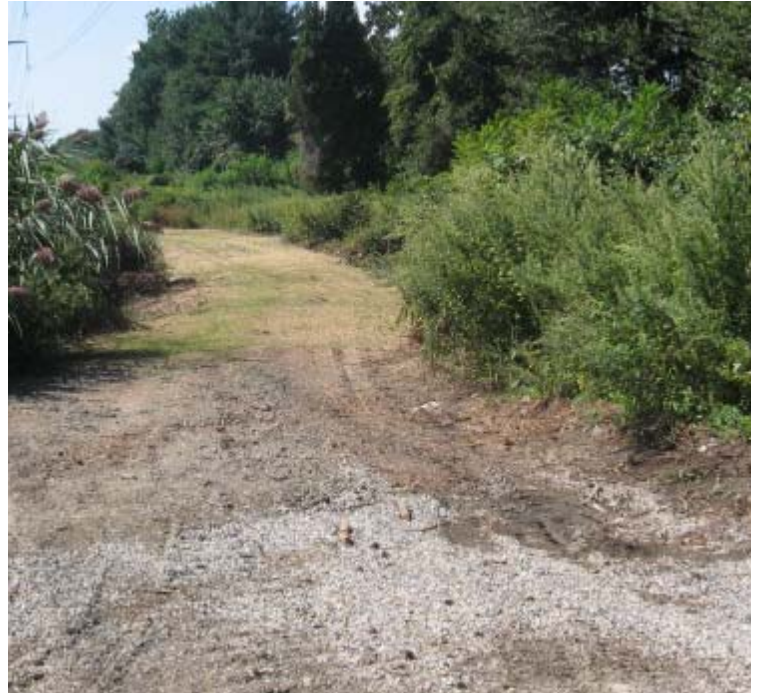
Treat Ln: The permanent wetland crossing here has been stabilized with mulch and seed. Vegetation growth is evident.

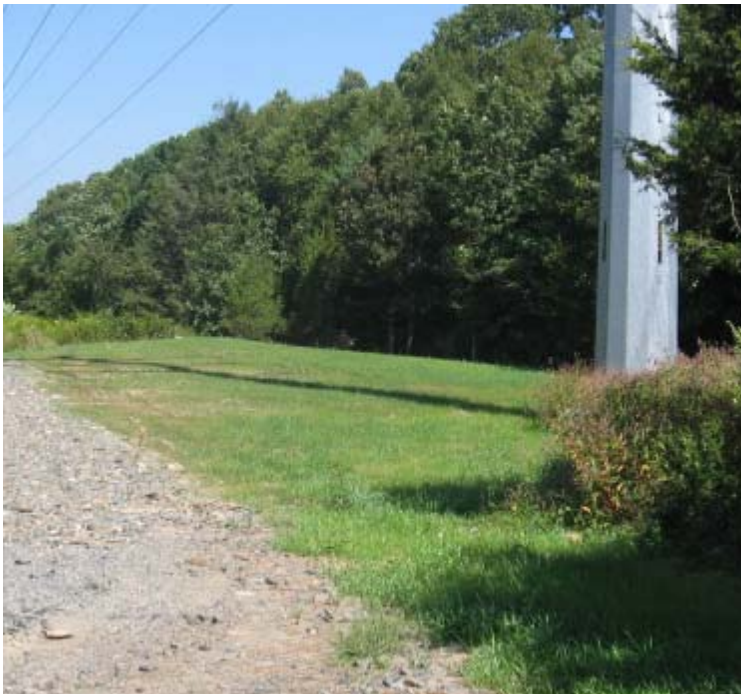
Cowpath Ln (Woodbridge): Vegetation covers approximately 70% of the former crane pad area near structure #3940.

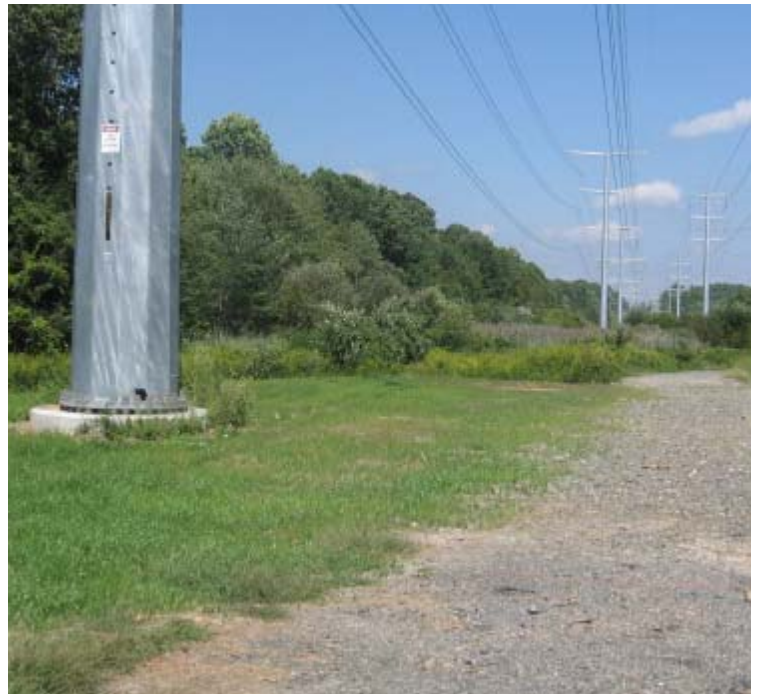
Cowpath Ln: Vegetation covers approximately 70% of the former crane pad area near structure #24127.

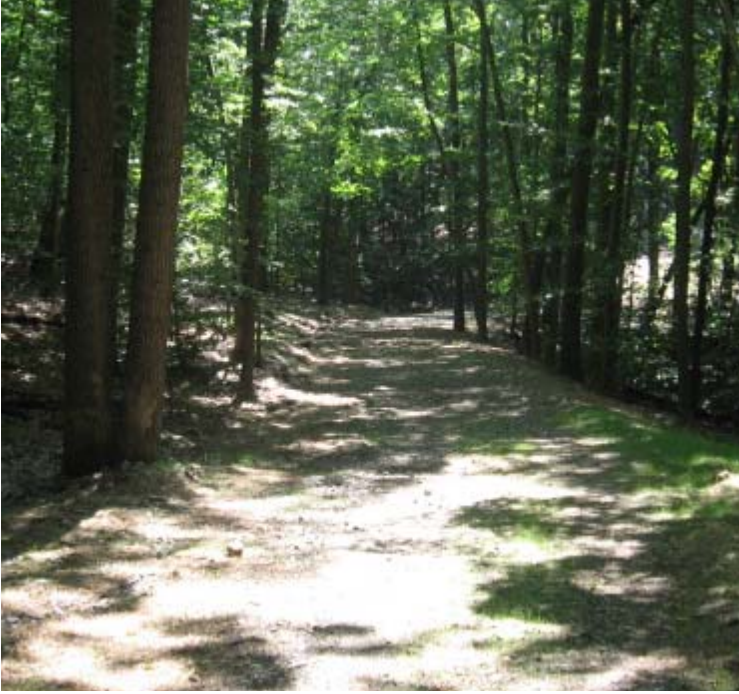
Cowpath Ln: The access Rd between structures #24129-24130 remains stable.

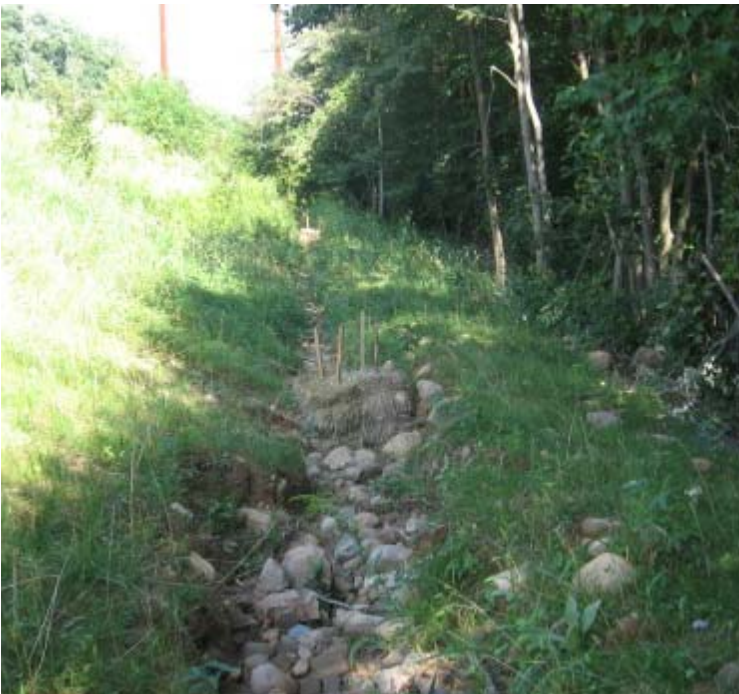
Hamden, CT West Todd Street/ Gaylord Mountain	<p>A small swale was installed along the ROW perimeter and the access road in an attempt to help control/divert stormwater runoff. An erosive gully has been observed in the northern portion of the swale. Haybale controls have been installed within the swale. 9/5/08</p>	<p>Continue to monitor until final stabilization is achieved. The swale remains functional but additional controls are needed to help control stormwater and erosion. Remove sediment from the wetland. 9/5/08</p>	<p>Haybale controls have been installed within the swale <i>Needs additional attention</i></p>
Gaylord Mountain (North)	<p>Sediment is accumulating in the third sediment basin along the access road here. Additional controls/ stabilization measures may be necessary. Vegetative growth has been observed within the trench along the access road. 9/5/08</p>	<p>Remove sediment from the basin during 345 kV restoration efforts. 9/5/08</p>	<p>Sediment basins need attention during 345 kV restoration efforts</p>

Gaylord Mtn Rd (Hamden): Haybales have been placed in the swale to help control stormwater run-off.

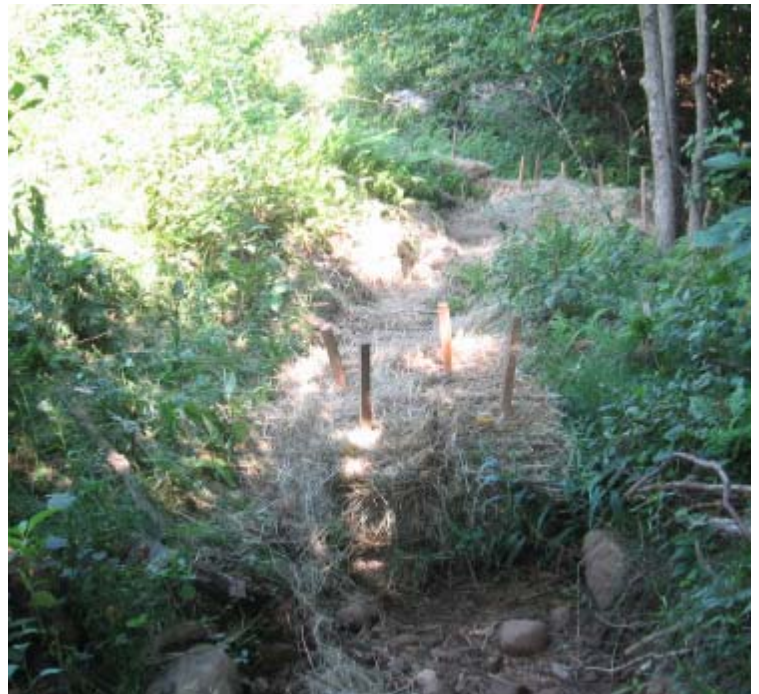
Gaylord Mtn Rd: An additional view of the haybales added to the Swale.
