Docket No. 272 – Development and Management Plan Inspection

Segment 2b Inspection

Date: September 11, 2008

Location: Segment 2b – Cheshire/Hamden Town Line to East Devon Substation

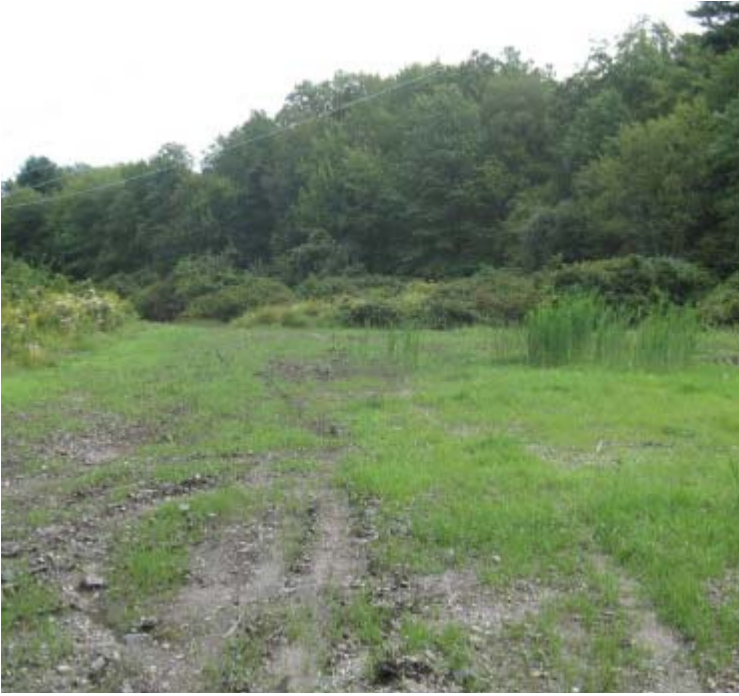
West River St (Milford): Vegetation growth continues. Vegetation covers approximately 50-55% of the area shown here.

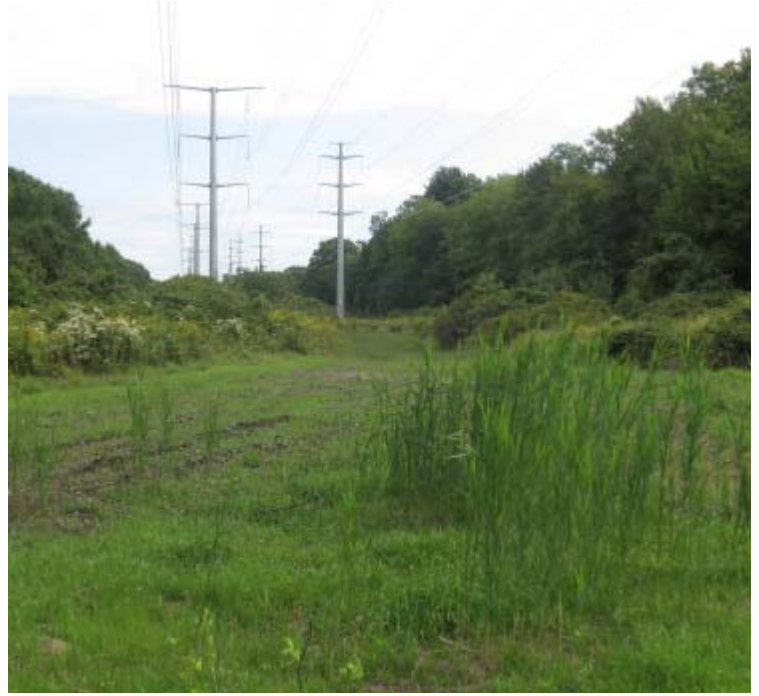
West River St: Vegetation covers approximately 70-75% of the former access road located within the wetland area.

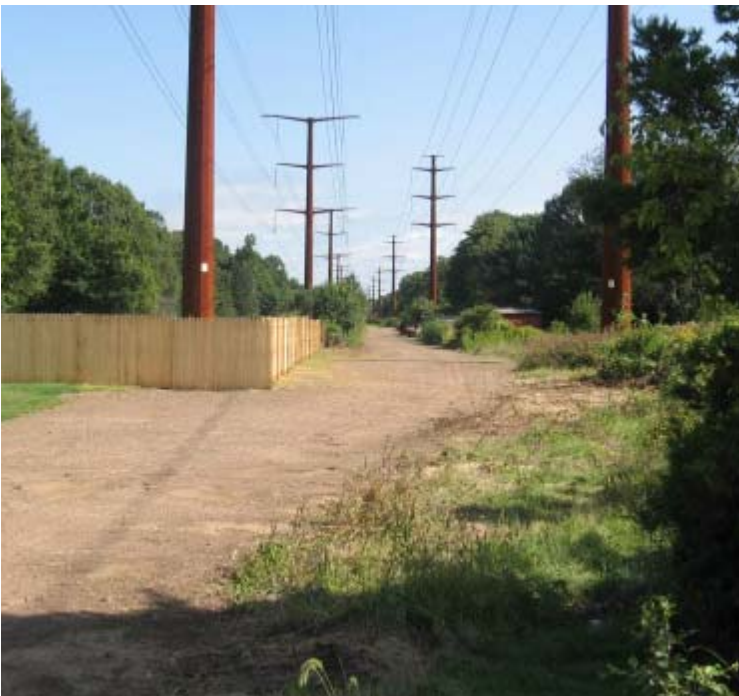
Treat Ln (Orange): A view of the restoration efforts in this area.

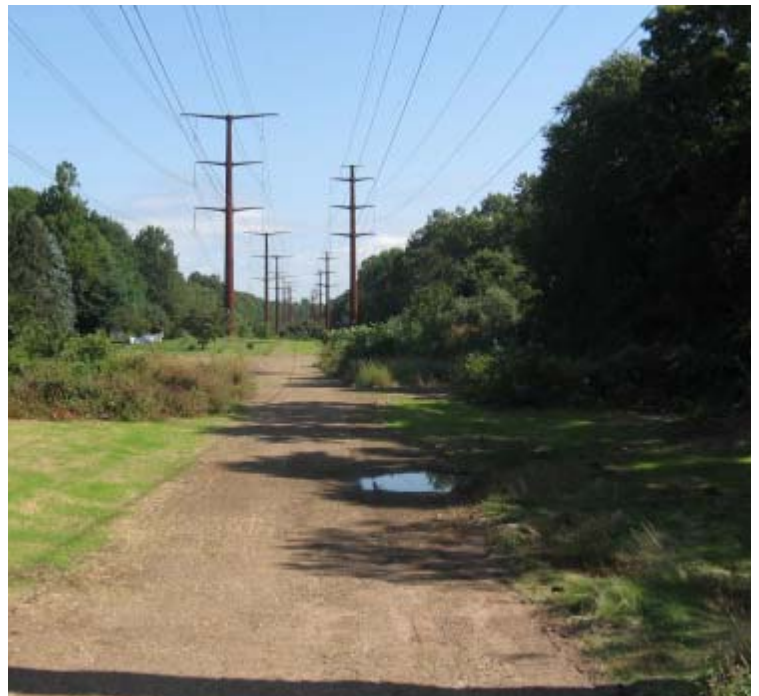
Treat Ln: An additional view of the restoration efforts in this area.

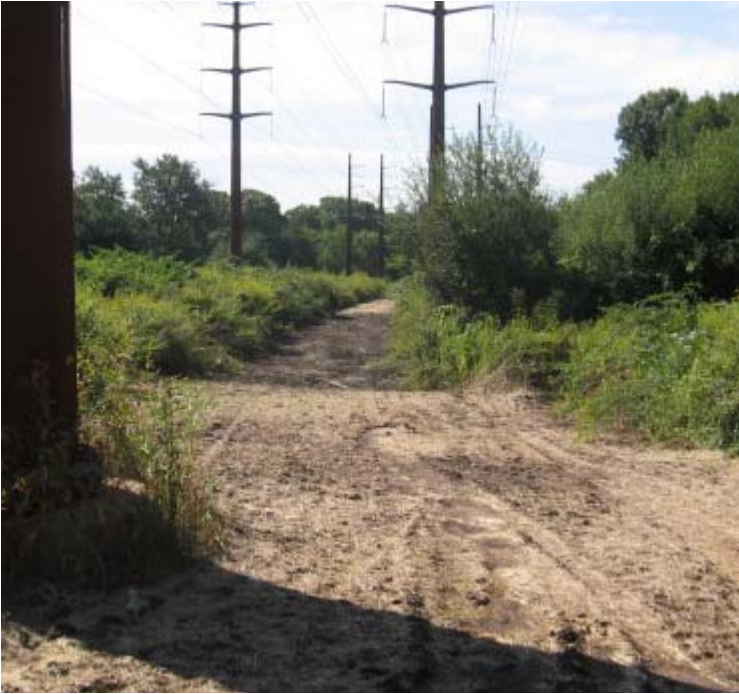
Sunset Dr (Orange): A view of the restoration efforts near the wetland area here. Exposed upland soils have been graded, mulched and seeded. Wetland soils have been graded.

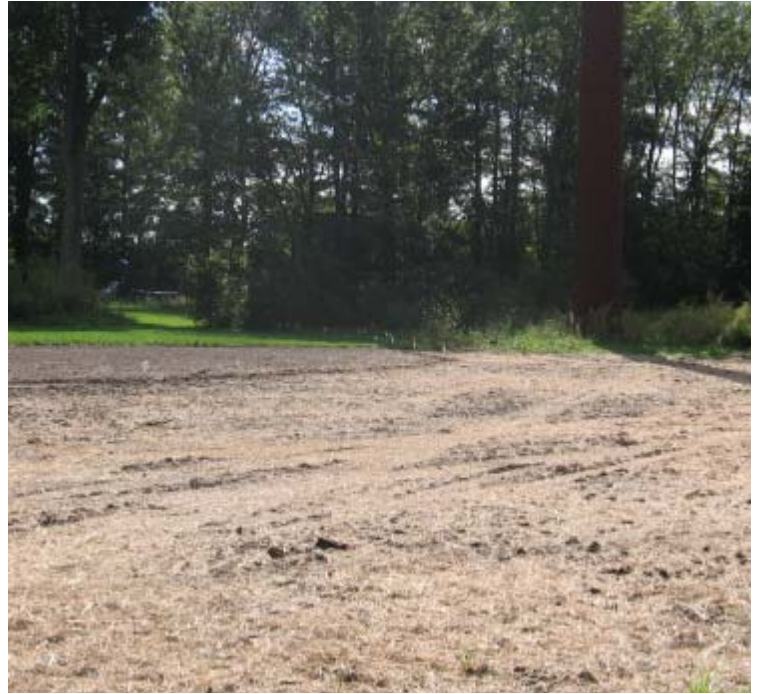
Hall Dr (Orange): A view of the restoration efforts near structure #3868/24055.

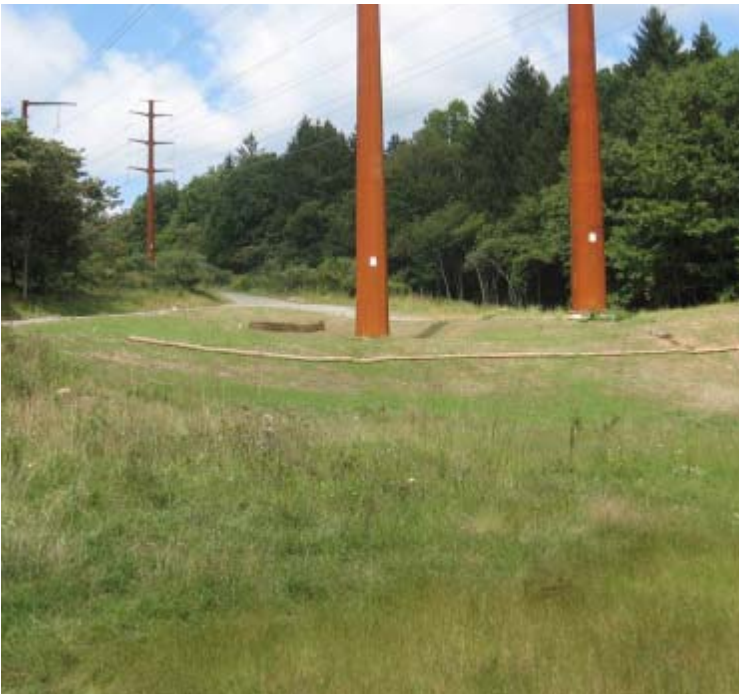
Dogburn Rd (Orange): Restoration efforts near structures # 3890/24077.

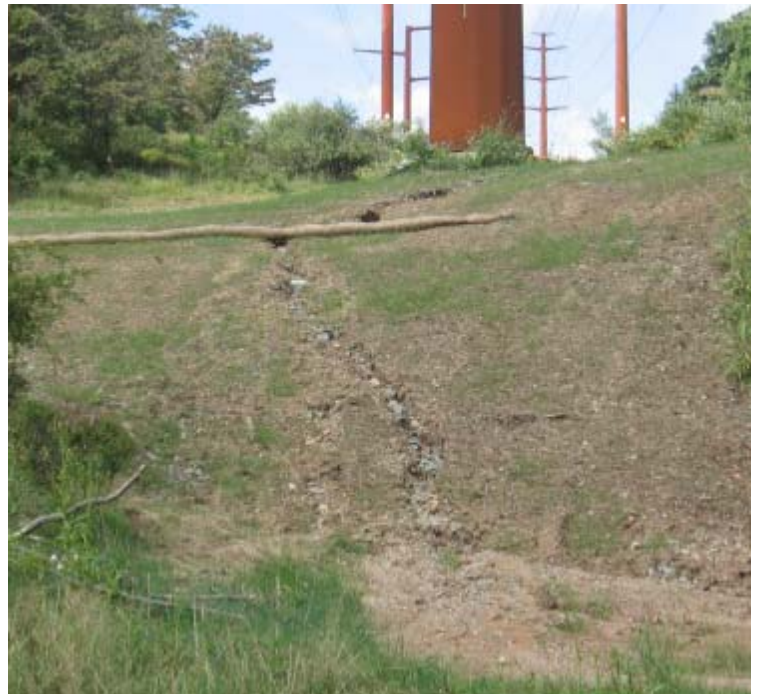
Orange, CT Dogwood Rd	Silt fence is in need of repair near structure #24067. 3/12-9/11/08	Repair/ remove controls as necessary during 345 kV restoration efforts. 9/11/08	Needs attention during 345 kV restoration efforts
Dogburn Rd	Stormwater run-off has caused scouring in the restored crane pad area near structure #24077. 8/22-9/11/08	Stabilize exposed soils and continue to monitor and repair/add controls as necessary. 9/11/08	Needs attention
Route 34	Spoils remain within the ROW off Rt. 34. Piles appear to be contained in the upland portions of the ROW. 9/11/08	Remove spoil piles when feasible. 9/11/08	Needs attention during 345 kV restoration efforts

Dogburn Rd: Stormwater run-off continues to erode the disturbed area near structure #24077.

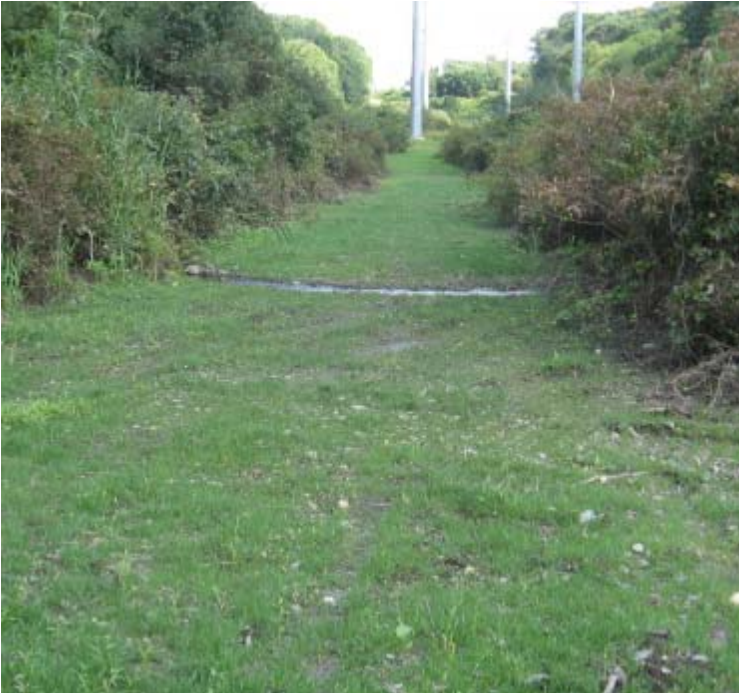
Rimmon Rd/B'nai Jacob (Woodbridge): A view of the vegetative cover within the former access road.

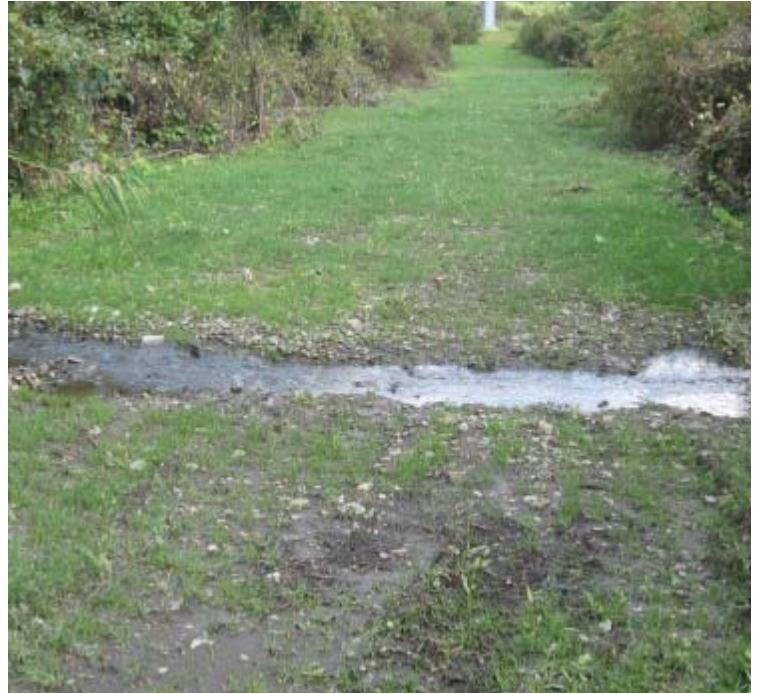
Rimmon Rd/B'nai Jacob: Vegetation growth continues and sediment was not observed in the stream.

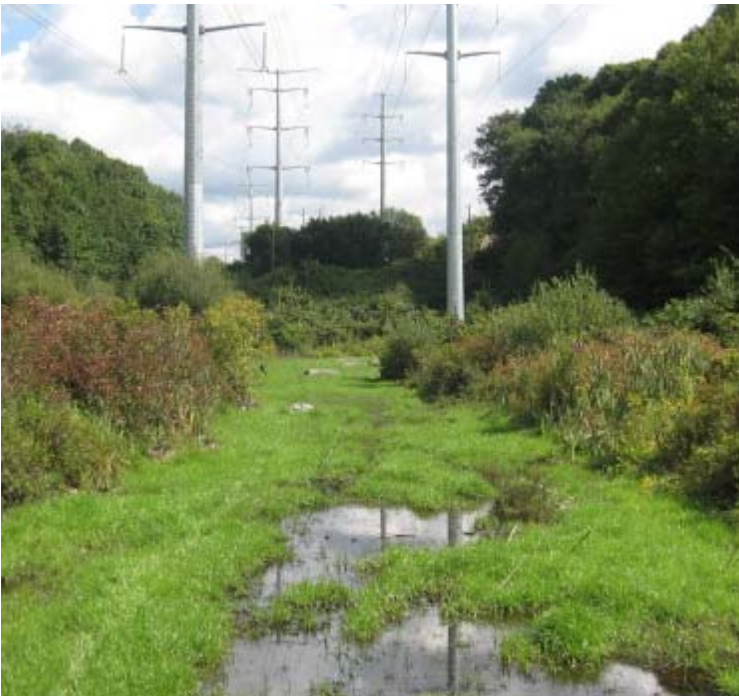
Rimmon Rd/B'nai Jacob: A view of the restored access road near structures # 3923/24110.

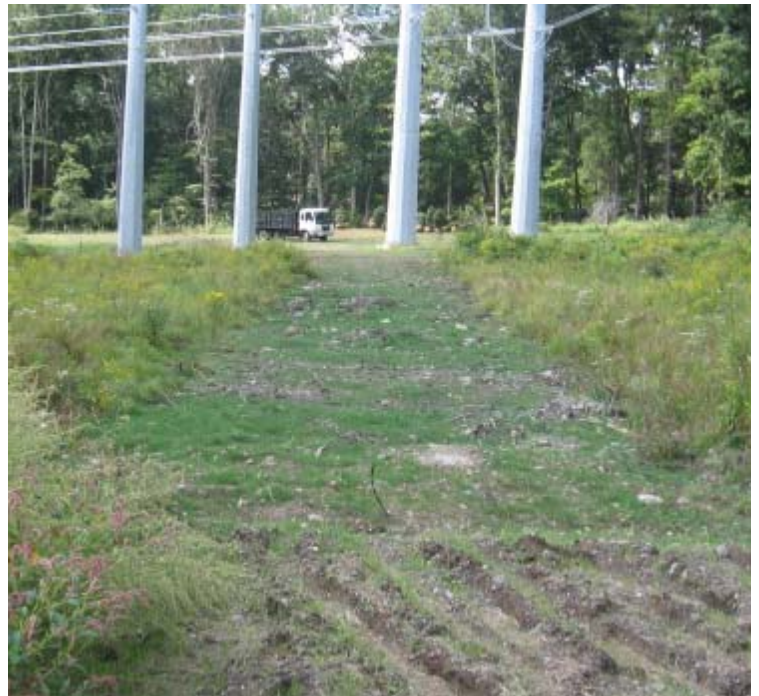
Rimmon Rd/B'nai Jacob: A view of the restored access road through the newly routed ROW. Vegetation growth continues here.
