Docket No. 272 – Development and Management Plan Inspection

Segment 2b Inspection

Date: September 25, 2008

Location: Segment 2b – Cheshire/Hamden Town Line to East Devon Substation

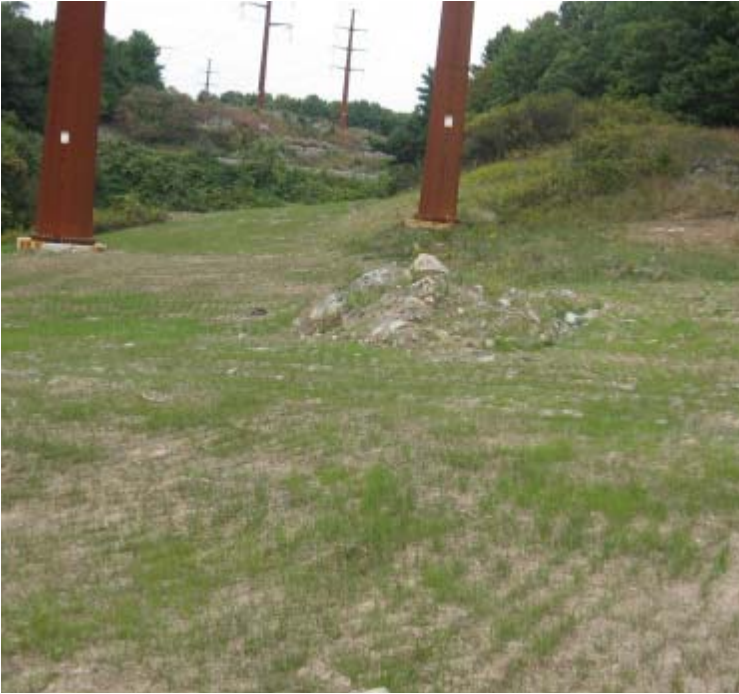
Rt 34 (Orange): Vegetative growth continues within the restored access road and crane pad near structures #3887/24074.

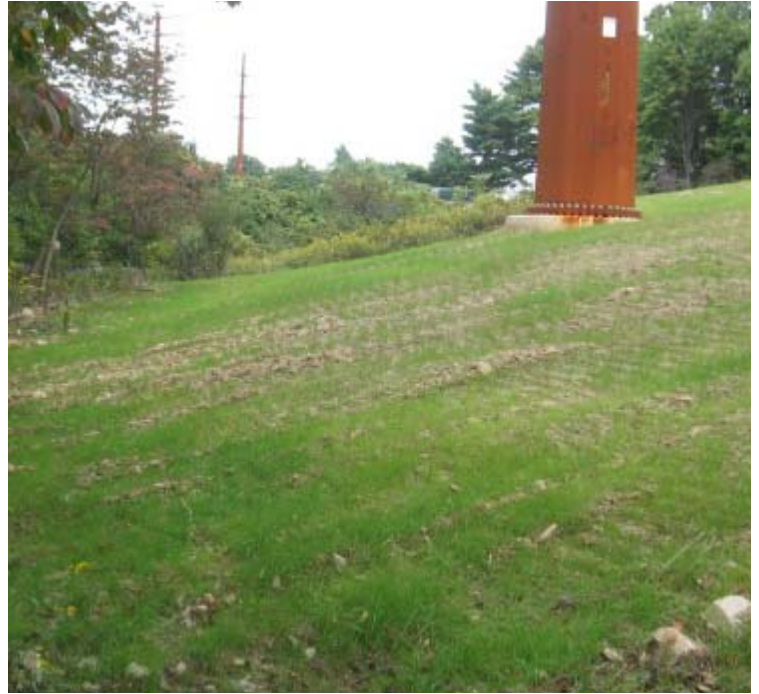
Rt 34: An additional view of vegetative cover near structures #3887/24074. Soils appear stable along the slope at this time.

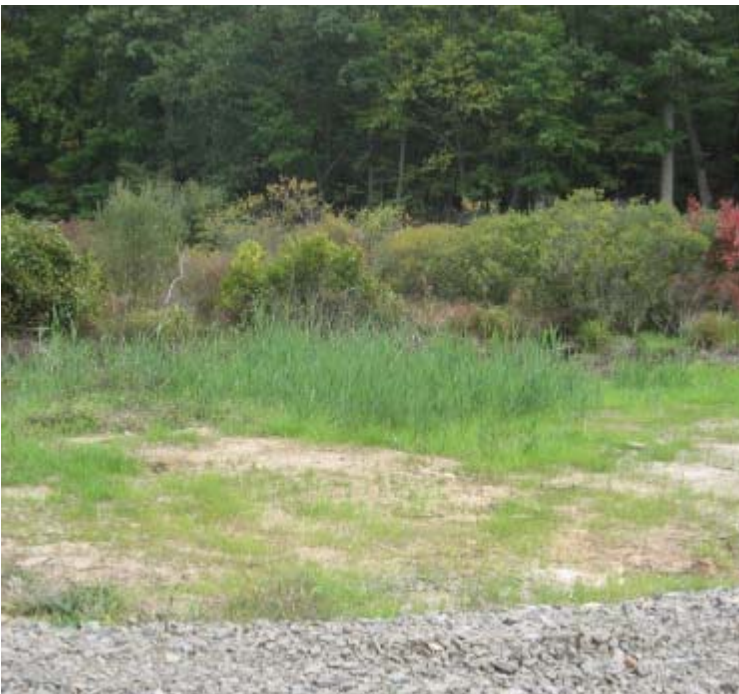
Rt 34: Timber mats have been removed from the wetland near structures #3885/24072.

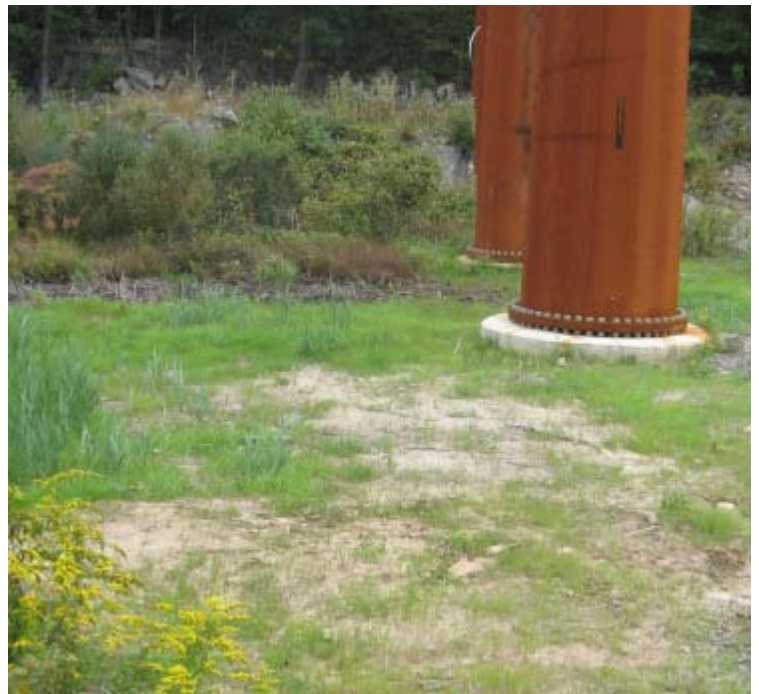
Rt 34: An additional view of the area near structures #3885/24072. Vegetative growth continues to increase here.

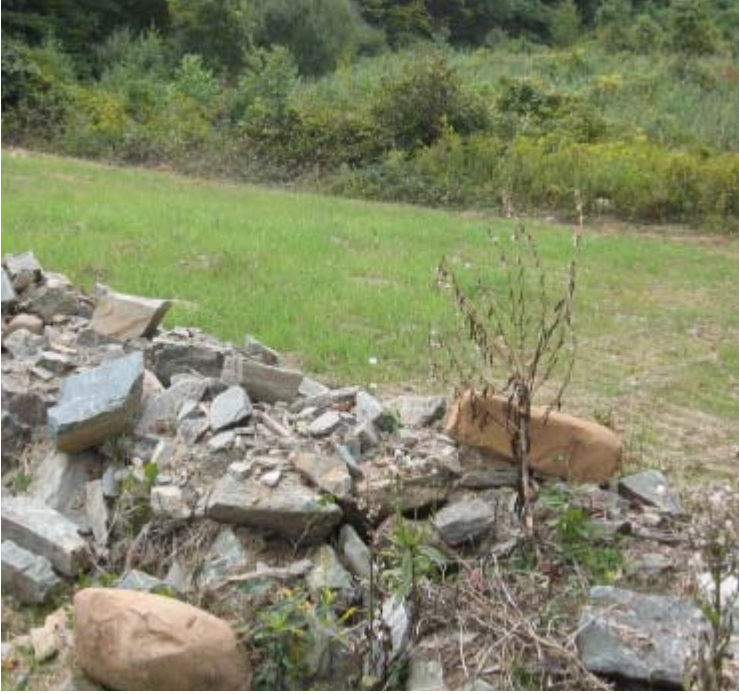
Rt 34: A view of a restored wire pulling site. No direct impacts to the wetland are evident here, and vegetative growth increases within the wetland buffer.

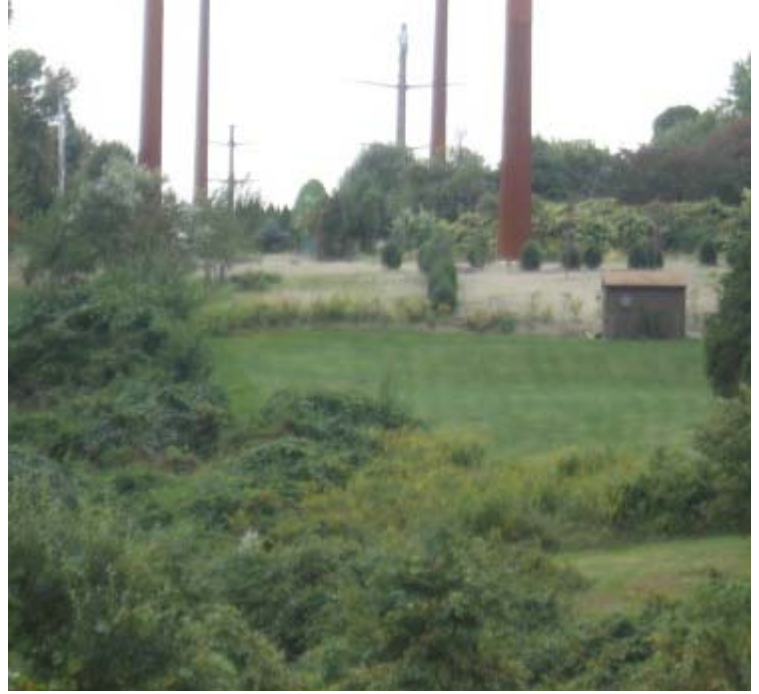
Rt 34: A view of the restoration efforts and plantings off Saddle Ridge road near structures #3884/24071.

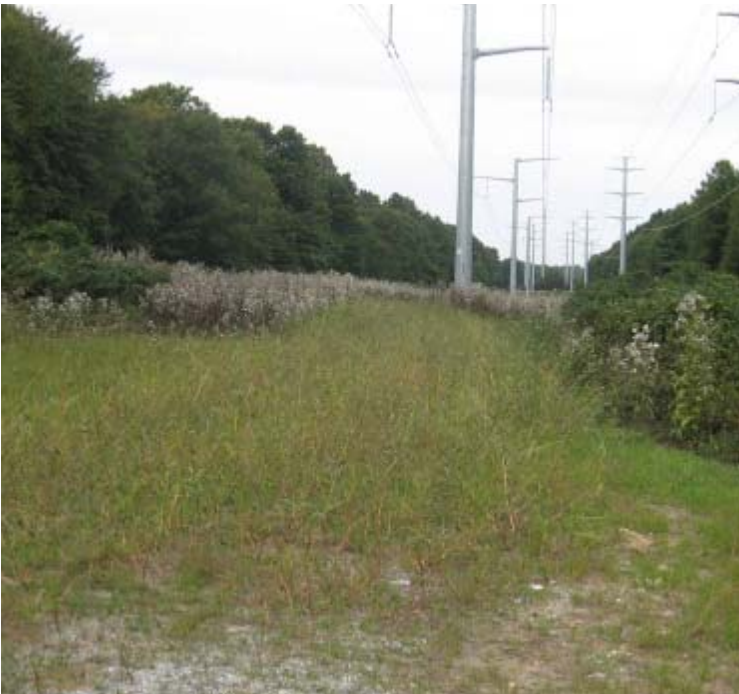
Clearview Ln (Woodbridge): A view of the restored upland access road near structures # 3901/24088.

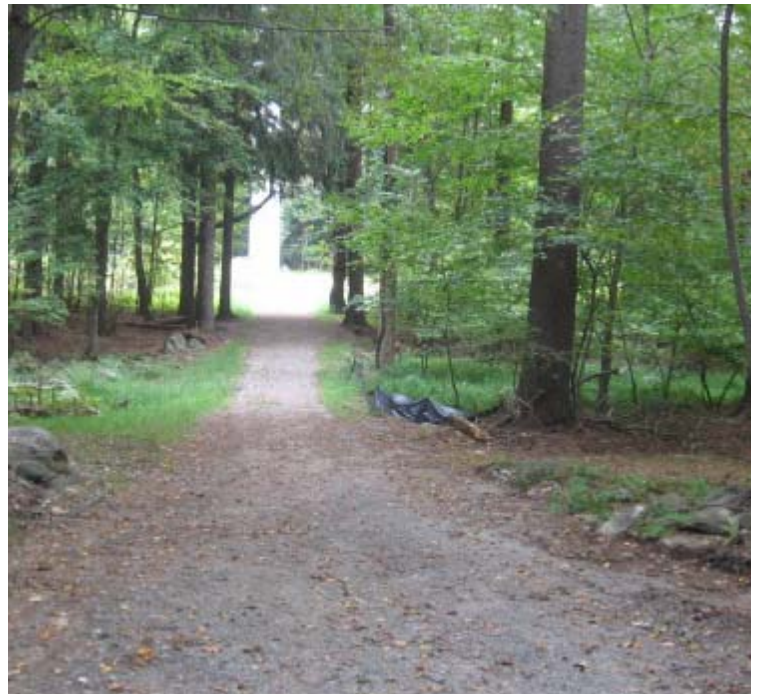
Clearview Ln: A view of a permanent wetland crossing near structures #3903/24090. This crossing is located off ROW and disturbed areas have been restored and stabilized with vegetative cover. Silt fence controls can be removed at this time.

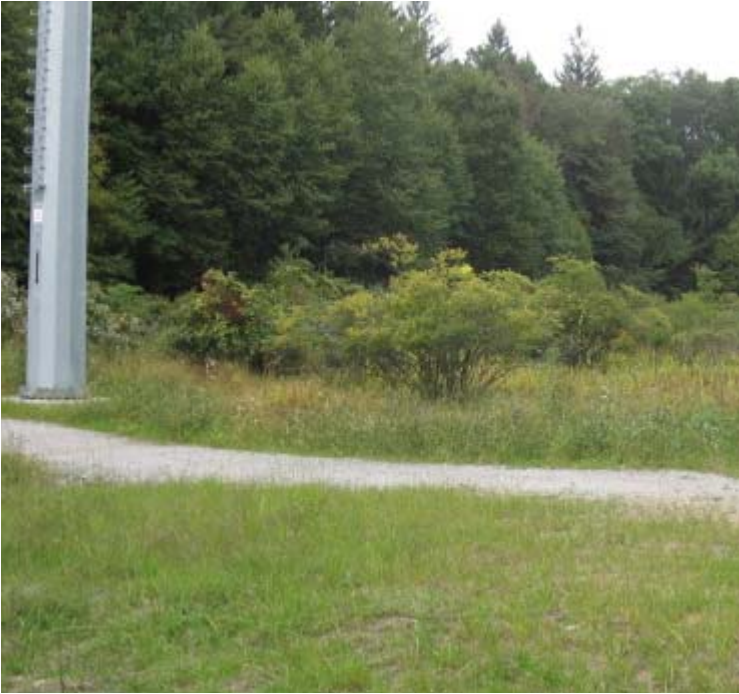
Clearview Ln: A view of the restoration efforts near structure #3903/24090. A permanent wetland crossing remains here as permitted. Final stabilization efforts have been achieved in this area.

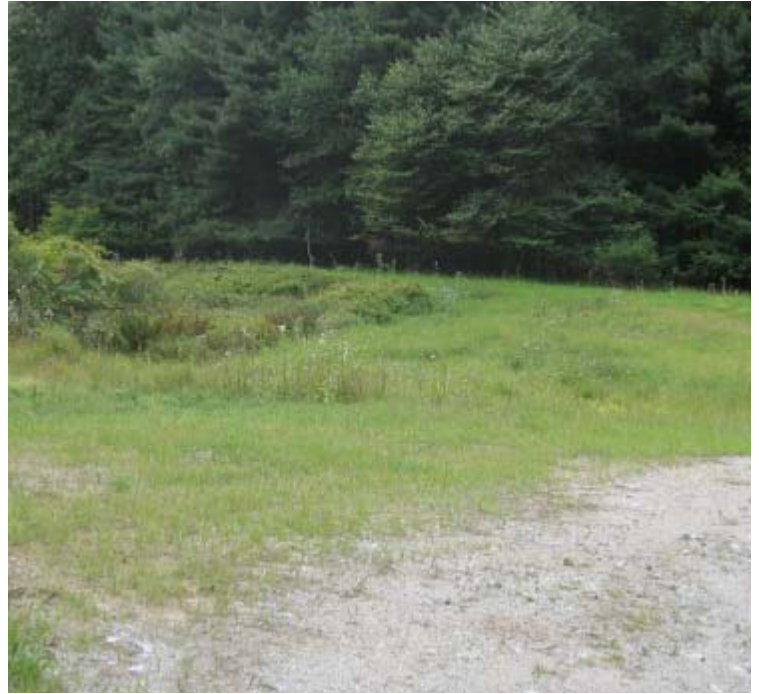
Clearview Ln: An additional view of the restoration efforts near structures #3903/24090. This area was a former wire pulling site.

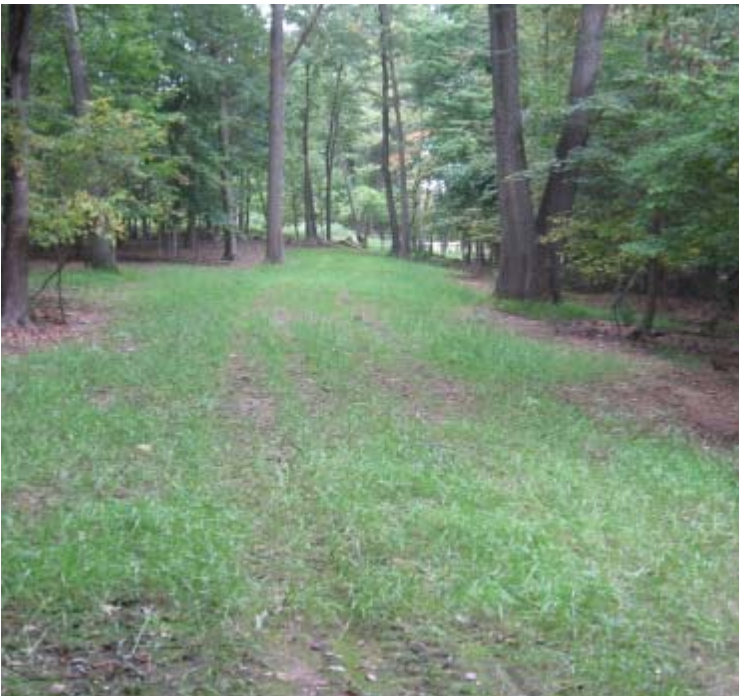
Clearview Ln: A view of the access road restoration efforts near structures #3904/24091. Vegetation growth continues here.

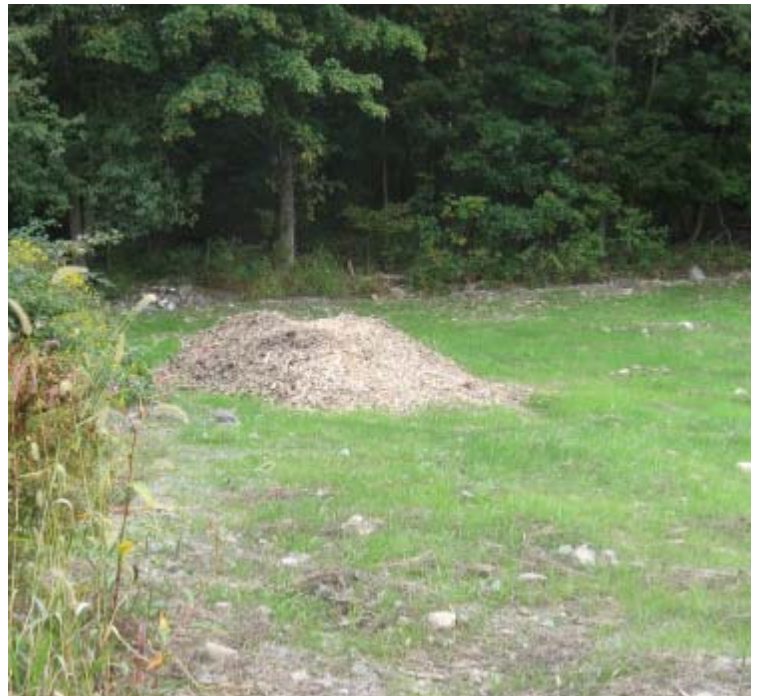
Brookwood Dr (Woodbridge): A view of the restored crane pad near structures #3909/24096. A woodchip pile has been stored here recently.

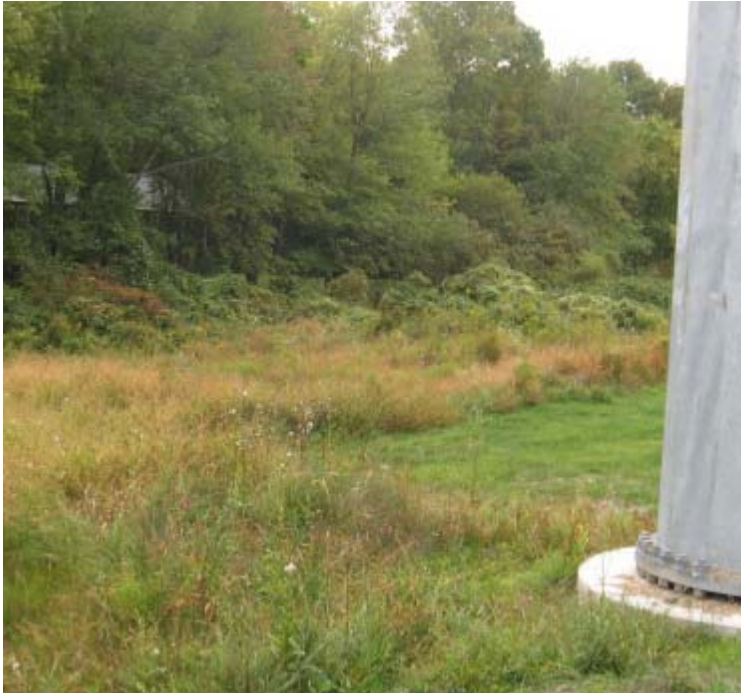
Manville Rd (Woodbridge): Good vegetative cover exists within the wetland area near structures #3915/24102.

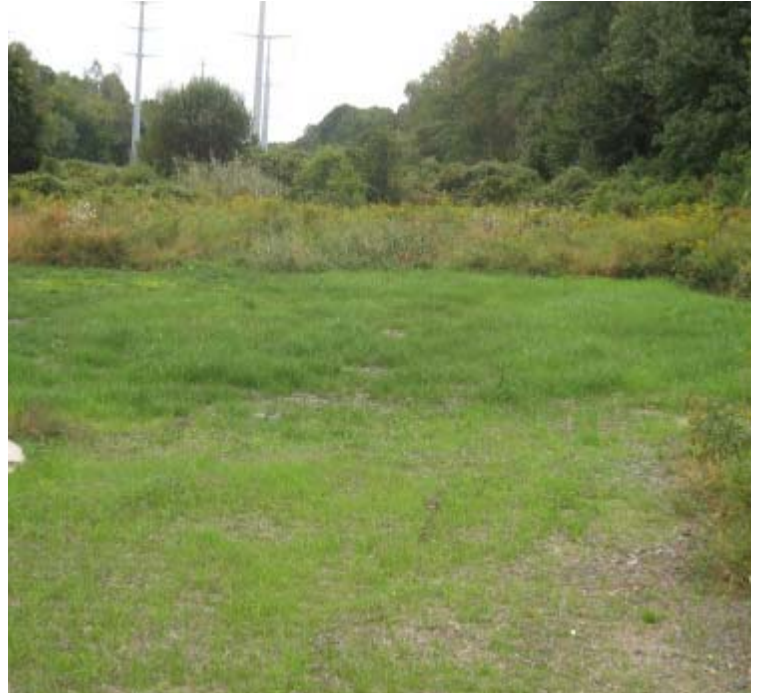
Manville Rd: An additional view of the restoration efforts near structures #3915/24102.

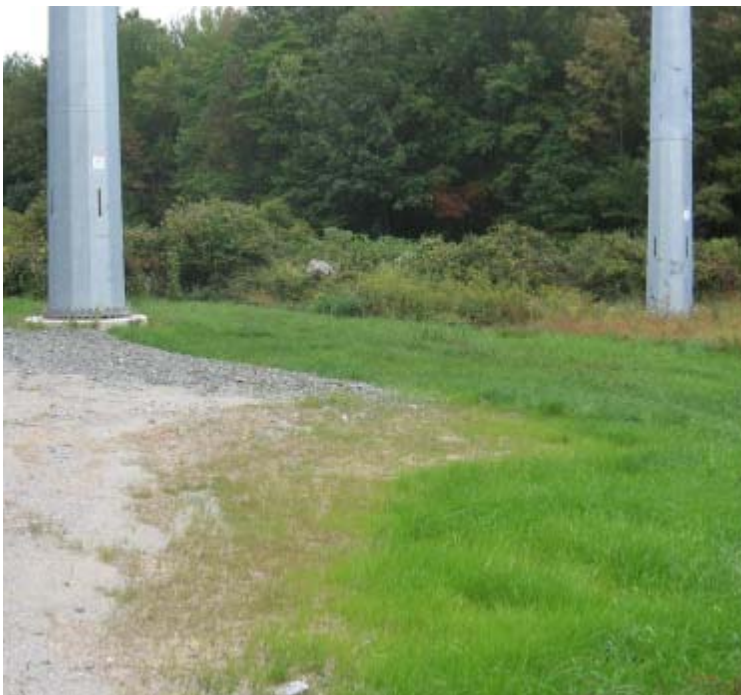
Manville Rd: A view of the restoration efforts near structures #3916/24103. This area has achieved final stabilization.

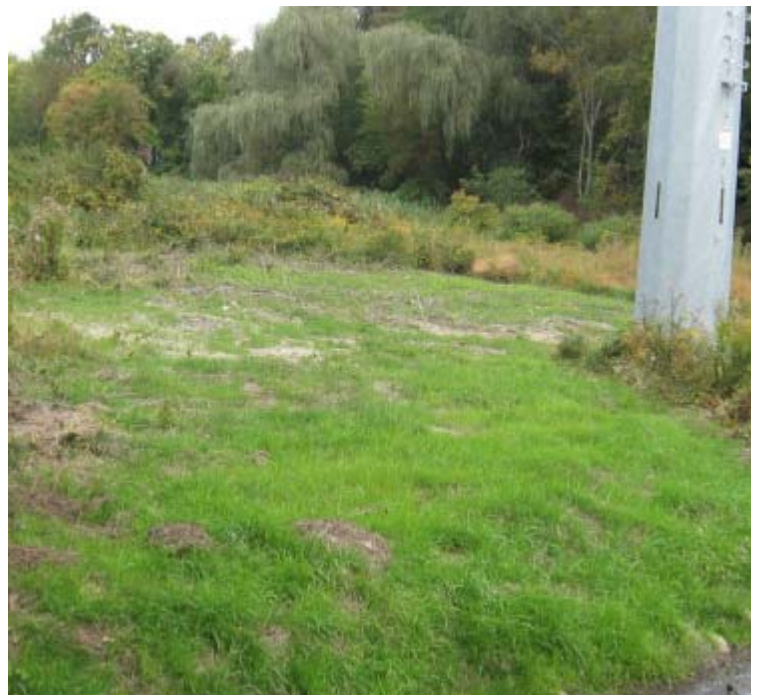
Ansonia Rd (Woodbridge): A view of the restoration efforts near structures # 3914/24101. Approximately 60-65% vegetative cover exists here.
