Docket No. 272 – Development and Management Plan Inspection

Segment 2b Inspection

Date: October 8, 2008

Location: Segment 2b – Cheshire/Hamden Town Line to East Devon Substation

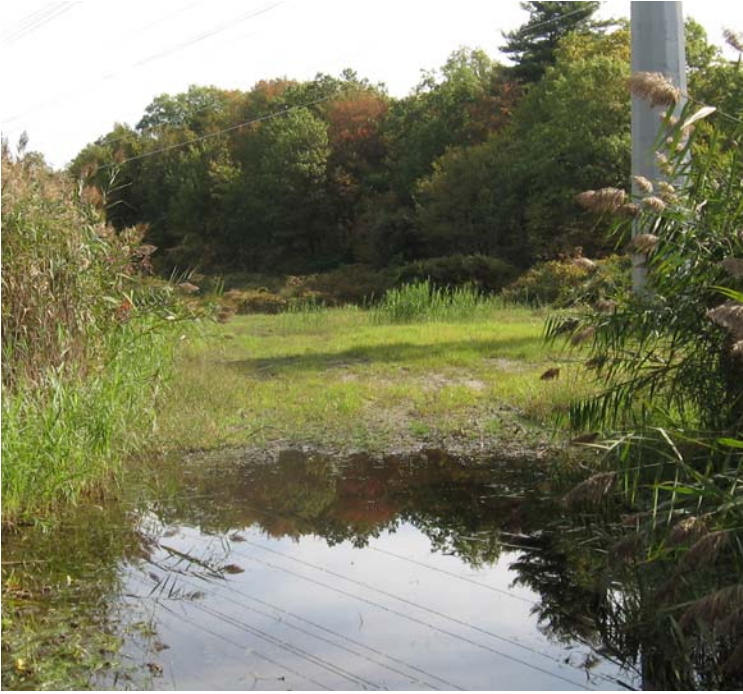
West River St (Milford): Vegetative growth continues within the restored access road area. Final stabilization has been achieved here.

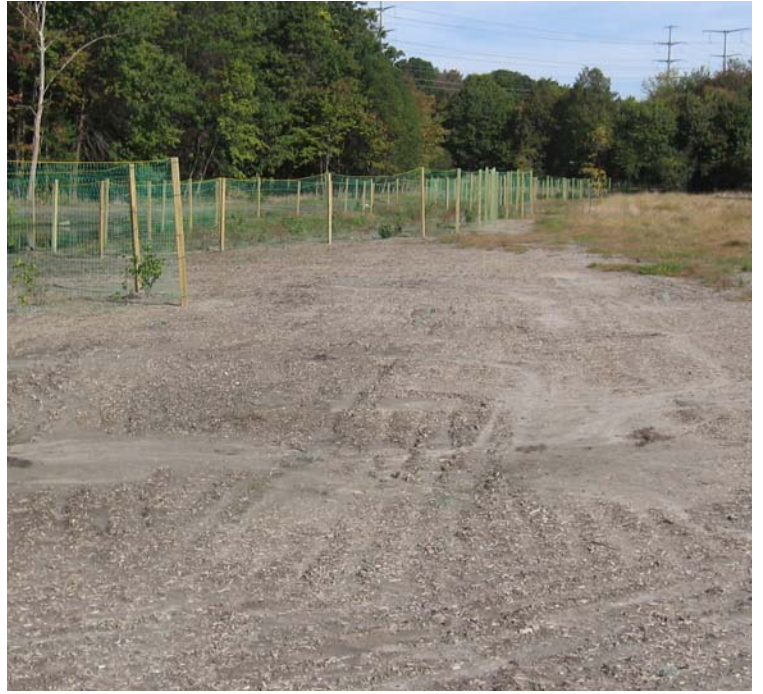
Eisenhower Park Mitigation Area (Milford): Exposed soils remain. Good vegetative growth has been noted.

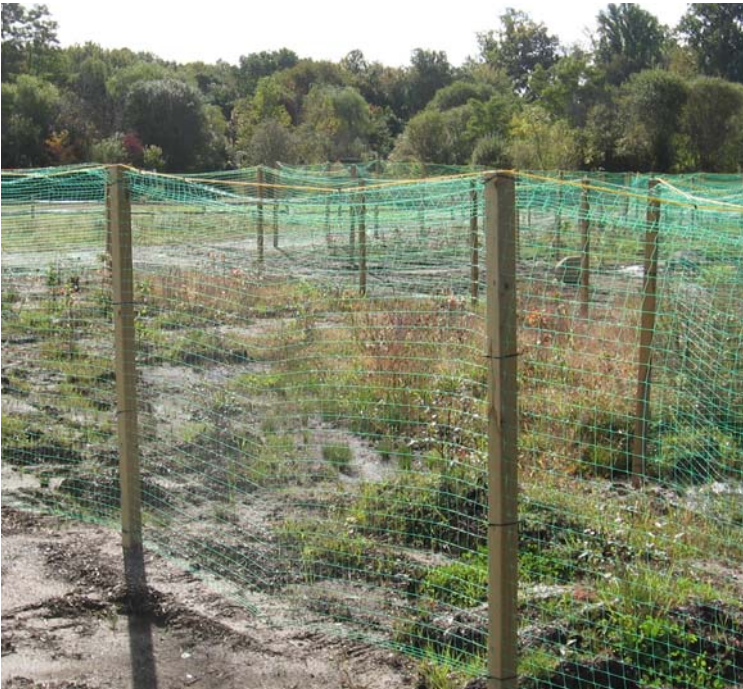
Eisenhower Park Mitigation Area: The plantings continue to do well.

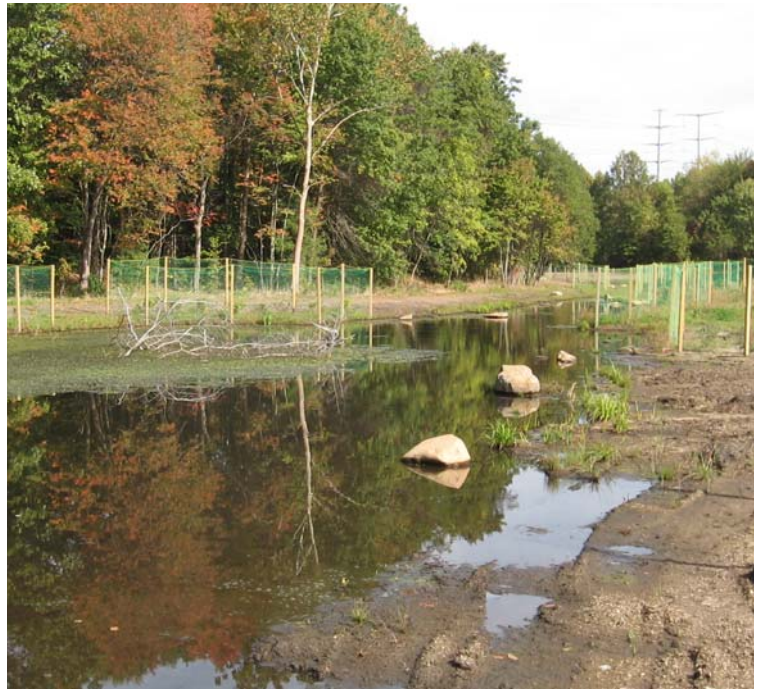
Eisenhower Park Mitigation Area: The mitigation area continues to provide habitat for numerous species of wildlife.

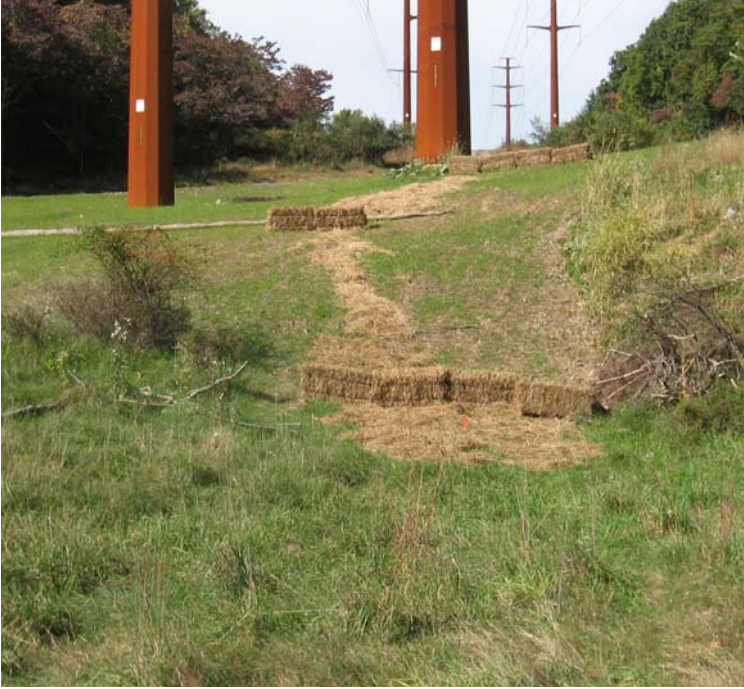
Dogburn Rd south (Orange): The erosive gully near structure #24077 has been graded and temporarily stabilized with mulch.

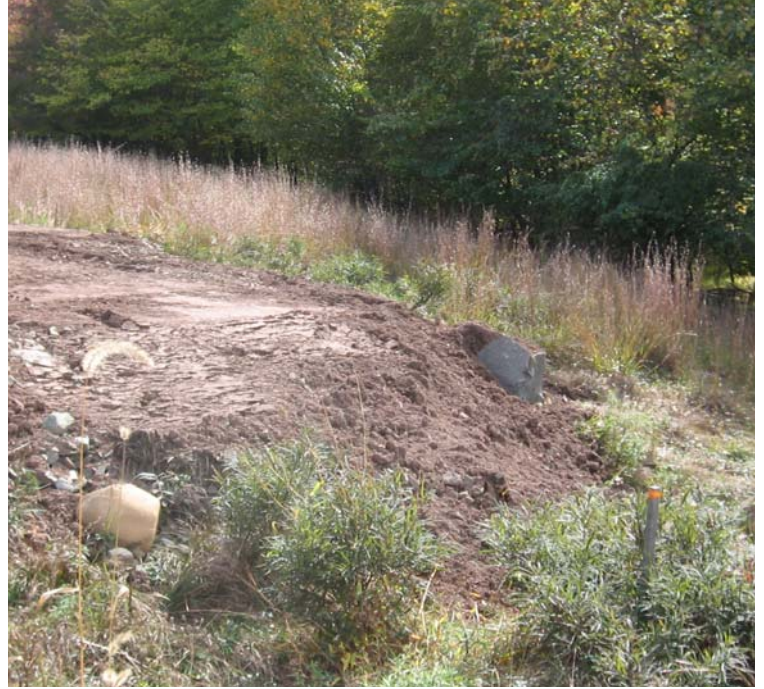
Dogburn Rd south: Exposed soils remained upgradient of a wetland following crane pad reclamation near structure #24082.

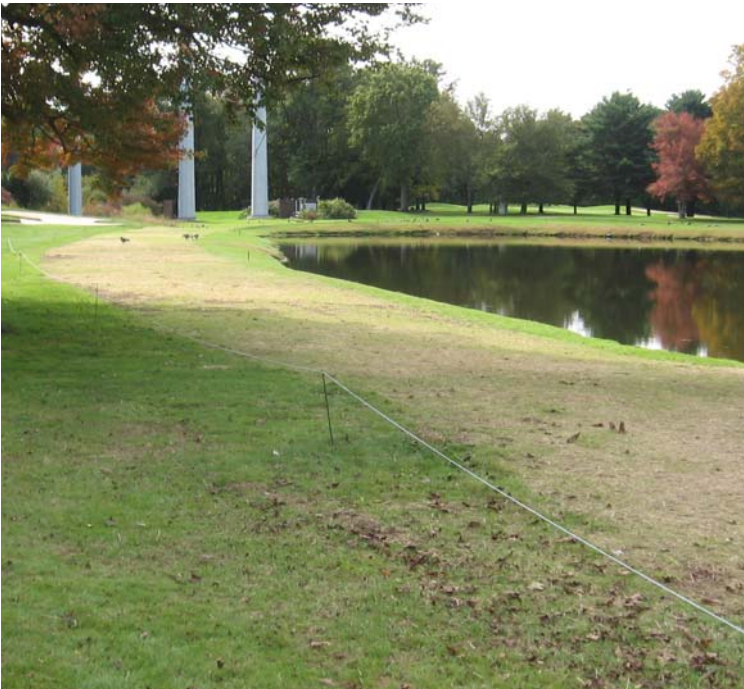
Oak Ln CC (Woodbridge): Reclamation and restoration efforts are complete here.

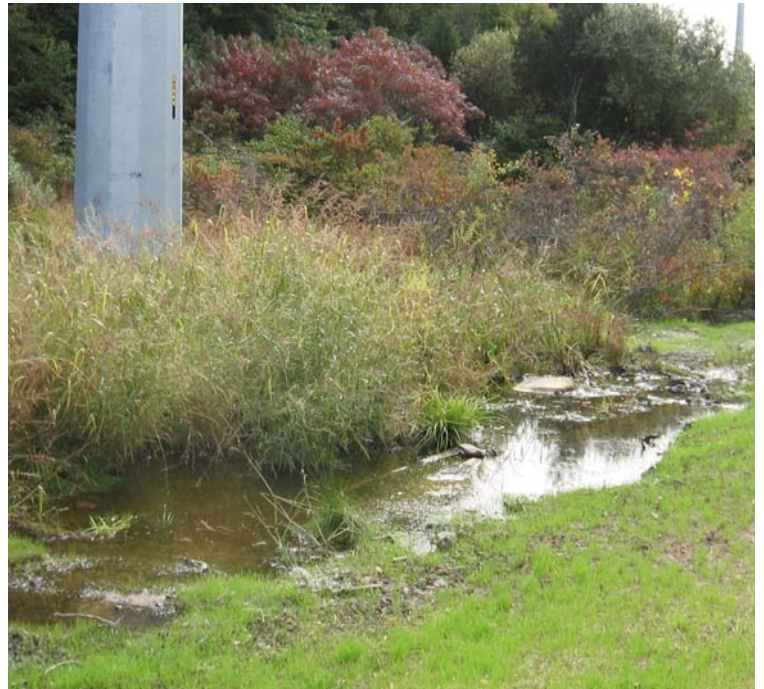
Oak Ln CC: View of the restored wetland impact area near structure #3905/24092.

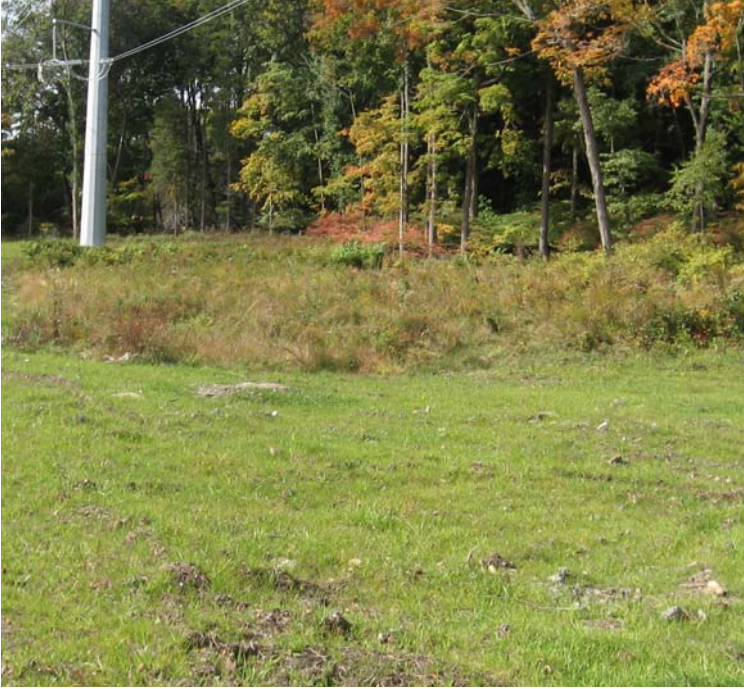
Rimmon Rd/B'Nai (Woodbridge): Good vegetative cover has been noted within the cleared wetland. Final stabilization has been achieved in this section.

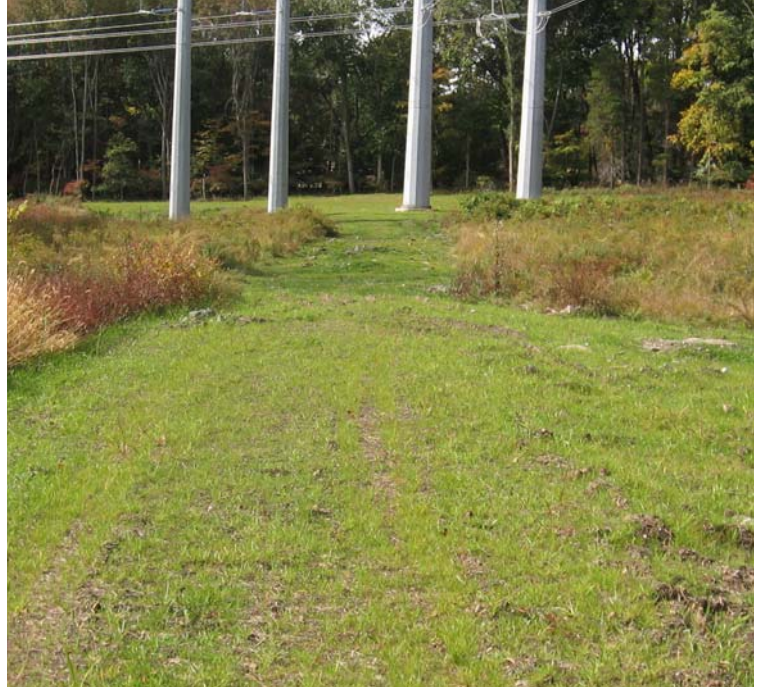
Rimmon Rd/B'Nai: Good vegetative cover has been noted within the restored access road and crane pad areas. Final stabilization has been achieved here.

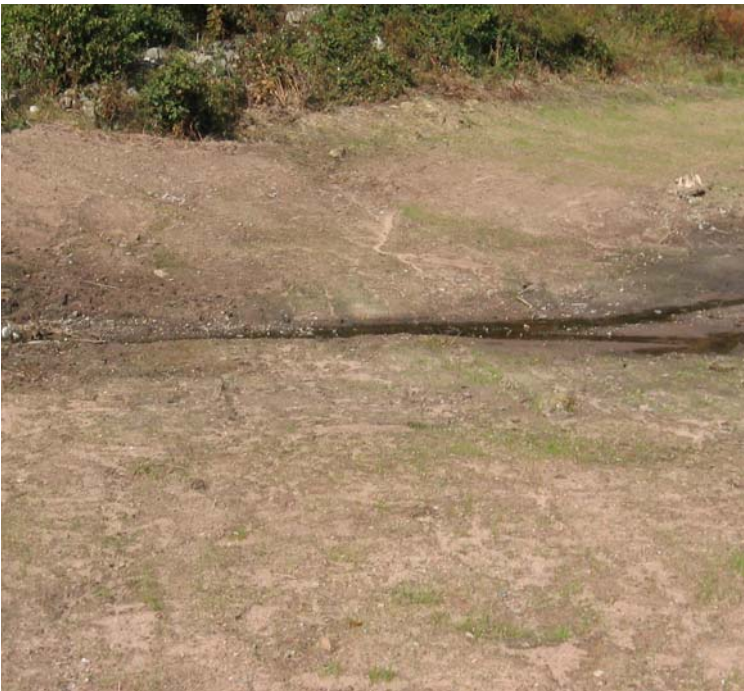
Pease Rd/JCC (Woodbridge): Haybale controls are needed along the intermittent stream within the restored access road.

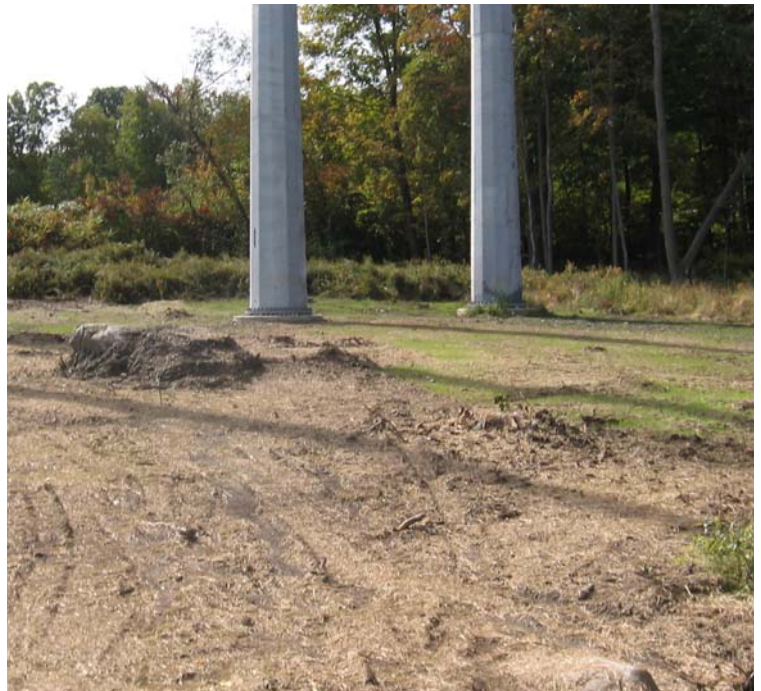
Pease Rd/JCC : View of the wetland restoration efforts near structure #24119.

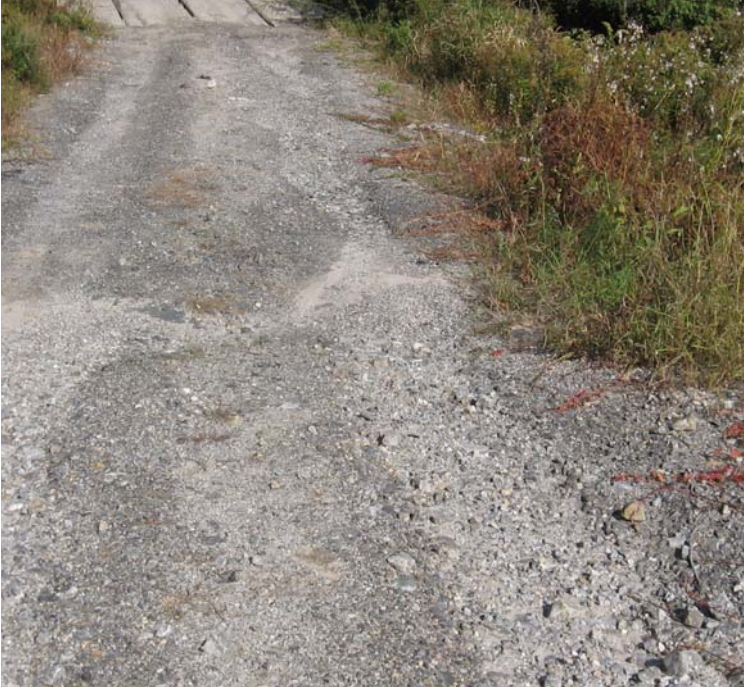
Litchfield Tpk (Bethany): Access road controls are no longer functional near the permanent timber mat crossings.

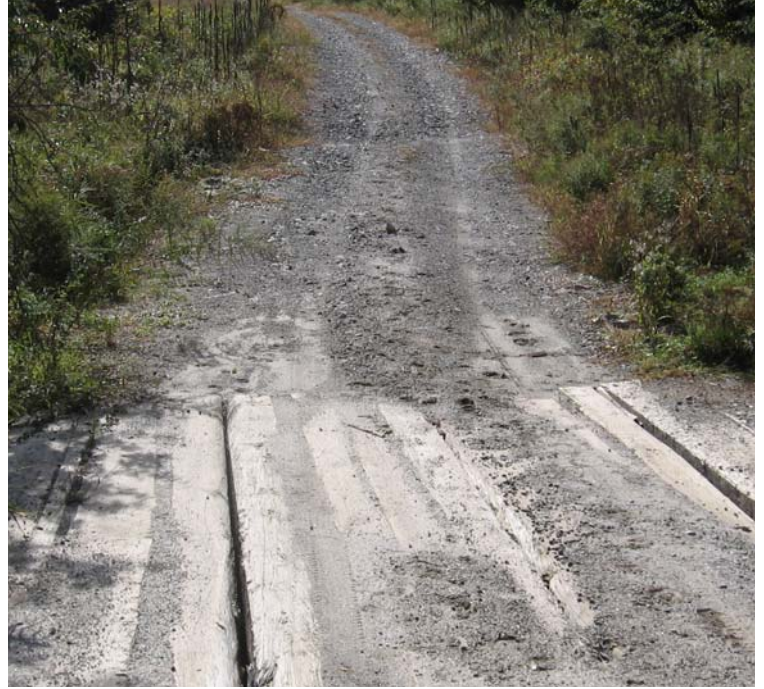
Litchfield Tpk: Sediment from the access road is migrating to the watercourse at the permanent crossings.

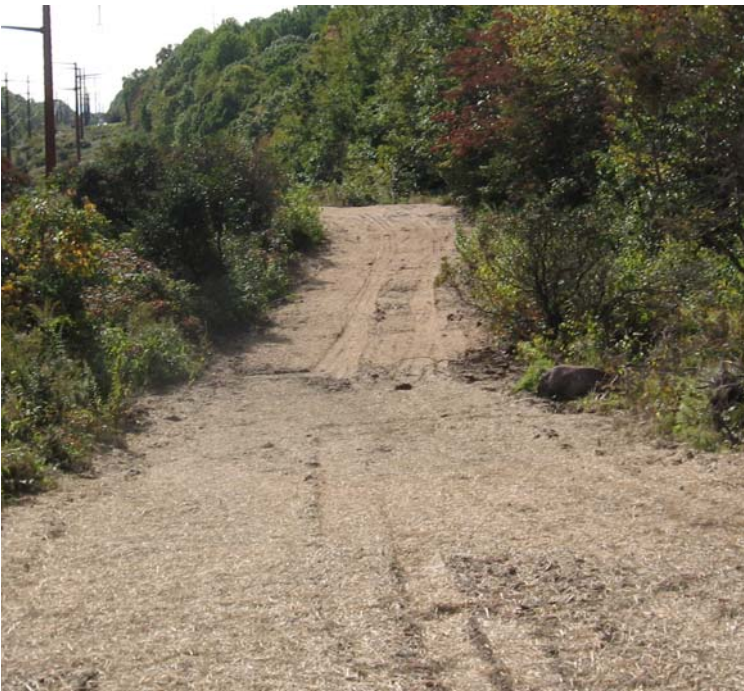
Tom Swamp (Hamden): View of the restored access road.

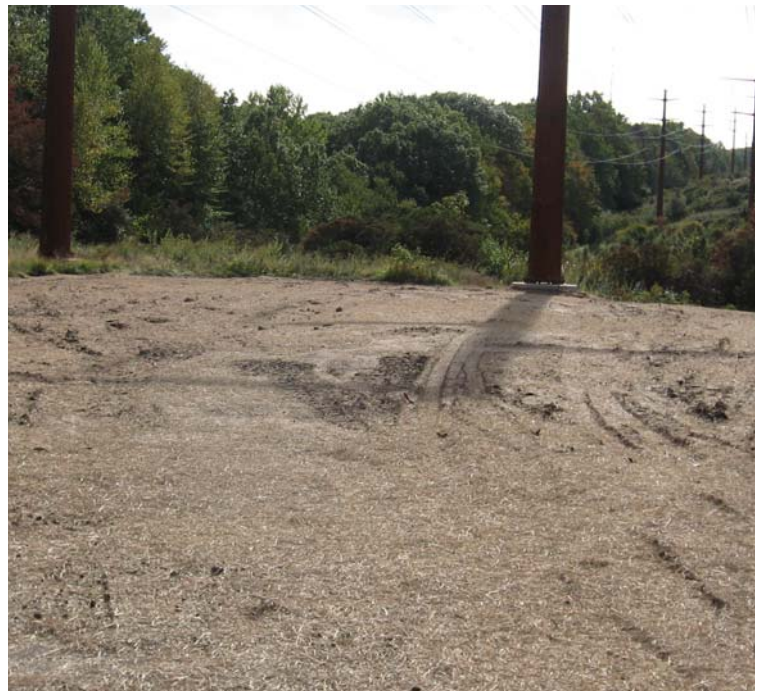
Tom Swamp: View of the restored crane pad near structures #3994/24181.

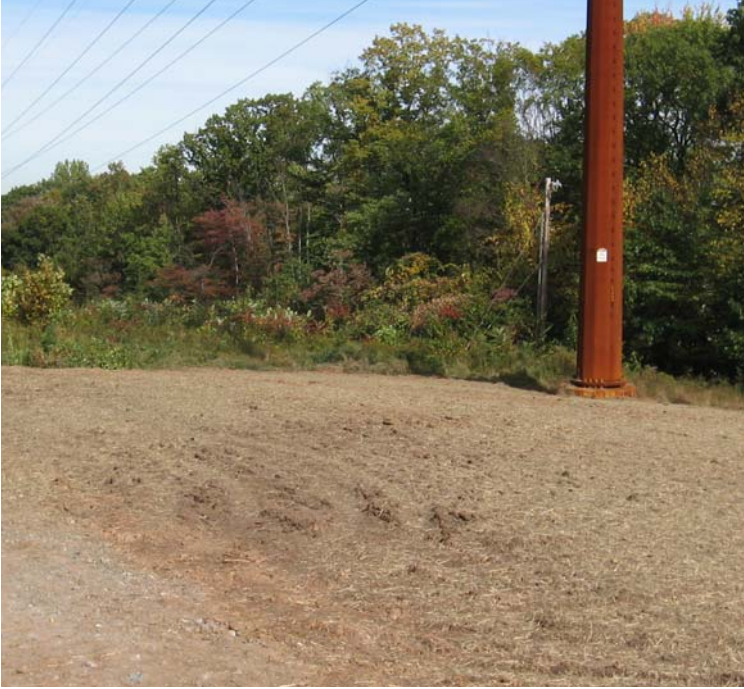
Tom Swamp: View of restoration efforts near structure #3996.

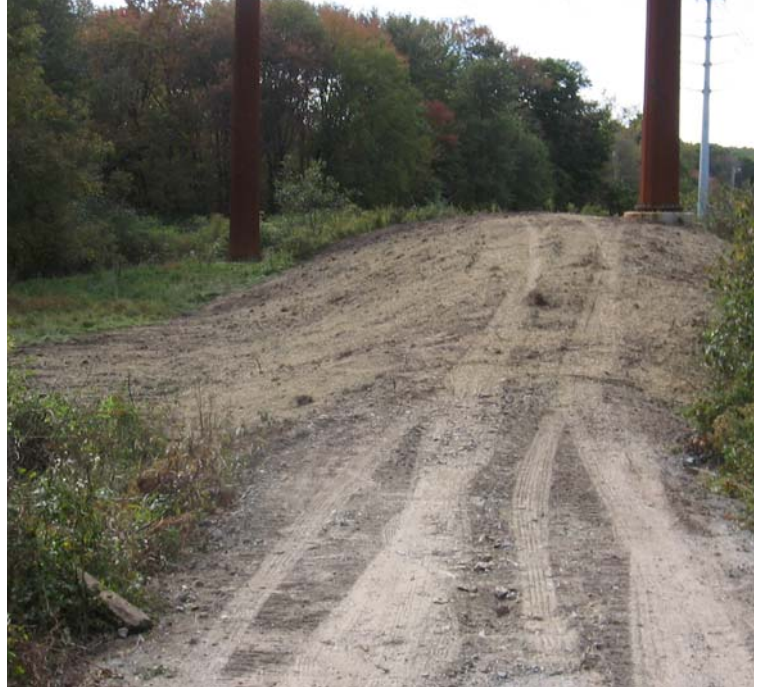
Willow St (Hamden): View of the restoration efforts here. Soils appear stable at this time.

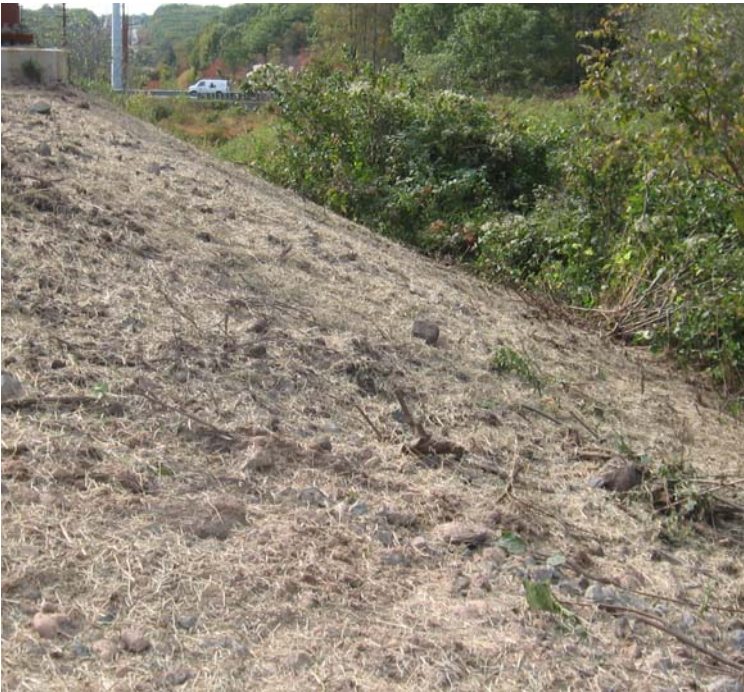
Willow St: View of the crane pad restoration efforts near structures #4009/24196.

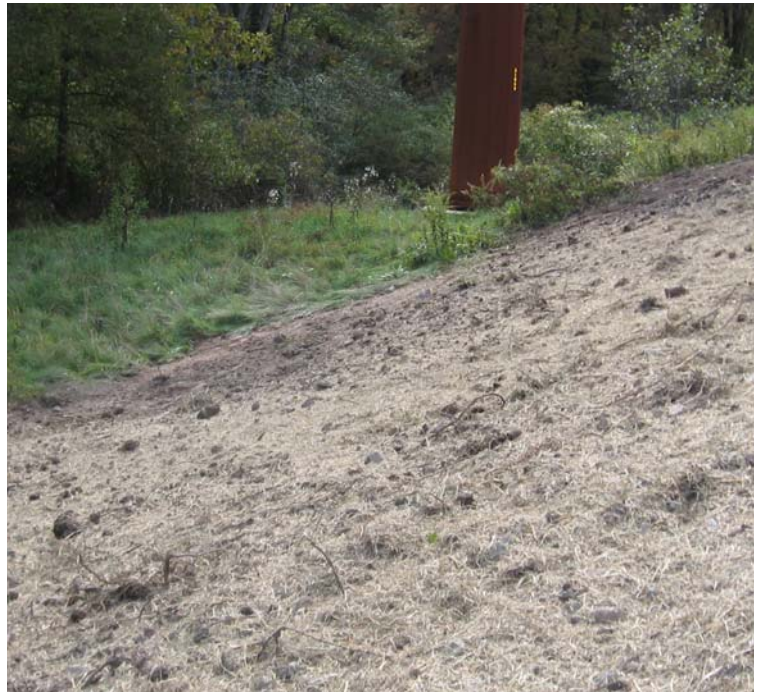
Willow St: Additional view of the crane pad restoration efforts near structures #4009/24196.
