Docket No. 272 – Development and Management Plan Inspection

Segment 2b Inspection

Date: October 23, 2008

Location: Segment 2b – Cheshire/Hamden Town Line to East Devon Substation

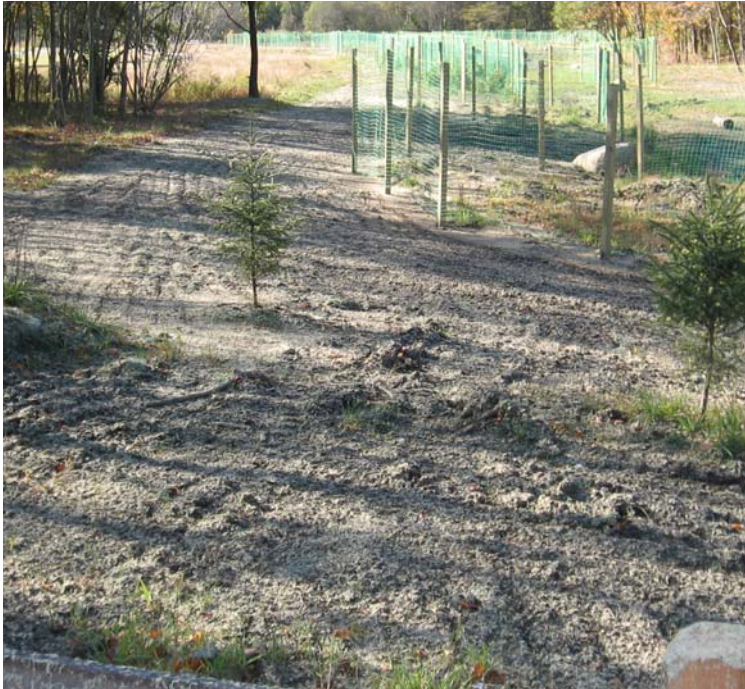
Eisenhower Park (Milford): Hydro-seed has been applied to the exposed soils around the mitigation area.

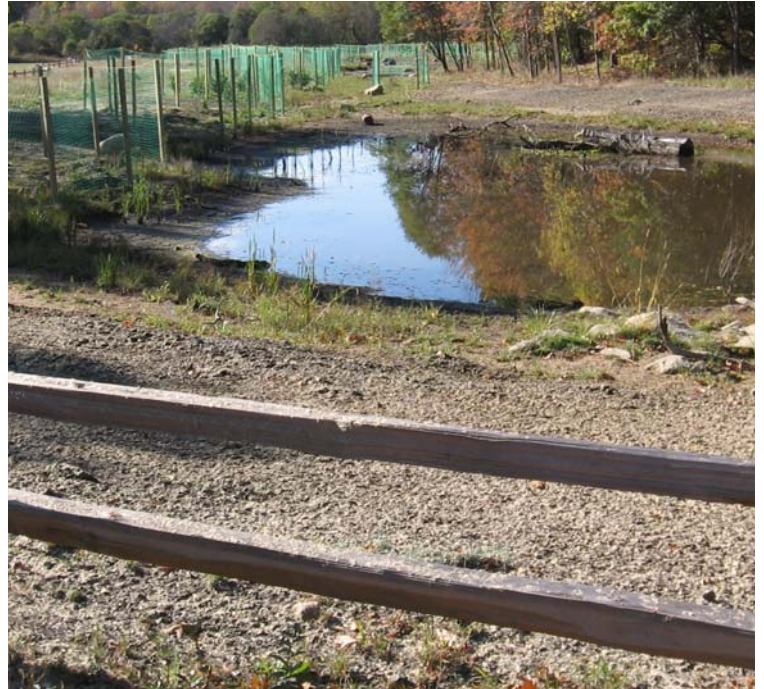
Eisenhower Park: An additional view of the mitigation area.

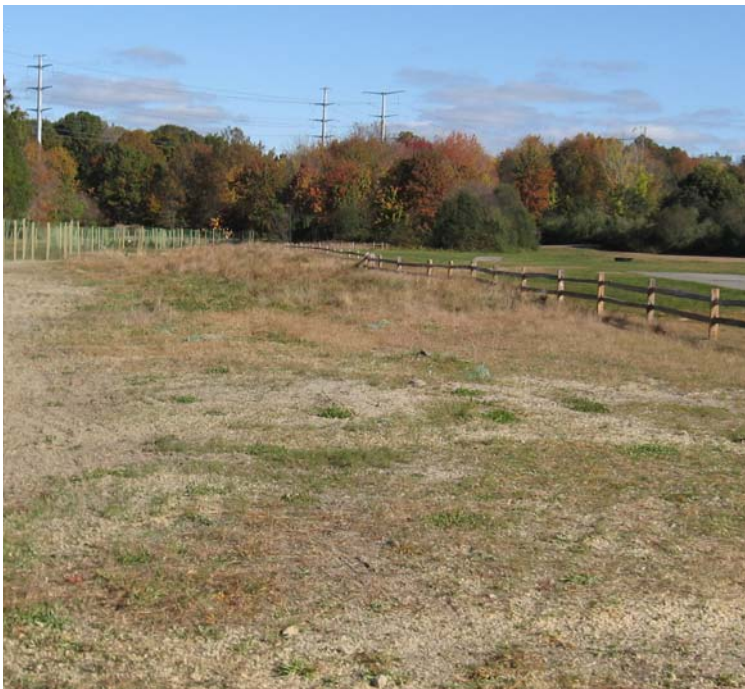
Eisenhower Park: Good vegetative cover exists around the perimeter of the mitigation area.

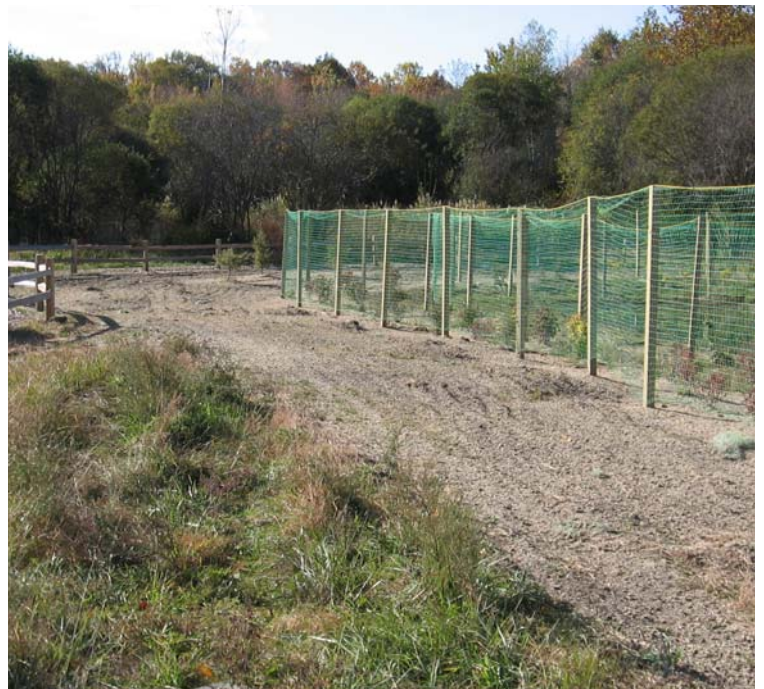
Eisenhower Park: A view of the northern end of the mitigation area.

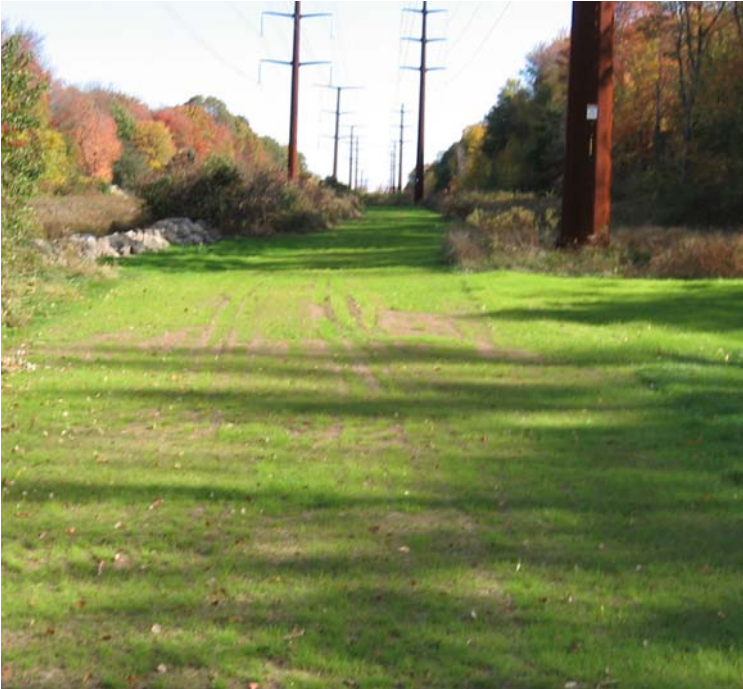
Treat Ln (Orange): A view of the vegetative cover within the access road. Final stabilization efforts have been achieved here.

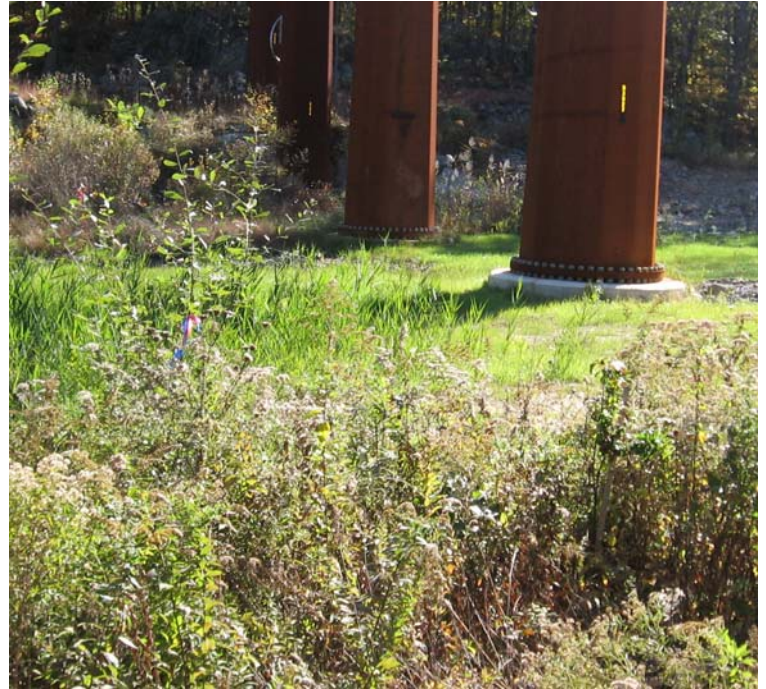
Rt 34 (Orange): Restoration efforts are complete in this area. Permanent access roads and structure foundations remain in the wetland near structure #24072.

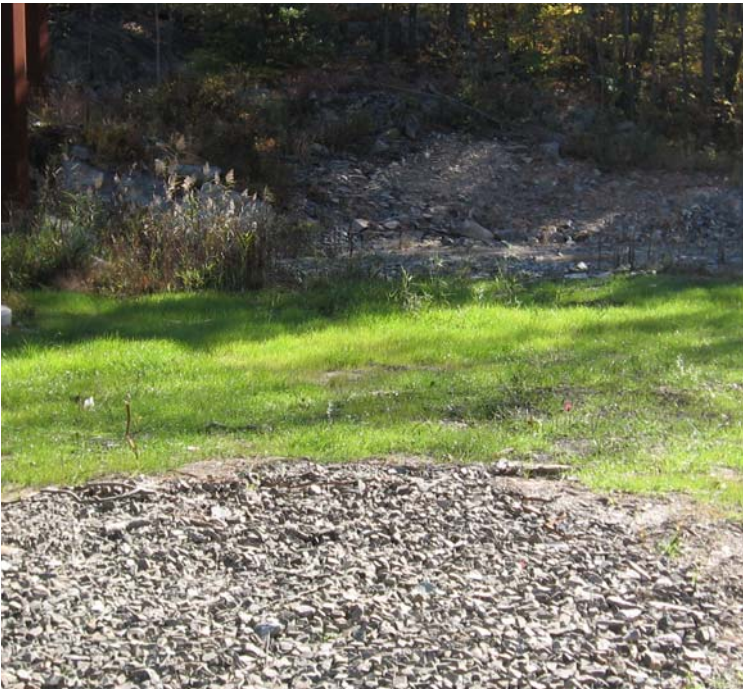
Rt 34: An additional view of the permanent access road within the wetland near structure #24072.

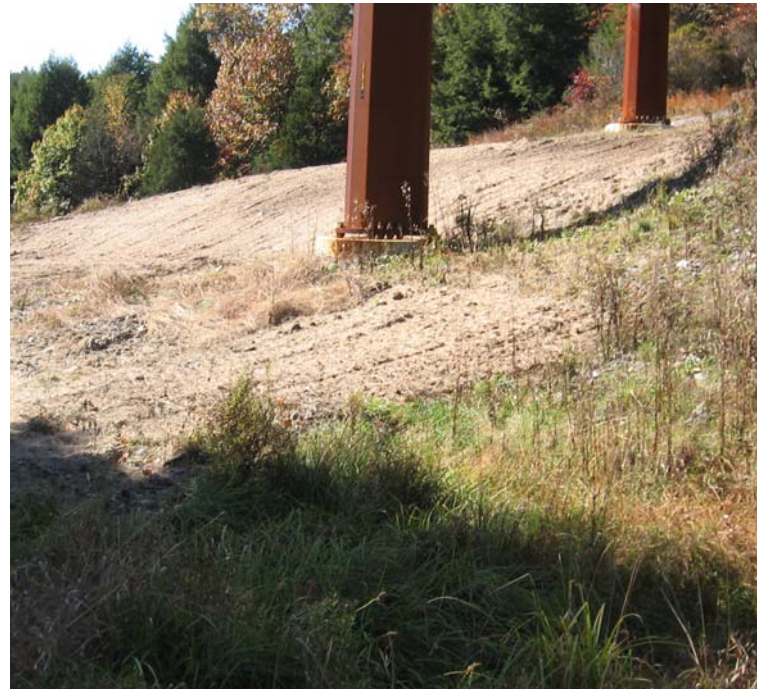
Hatfield Rd (Bethany): A view of the restoration efforts near structures #3971/24158.
