Docket No. 272 – Development and Management Plan Inspection

Segment 2b Inspection

Date: October 31, 2008

Location: Segment 2b – Cheshire/Hamden Town Line to East Devon Substation

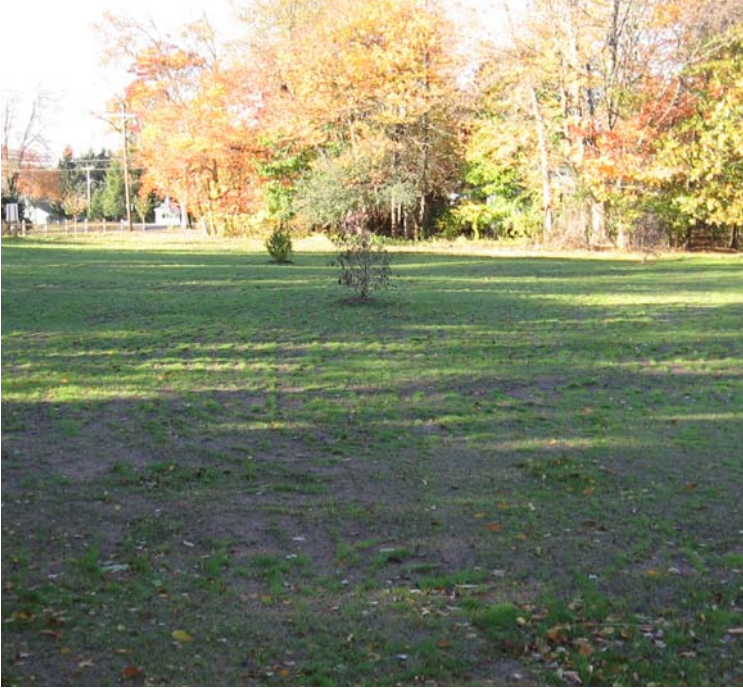
Russell Ave (Orange): A view of the restoration efforts near structure #3871/24058.

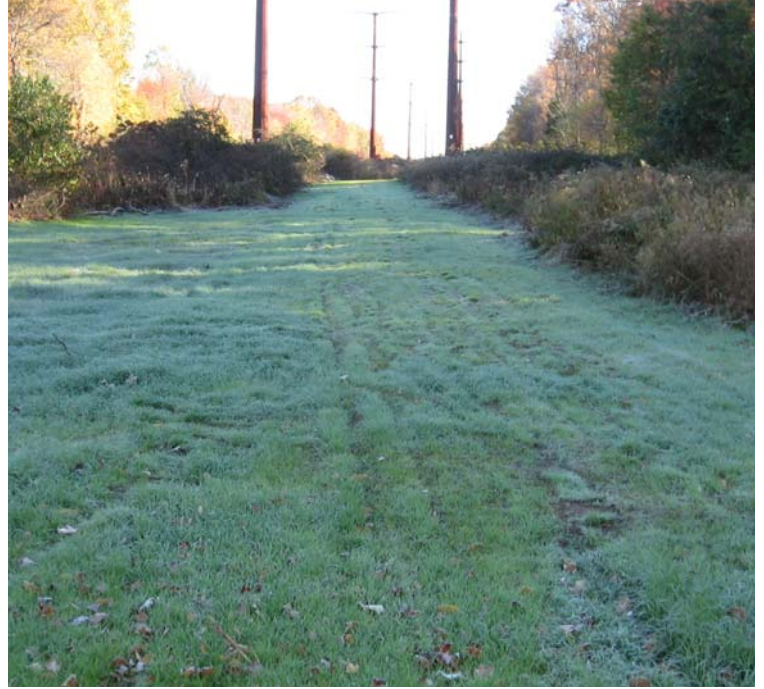
Russell Ave: An additional view of the restoration efforts within the access road.

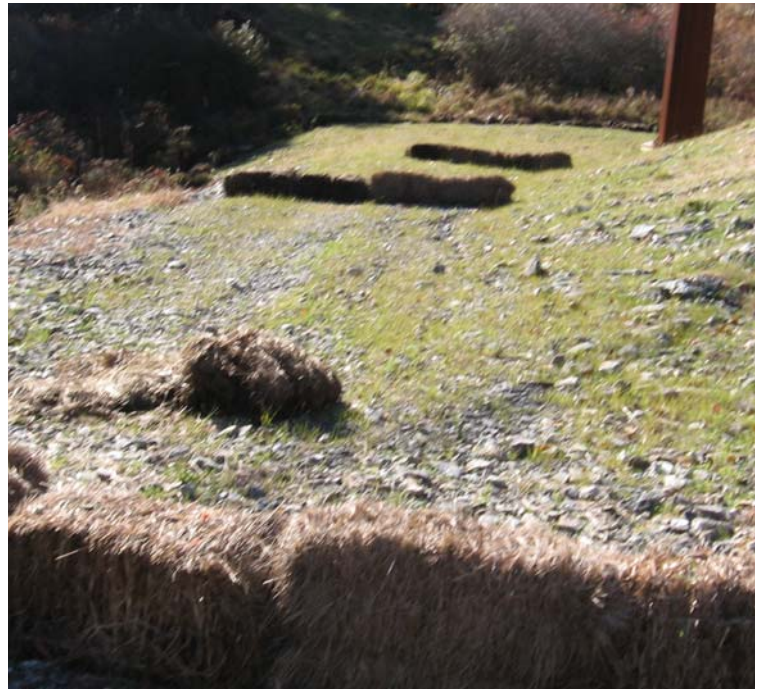
Litchfield Turnpike: A view of controls and restoration efforts near structure #3960/24147.

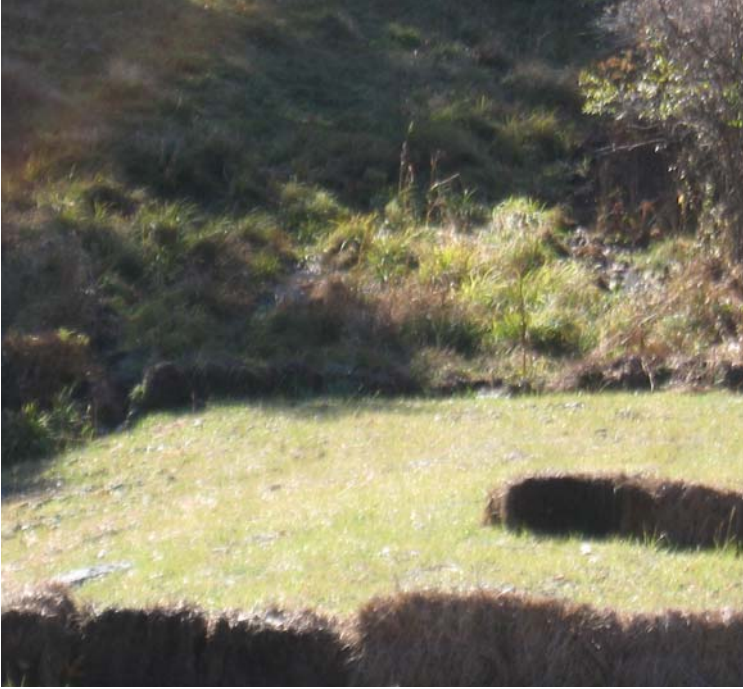
Litchfield Turnpike: A view of the restored wetland area near structures #3960/24147.

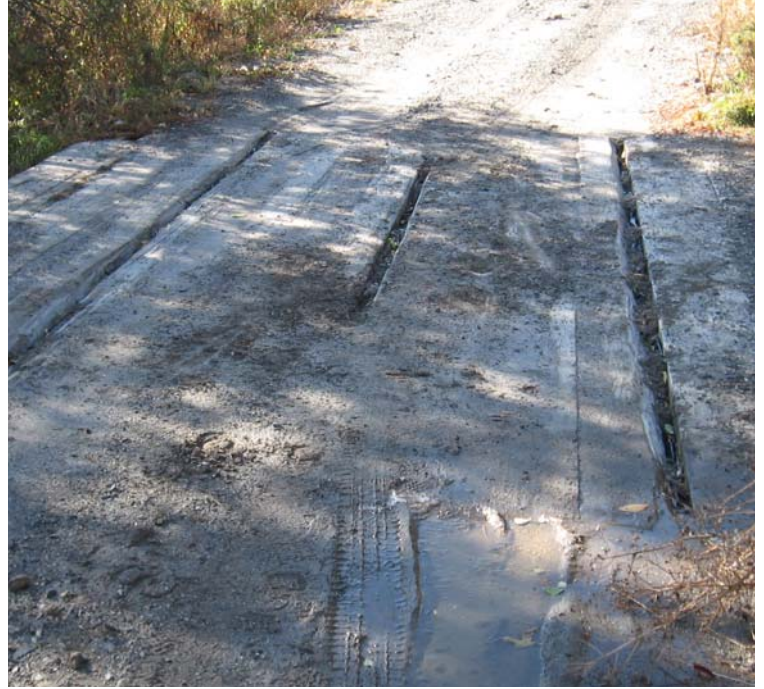
Litchfield Turnpike: Silt fence has been placed in the cracks of the timber mat crossings as a temporary sediment control.

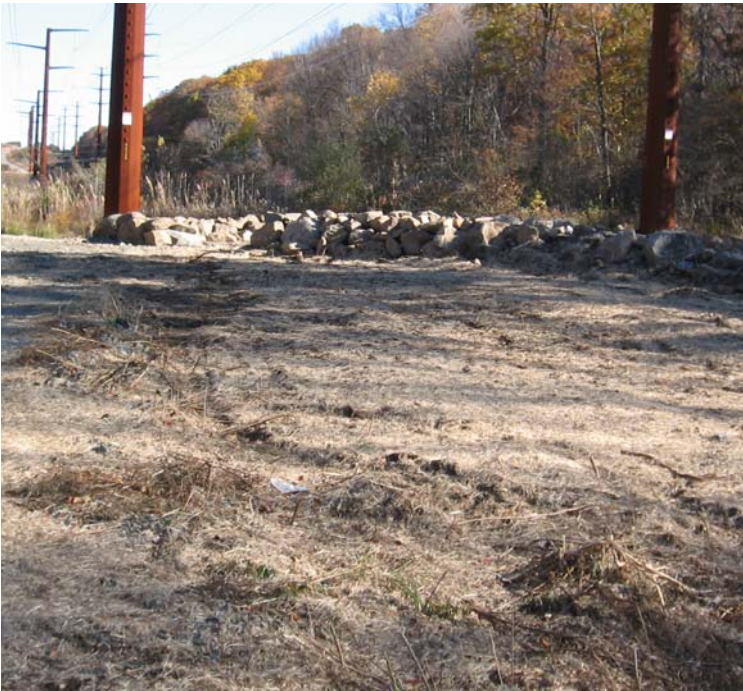
Hatfield Rd (Bethany): A view of the restoration efforts near structures #3979/24166.

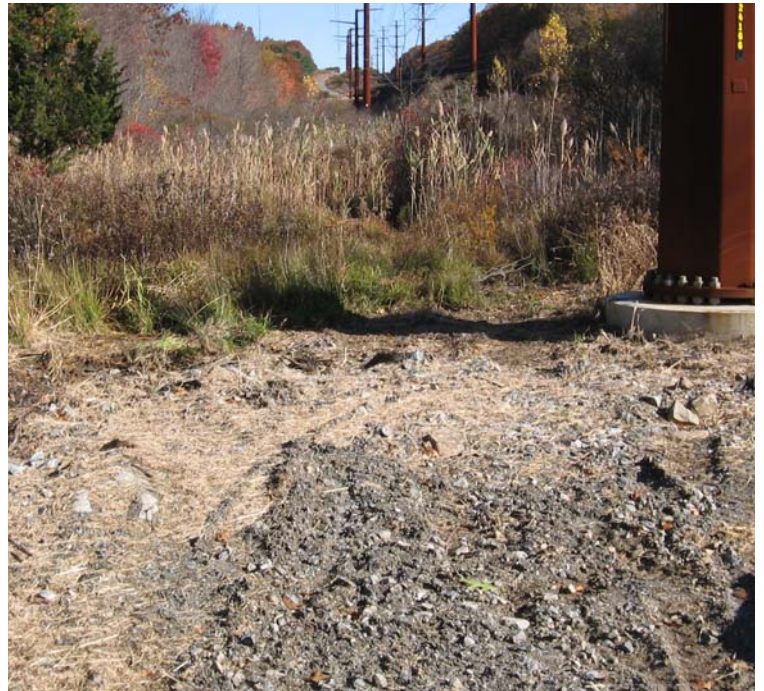
Hatfield Rd: A view of the wetland restoration efforts near structures #3979/24166.

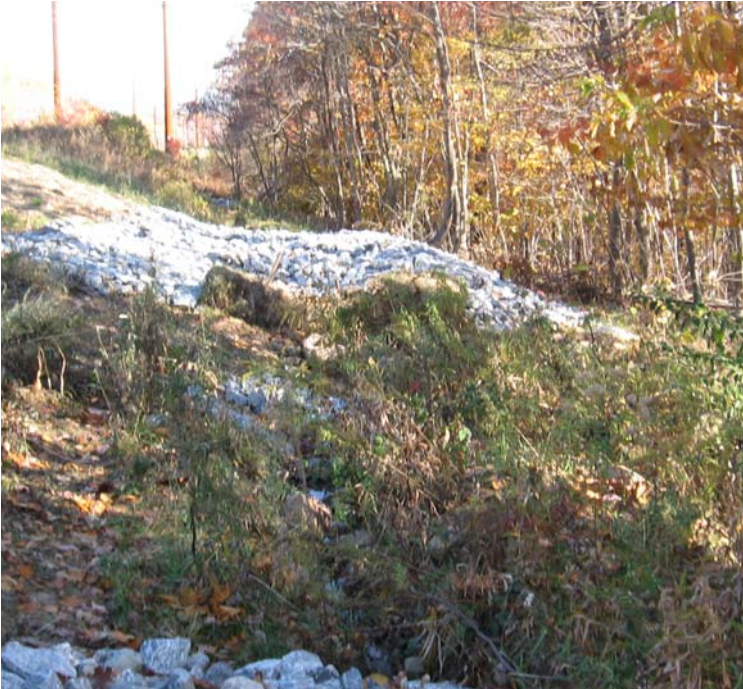
Gaylord Mtn Rd (Hamden): Stone has been added to portions of the swale located along the perimeter of the ROW.

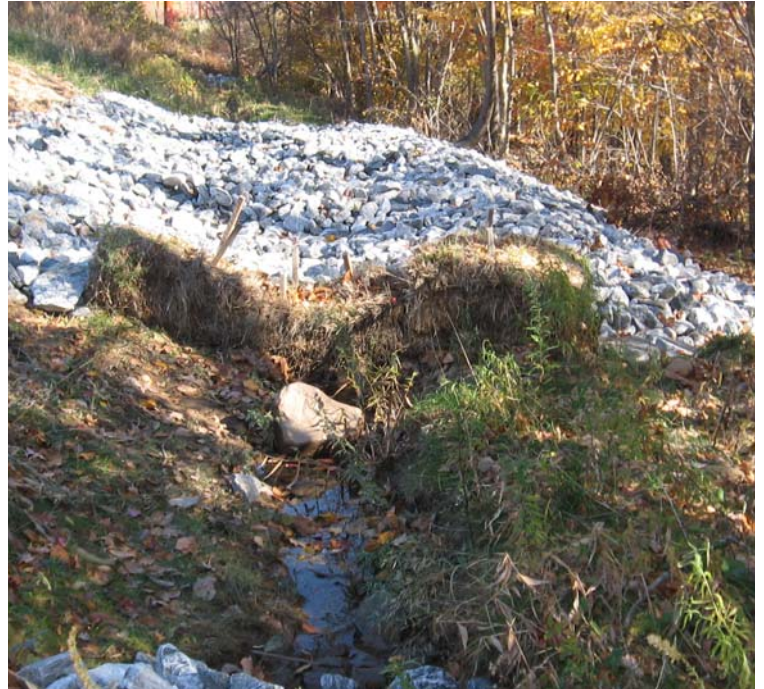
Gaylord Mtn Rd: An additional view of stone and haybale controls.

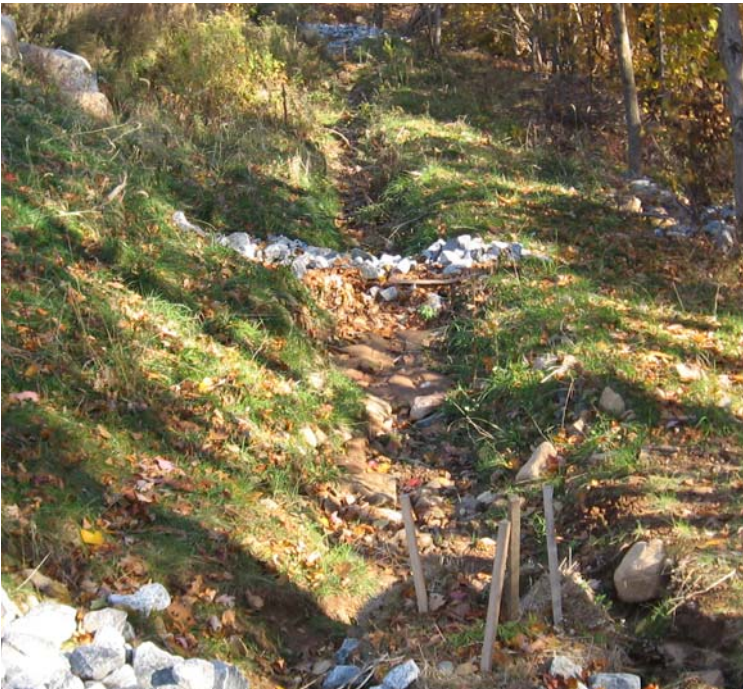
Gaylord Mtn Rd: An additional view of the controls installed within the swale.

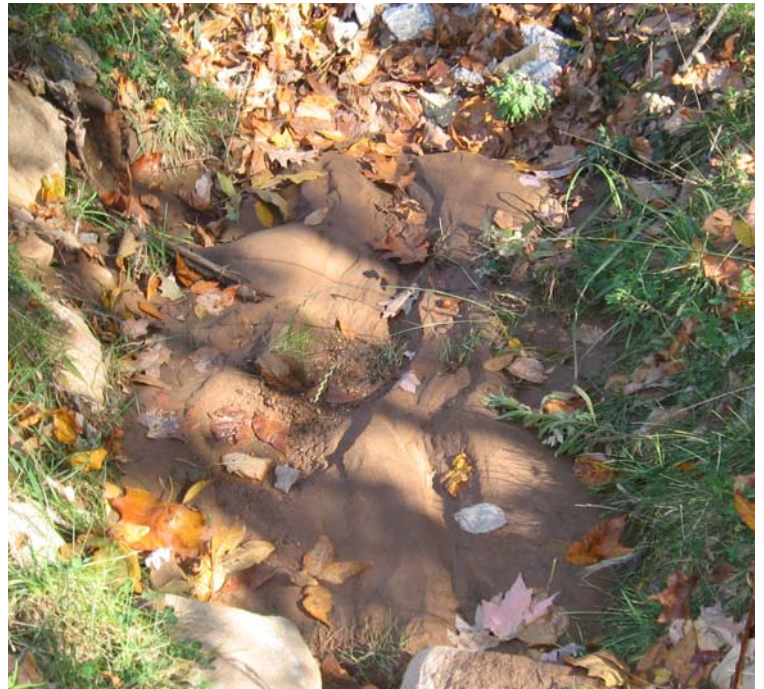
Gaylord Mtn Rd: Controls are containing sediments.

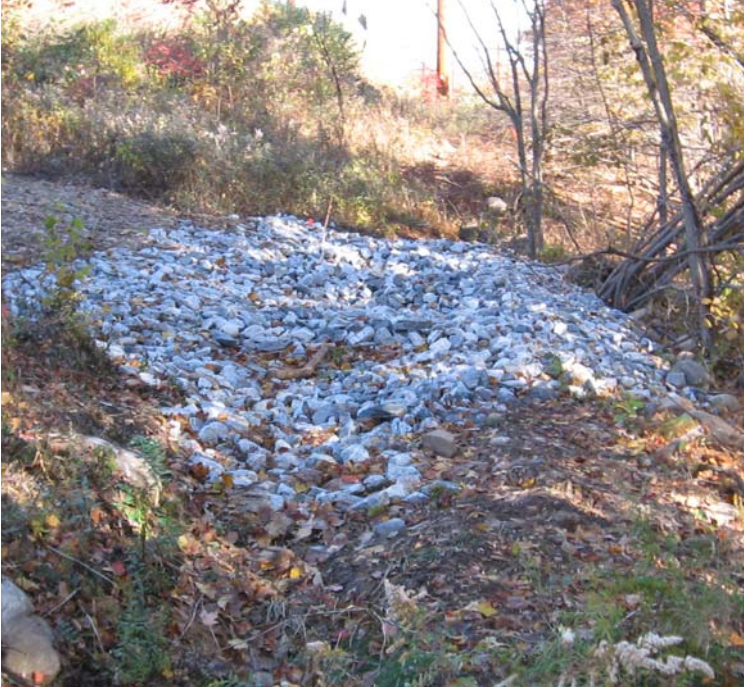
Gaylord Mtn Rd: This stone check dam is located at the end of the swale just prior to runoff leaving the ROW.

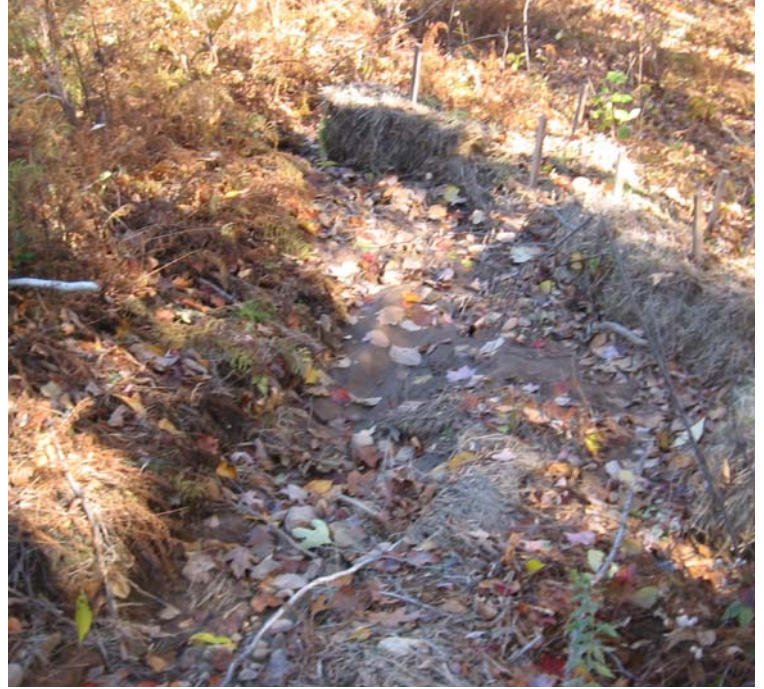
Gaylord Mtn Rd: The haybale controls at the end of the swale are helping to control sedimentation to a wetland off the ROW.

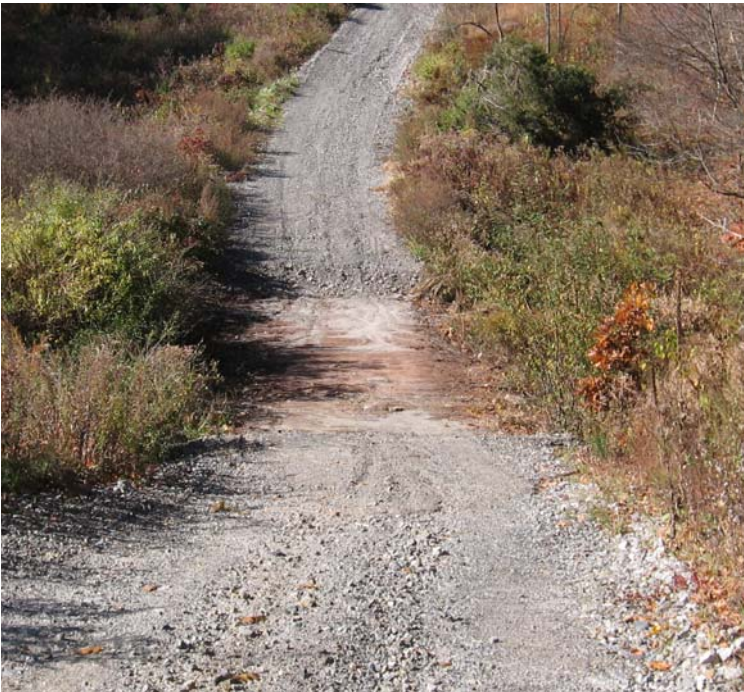
Brooksvale Ave: A view of the permanent wetland crossing at wetland #100.

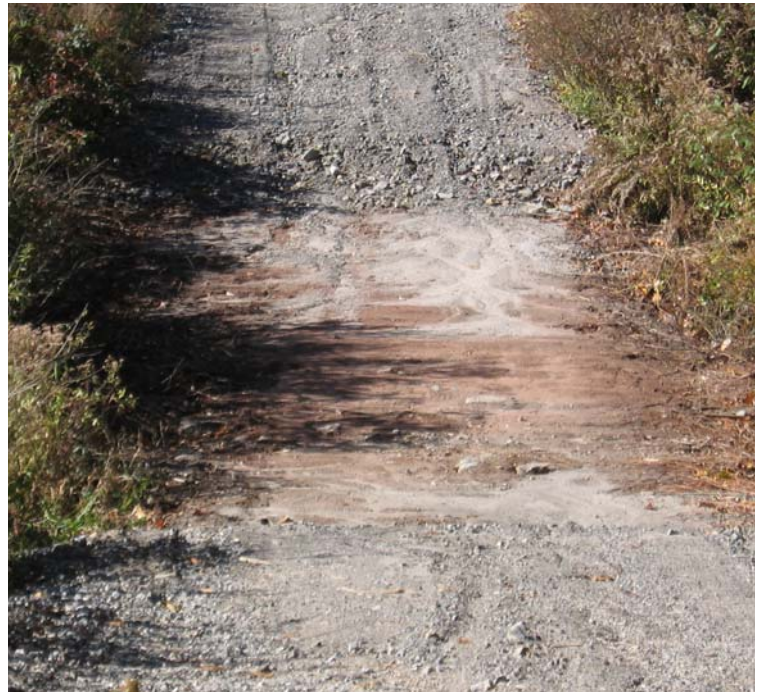
Brooksvale Ave	Sediment migration from the access road to a nearby wetland was observed this week. 10/31/08	Additional controls are needed. Continue to monitor. See wetlands section. 10/31/08	Needs attention
Old Ln	“Silt Sak” protection remains in the catch basin. Inlet protection is no longer needed. 10/31/08	Continue to monitor. Catch basin protection can be removed when the area becomes stabilized. 10/31/08	“Silt Sak” protection remains in the catch basin

<p>Hamden, CT Gaylord Mtn Rd, Tom Swamp, Willow Street, and Brooksvale Ave,</p>	<p>Permanent access roads remain in the wetlands in these sections (as permitted.) 10/31/08</p>	<p>Continue to monitor. 10/31/08</p>	<p>NA</p>
<p>Brooksvale Ave</p>	<p>It appears sediment from the access road is migrating into the wetland during storm events. 10/31/08.</p>	<p>Continue to monitor and add controls as necessary. Evaluate sediment accumulation within the wetland. 10/31/08.</p>	<p>Needs attention.</p>
<p>Gaylord Mountain Rd (South)</p>	<p>The majority of sediment has been removed from the wetland area between structure #'s 3990-3991. 10/31/08</p>	<p>Continue to monitor. 10/31/08</p>	<p>The appropriate erosion controls have been installed in this area and further sedimentation to wetland is unlikely.</p>
<p>State species of concern, threatened and endangered species.</p>	<p>According to the D&M plan, Wood Turtles are known to occur near the Wepawaug River at Eisenhower Park.</p>	<p>If active work is to continue in this area after April 1, 2009, field crews should receive the appropriate training in the</p>	<p>Wood Turtles are dormant at this time.</p>

Brooksvale Ave: It appears sediment from the access road is migrating into the wetland during storm events. Additional controls are needed here.
