Docket No. 272 – Development and Management Plan Inspection

Segment 2b Inspection

Date: November 7, 2008

Location: Segment 2b – Cheshire/Hamden Town Line to East Devon Substation

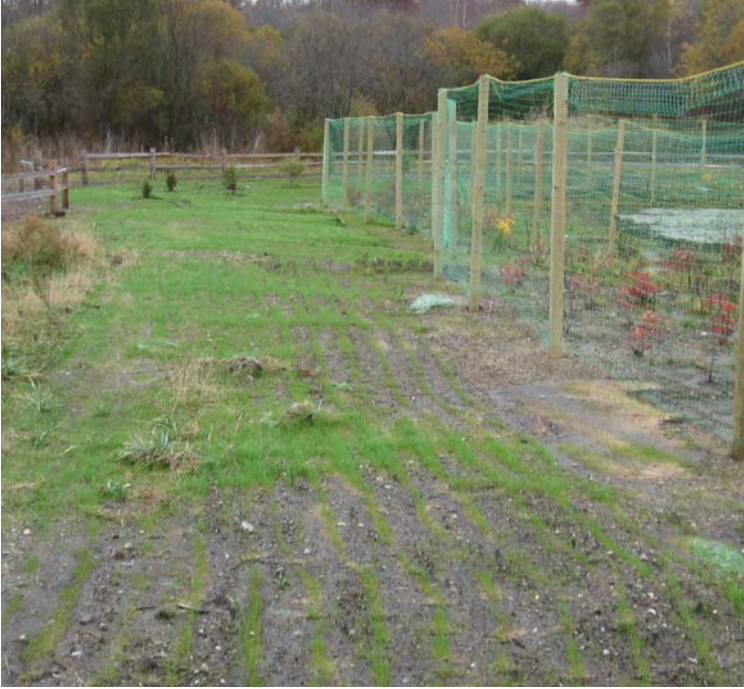
Eisenhower Park (Milford): Vegetative growth has been noted following the hydro-seed application at the mitigation area.

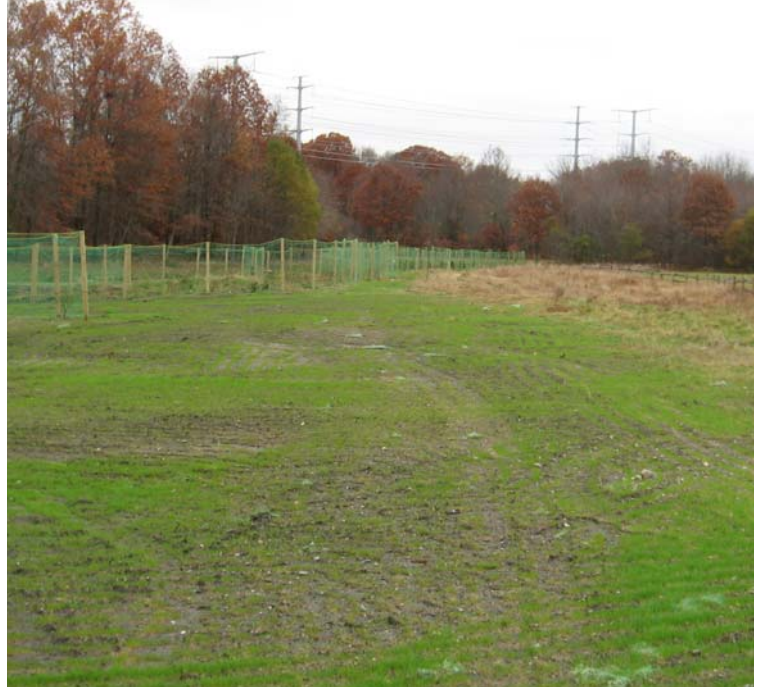
Eisenhower Park: An additional view of the vegetative growth at the mitigation area.

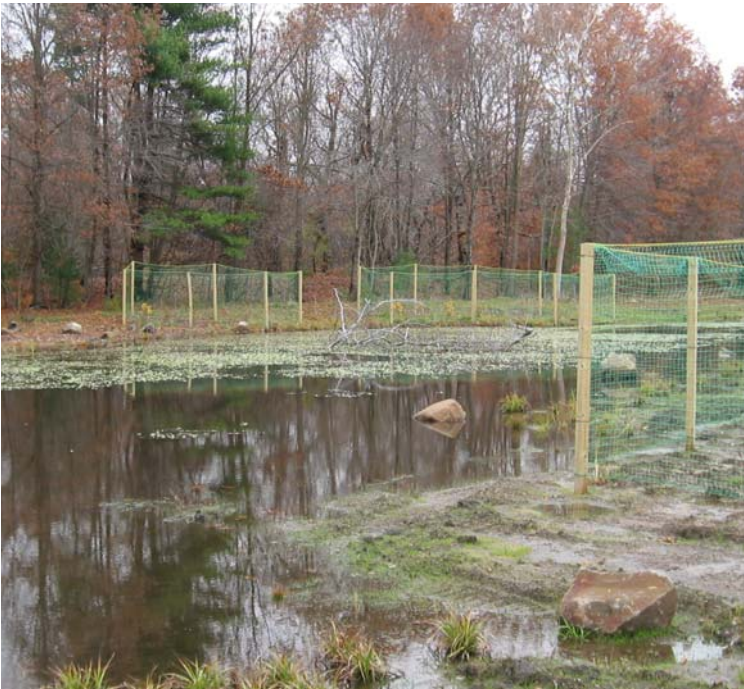
Eisenhower Park: A view of the mitigation area and plantings.

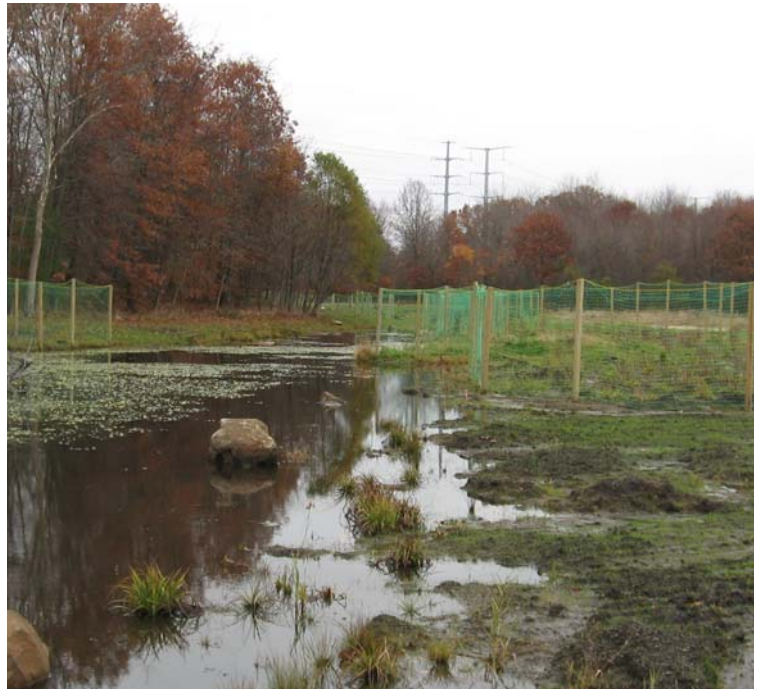
Eisenhower Park: Additional view of mitigation area and plantings.

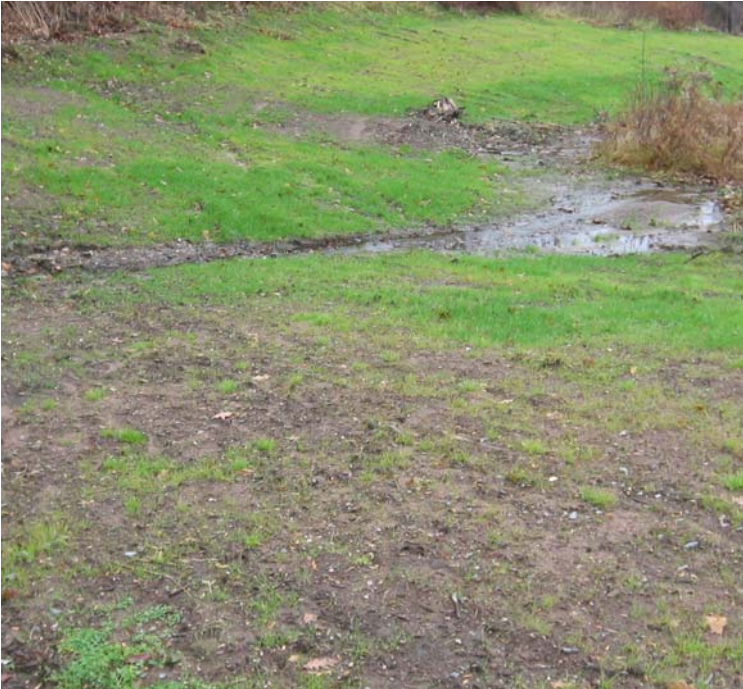
Pease Rd/JCC (Woodbridge): Vegetative growth continues within the restored access road.

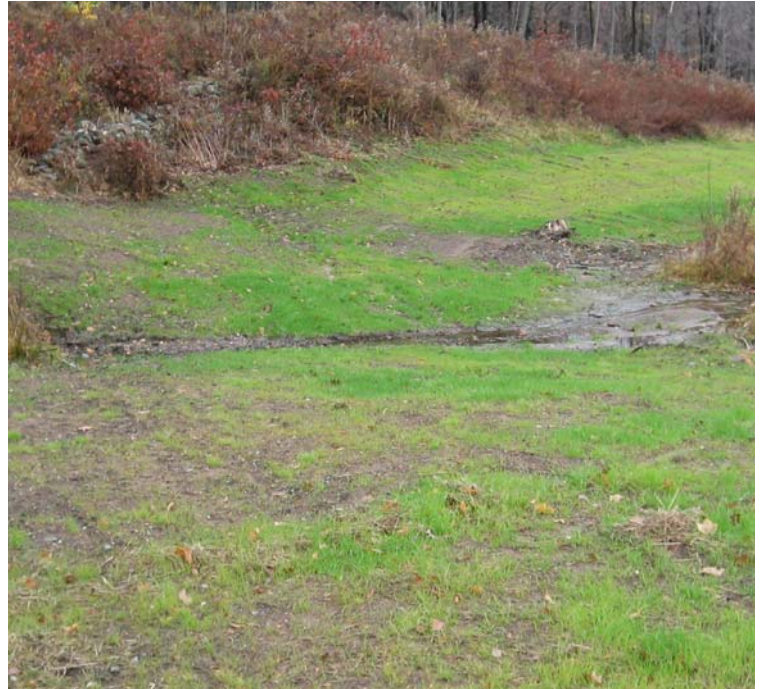
Pease Rd/JCC: No further scouring/sedimentation to the intermittent stream channel has been observed here. Haybale controls are recommended along the stream channel as a proactive measure.

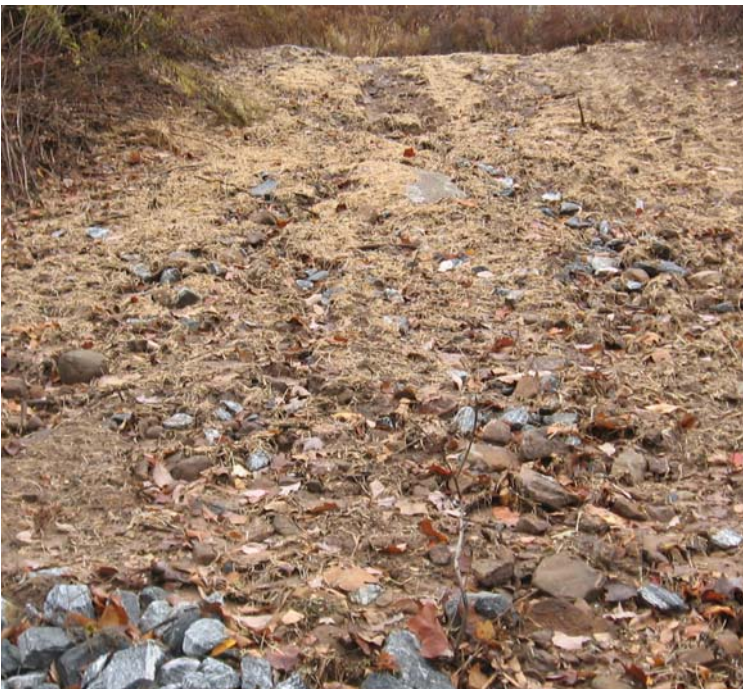
Areas of Inspection	Observation	Recommended Action	Corrected Action
<p>Brooksvale Ave</p> <p>Whitney Ave</p> <p>Old Lane Rd</p>	<p>controls. Sediment is migrating to the swale located downgradient and along the perimeter of the ROW. Additional stabilization measures are needed near the end of the swale. 11/7/08</p> <p>A permanent stone access road has been installed within wetland #100. Additional measures may be necessary to restore pre-existing stream flow. Sediment has been removed from the basin. 11/7/08</p> <p>Haybales have been placed at the base of the slope here in an effort to prevent sedimentation to the wetland. 11/7/08</p> <p>Haybale check dams and sediment basins remain in place here. Haybales also remain at the base of the slope to prevent sedimentation to the wetland. 11/7/08</p>	<p>11/7/08</p> <p>Continue to monitor and add/maintain controls as necessary. 11/7/08</p> <p>Continue to monitor and maintain controls as necessary. See stabilization section. 11/7/08</p> <p>Continue to monitor and maintain controls as necessary. 11/7/08</p>	<p>Sediment has been removed from the basin. <i>Additional attention is needed</i></p> <p>NA</p> <p>NA</p>

Gaylord Mtn Rd (Hamden): Some scouring has been observed where construction equipment accessed the ROW to install erosion controls. Sediment is migrating to the swale located down gradient and along the perimeter of the ROW.

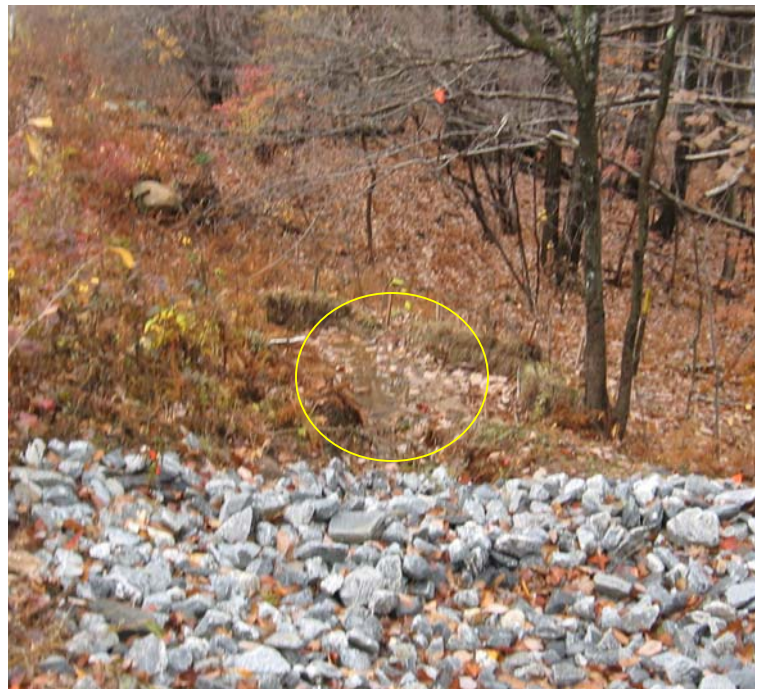
Gaylord Mtn Rd: Sediment from the scoured channels, shown in the previous photo, is accumulating at the haybale controls located at the end of the swale.
