Docket No. 272 – Development and Management Plan Inspection

Segment 2b Inspection

Date: November 14, 2008

Location: Segment 2b – Cheshire/Hamden Town Line to East Devon Substation

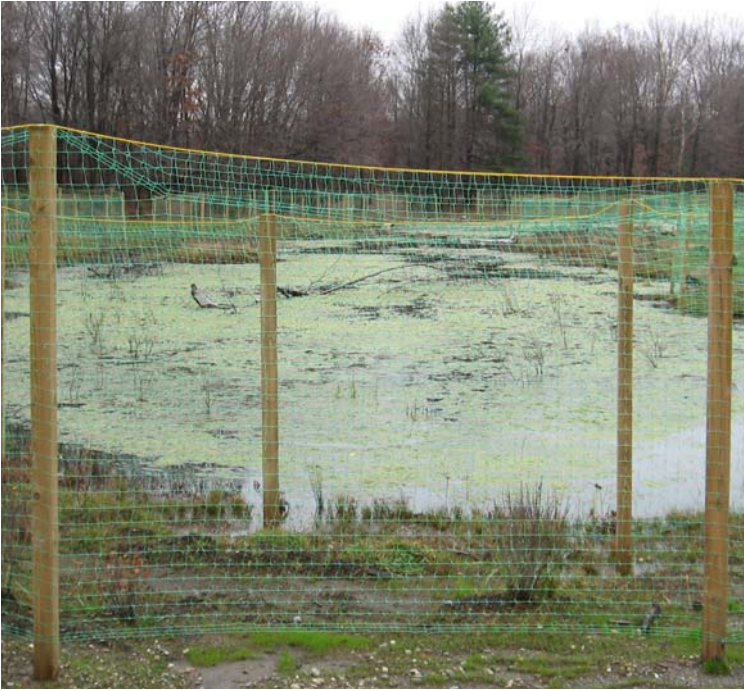
Eisenhower Park (Milford): A view of the mitigation area.

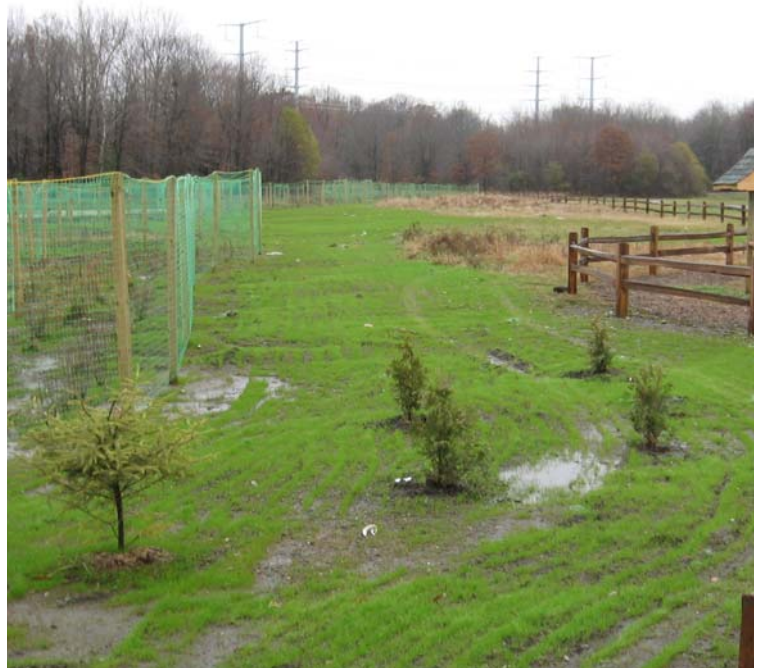
Eisenhower Park: A view of the vegetative growth at the mitigation area.

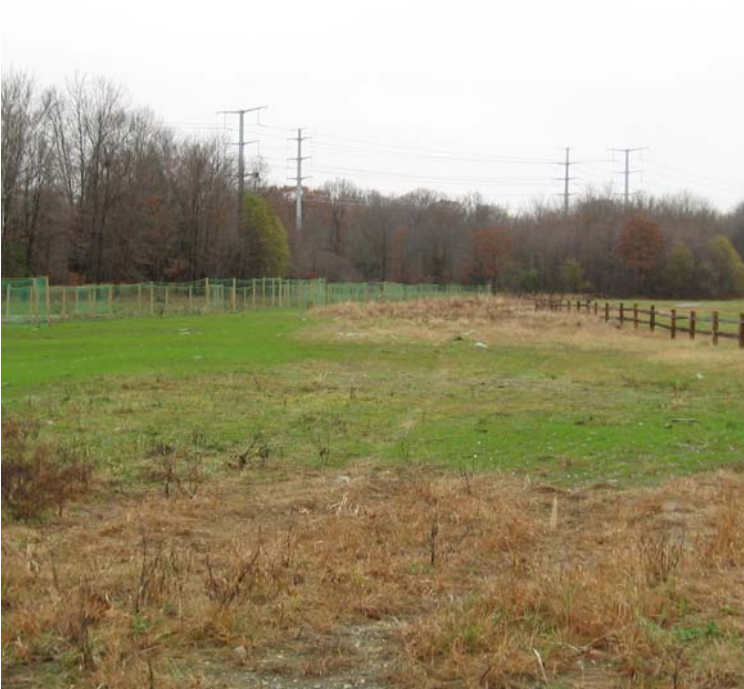
Eisenhower Park: A view of the mitigation area.

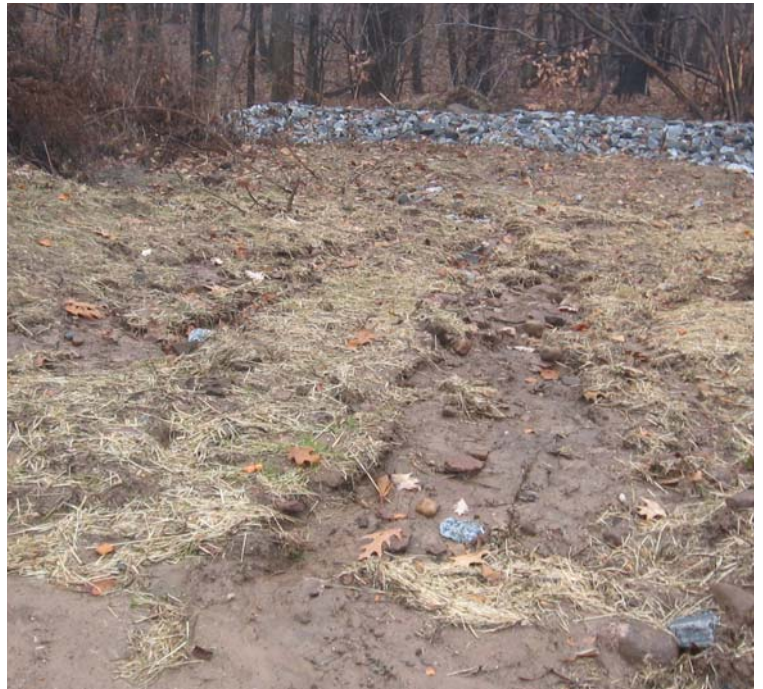
Gaylord Mtn Rd (Hamden): Runoff continues to scour exposed soils above the ROW perimeter swale.

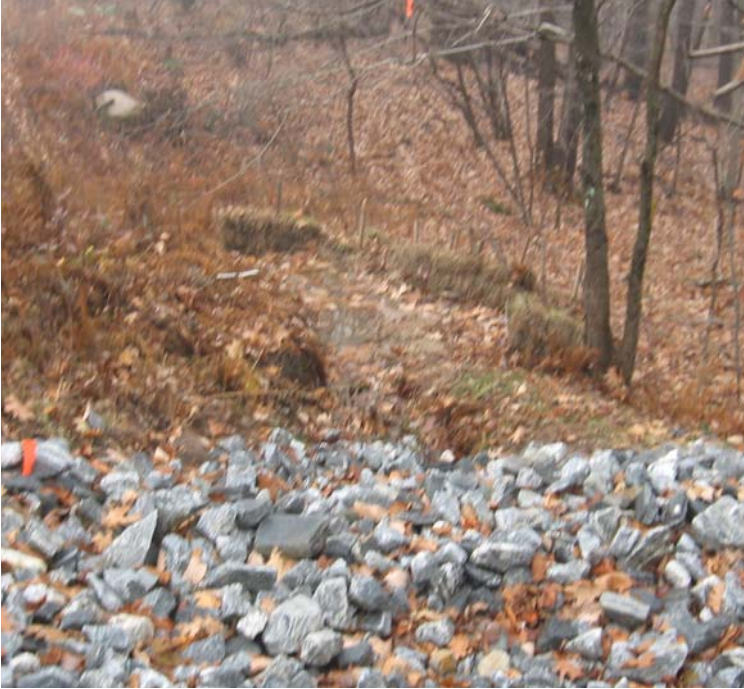
Gaylord Mtn Rd: Haybale controls continue to function near the end of the swale.

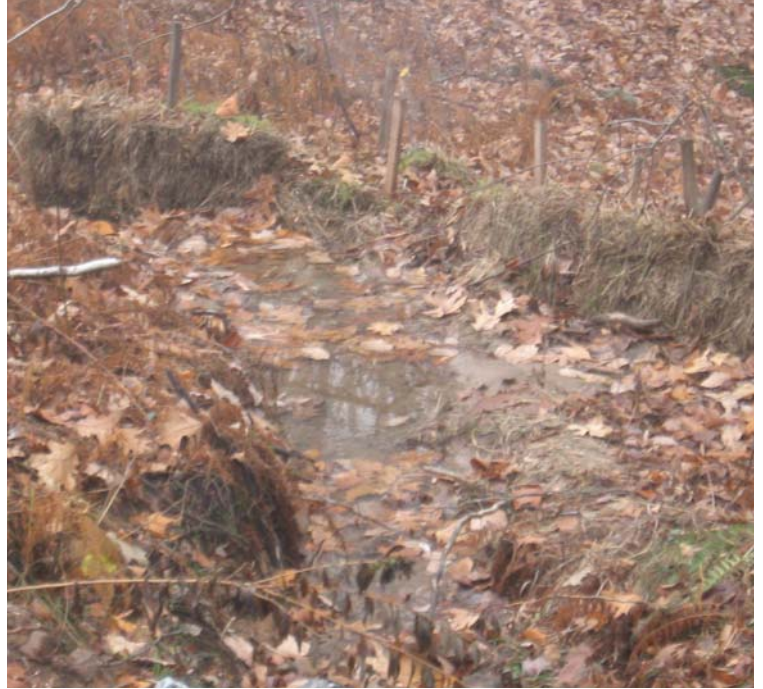
Gaylord Mtn Rd: An additional view of sediment being contained by the haybale controls.

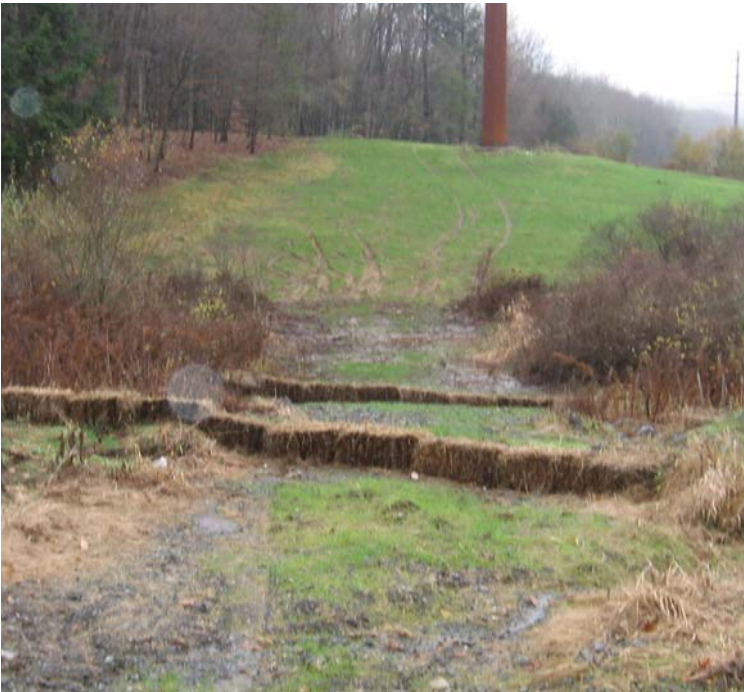
Old Ln (Hamden): A view of the restoration efforts and controls that remain functional near structures #4012/24199.

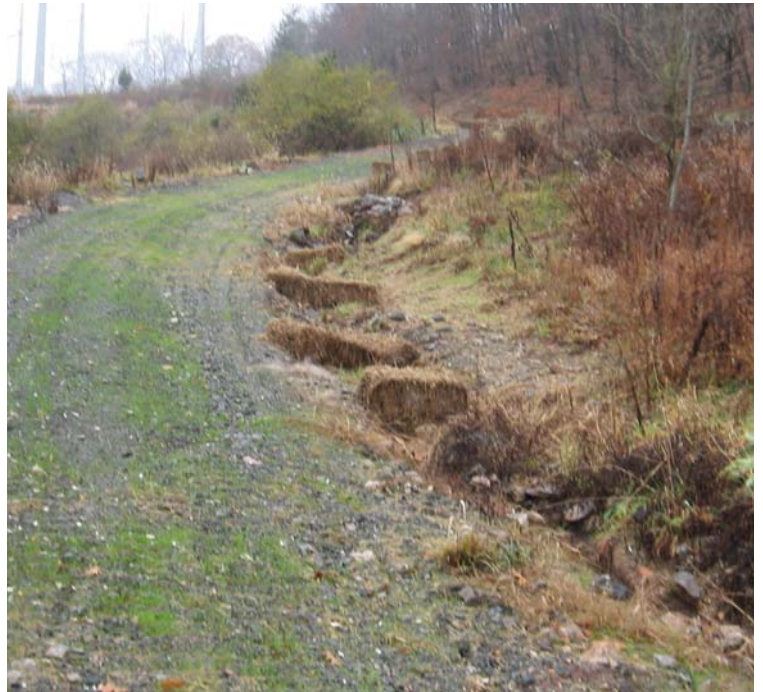
Old Ln: The access road appears to be stable at this time.
