Docket No. 272 – Development and Management Plan Inspection

Segment 2b Inspection

Date: December 4, 2008

Location: Segment 2b – Cheshire/Hamden Town Line to East Devon Substation

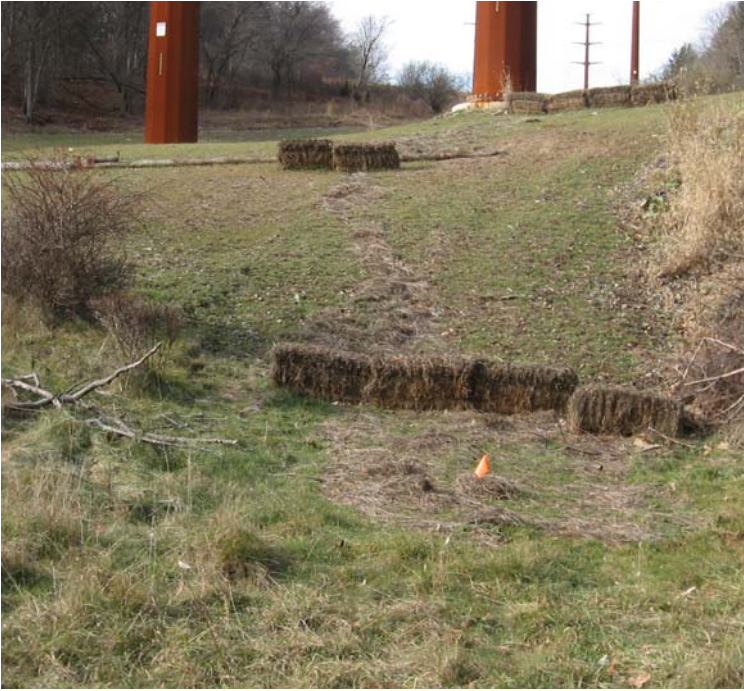
Dogburn Rd (Orange): Final stabilization has been achieved near structure #3890/24077.

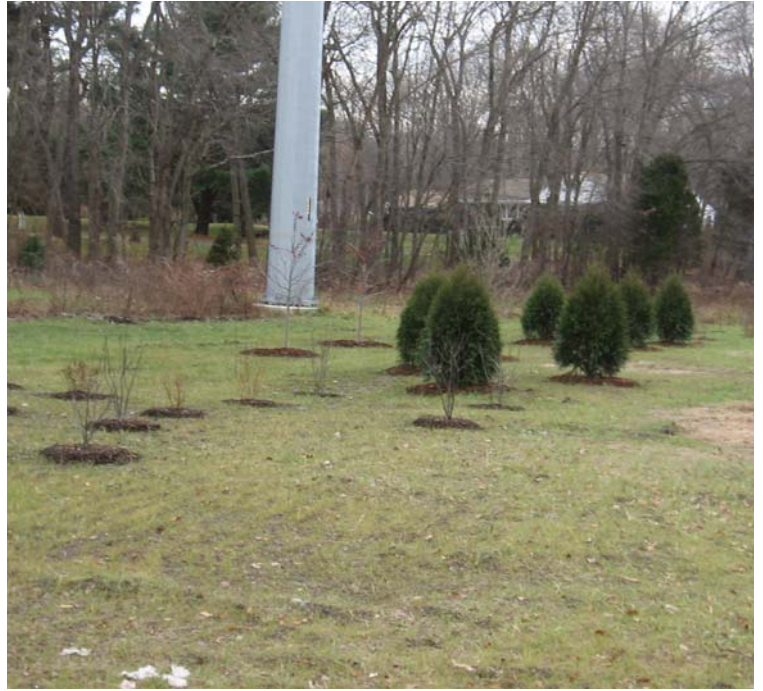
Salem Rd (Woodbridge): A view of the restoration efforts and plantings near structure #3910/24097.

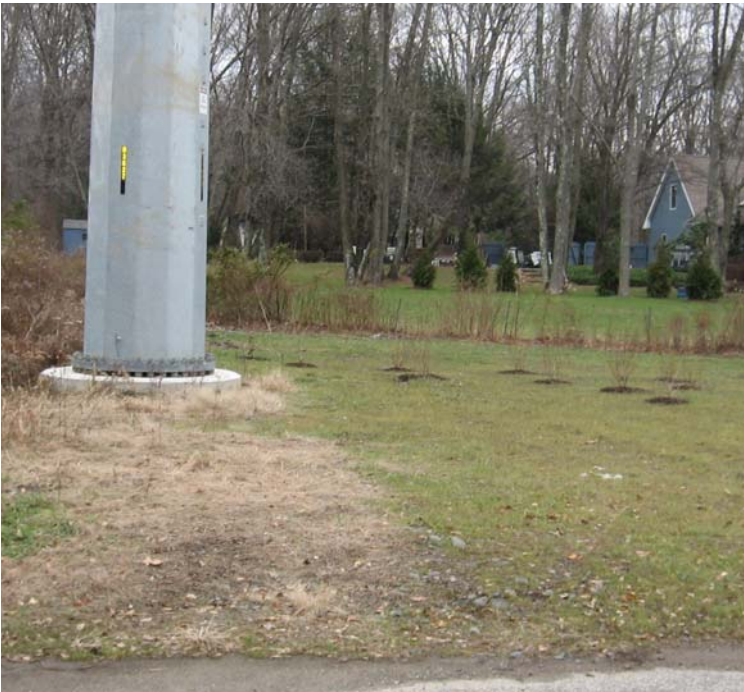
Salem Rd: An additional view of restoration efforts and plantings near structure #3910/24097.

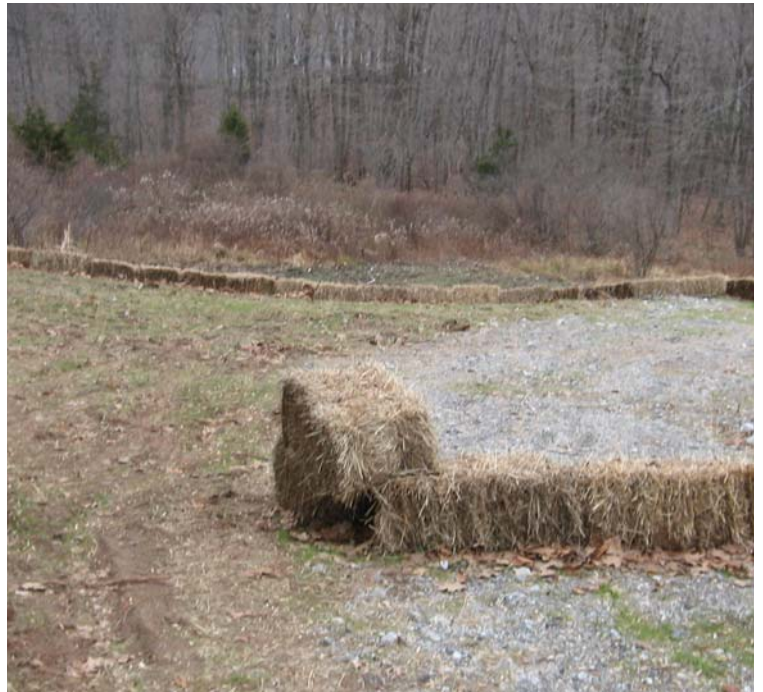
| Areas of Inspection | Observation | Recommended Action | Corrected Action |
|---|--|---|--|
| <p>Hamden, CT Gaylord Mtn. Rd.</p> | <p>Haybale controls have been added along the slope near structure #3993/ 24180. Soils appear stable at this time. 12/4/08.</p> | <p>Continue to monitor until final stabilization is achieved. 12/4/08.</p> | <p>Haybale controls have been added and soils appear stable at this time.</p> |

Gaylord Mtn Rd (Hamden): Haybale controls have been added along the slope near structure #3993/24180. Soils appear stable in this area at this time.

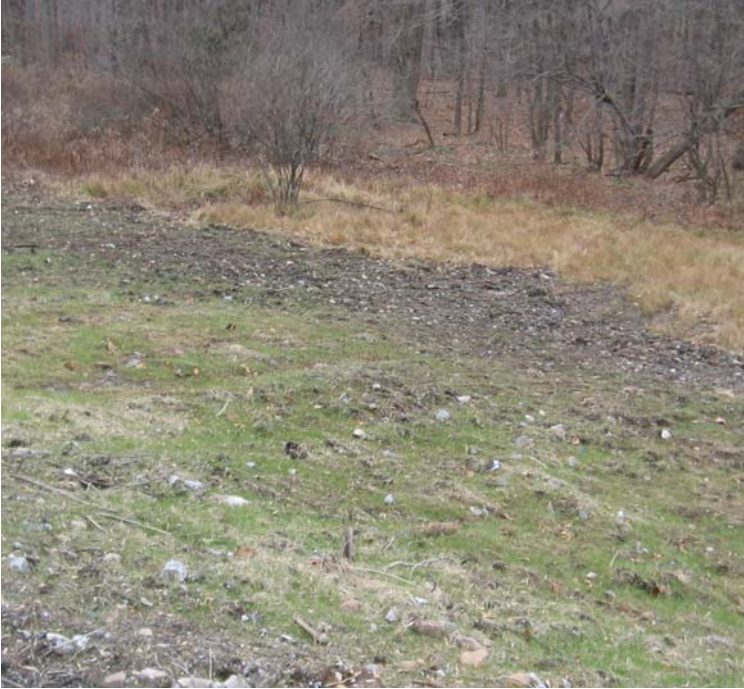
Gaylord Mtn Rd: Vegetation growth has been noted following restoration efforts near structure #3993/24180.

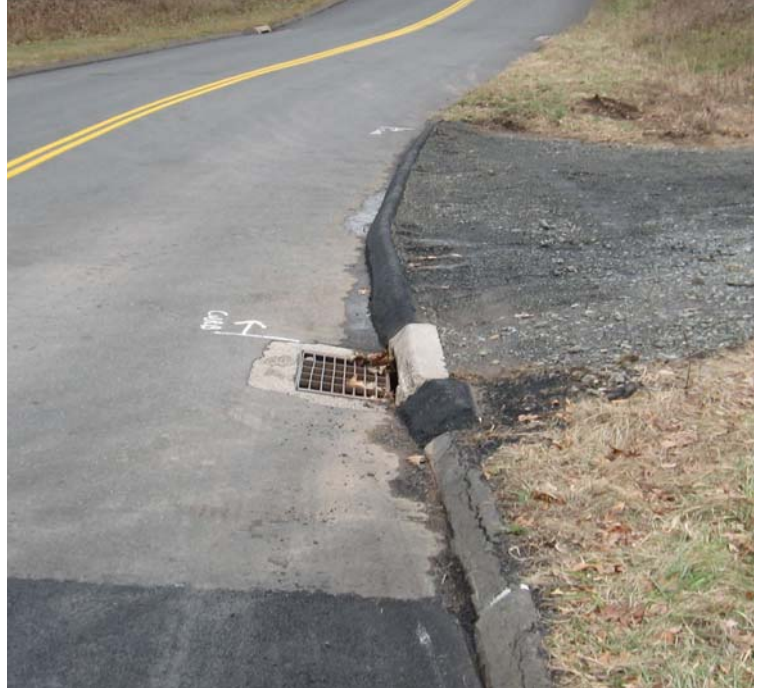
Old Ln (Hamden): A new curb has been installed at the Old Ln. ROW access. The curb will help control sediment migration to the catch basin. Catch basin protection has been removed.

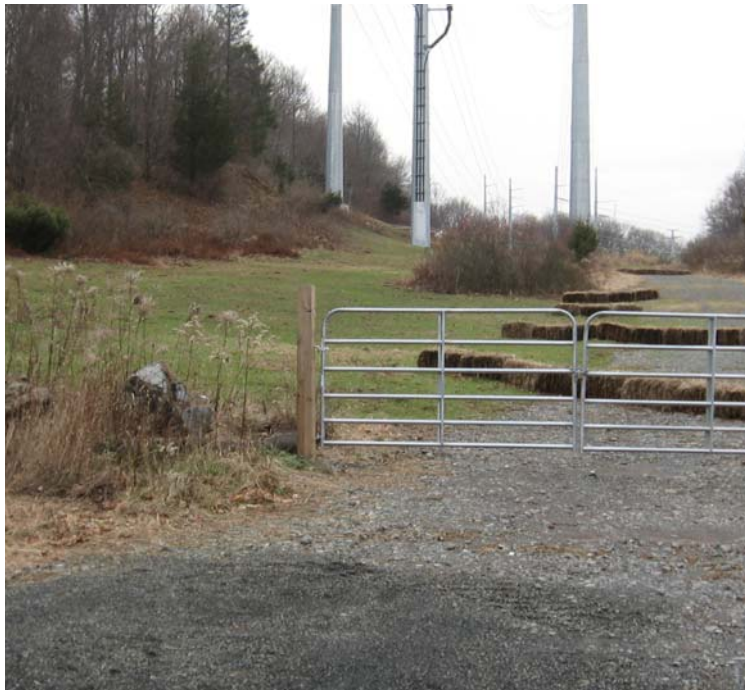
Old Ln: A view of the controls and restoration efforts near structure #4015/24202.
