Docket No. 272 – Development and Management Plan Inspection

Segment 3 Underground Line

Date: January 11, 2008

Location: East Devon Substation to the Housatonic River Crossing

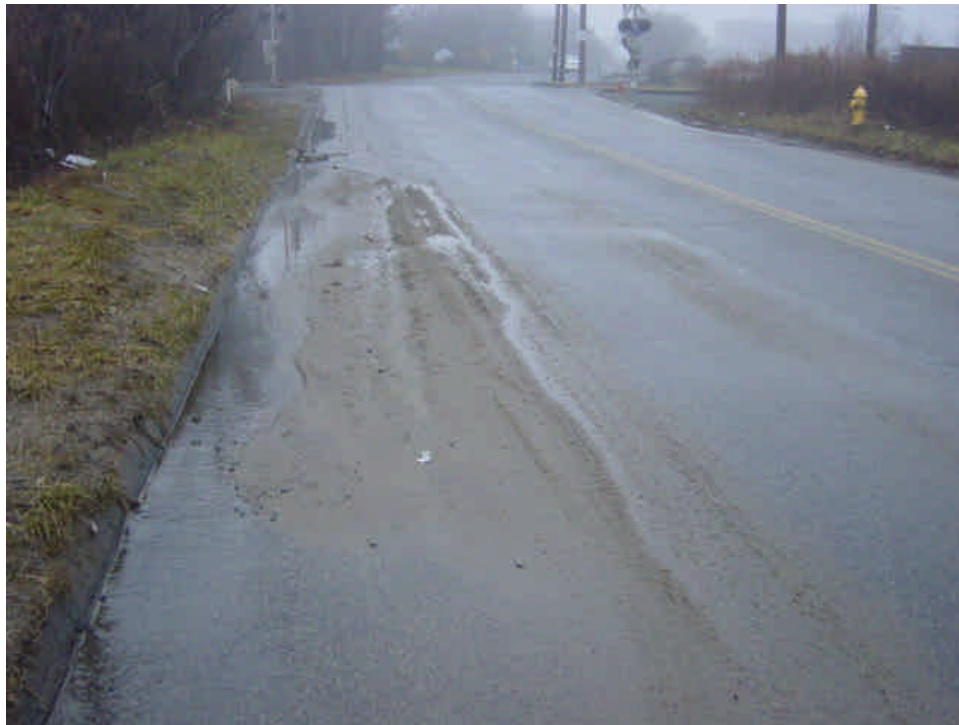
Sediment remains upgradient of the catch basin on Caswell Street. However, this tracking does not appear to be associated with the Segment 3 work. (See the overhead 2B report for more information.)

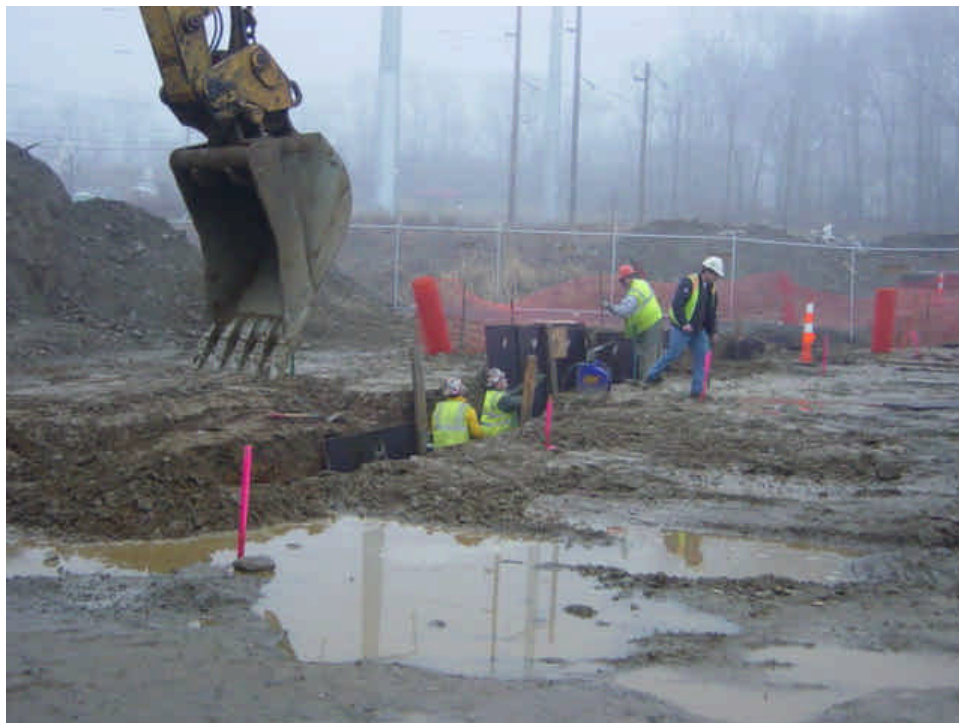
Trench work has resumed near the East Devon substation, from station #1114-1117.
