Docket No. 272 – Development and Management Plan Inspection

Segment 3 Underground Line

Date: January 18, 2008

Location: East Devon Substation to the Housatonic River Crossing

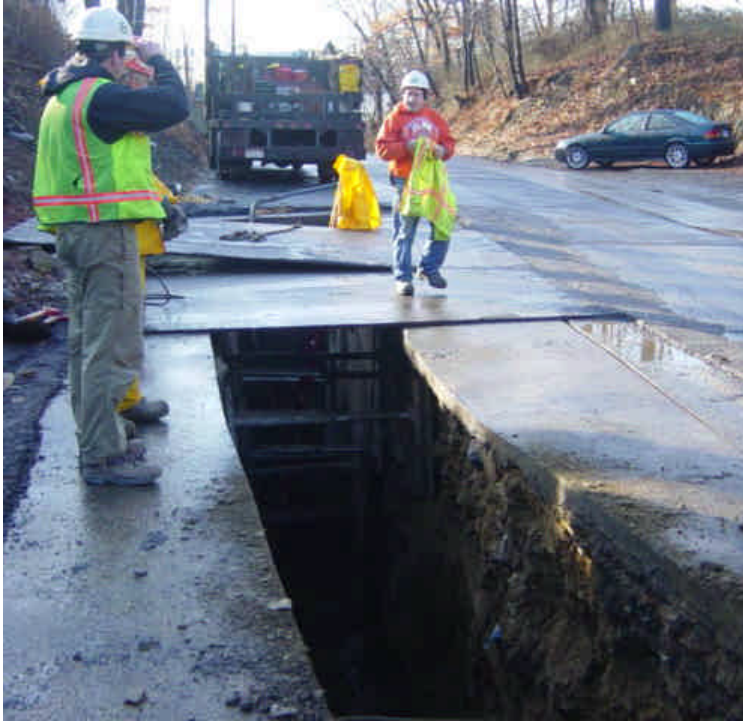
Trenching has resumed at stations #1031-1034 on Naugatuck Ave, which was closed to traffic. Water was being pumped into the empty vault for temporary storage.

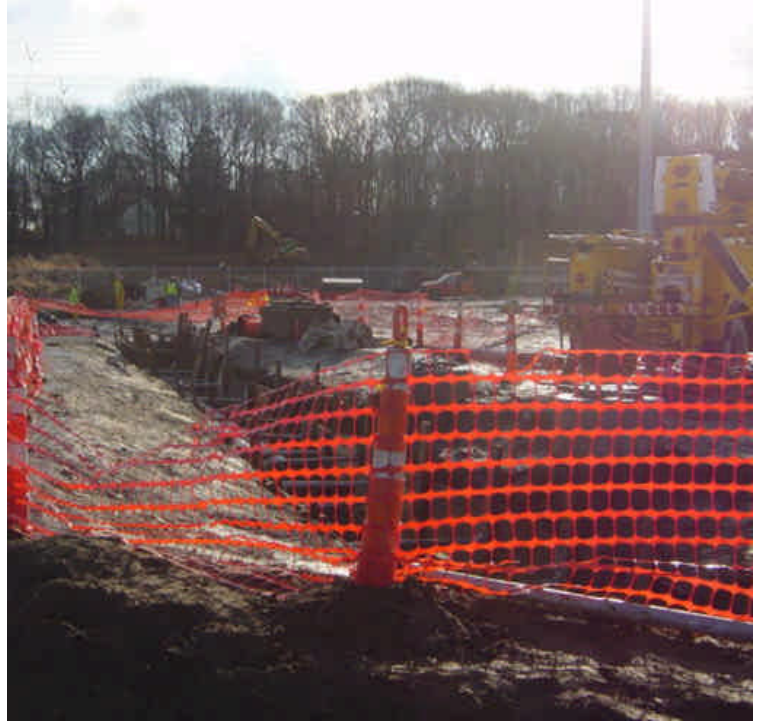
Vault Openings and Trench Construction	Work continues adjacent to/at the East Devon Substation. Trenching activities were observed from sta. #1114-1119.	None. 1/18/08	NA

Trenching continues adjacent to the East Devon substation, between sta#1114-1119. There are large areas of exposed soil present but site is largely contained.

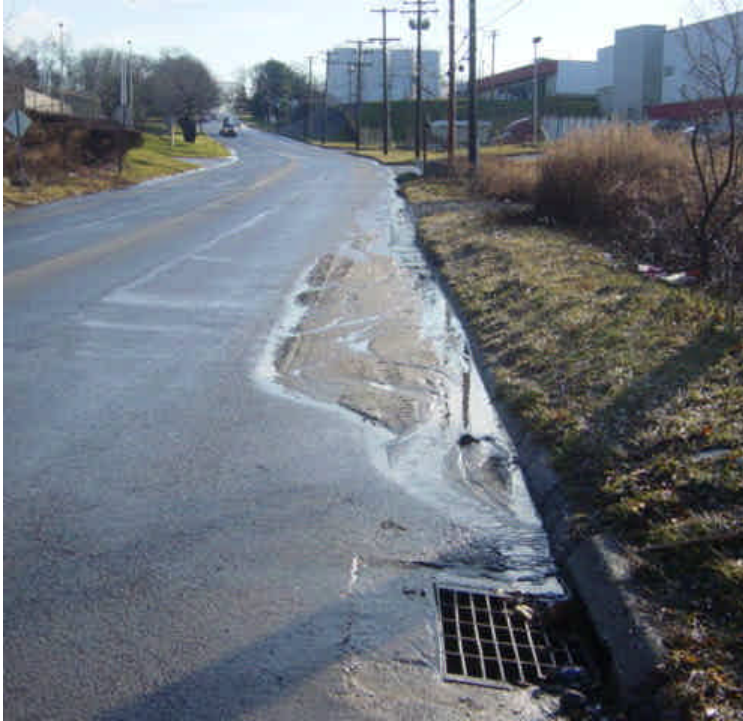
Areas of Inspection	Observation	Recommended Action	Corrected Action
	accumulation along the shoulder of Caswell Street has returned (This tracking was determined not to be associated with this portion of the project). 12/31-1/18/08	related to the M/N overhead work. Responsibility for maintaining catch basin controls will need to be shifted to overhead crews. 11/15/07-1/18/08	this D&M plan. See the 2B report.

On Caswell Street, accumulated sediment remains upgradient of the protected catch basin. However this tracking is not associated with the Segment 3 work. (See overhead report 2B).

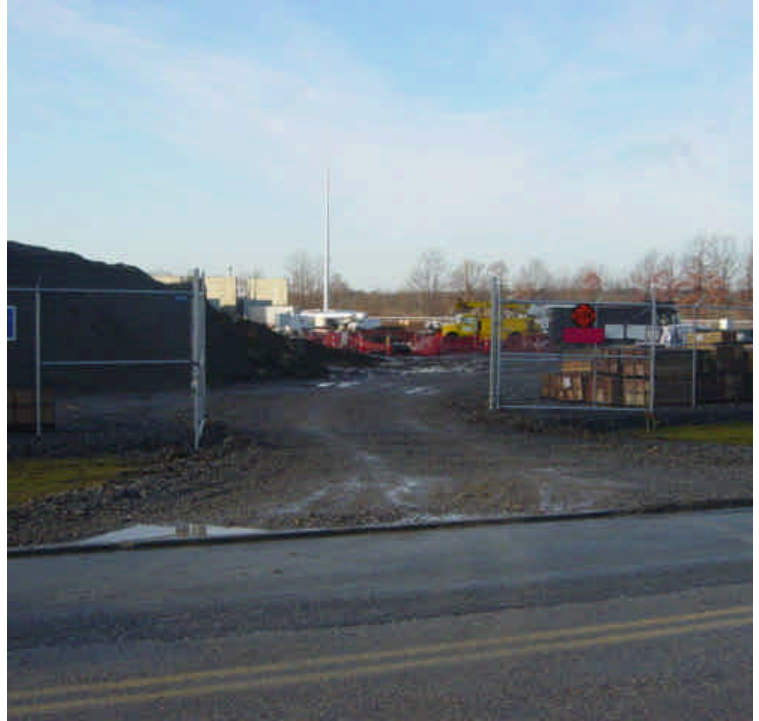
Crushed stone has been used to stabilize exposed soil at the East Devon substation entrance. Minor sediment tracking was observed on Plains Road. A very large soil stockpile is located at the entrance but this is not associated with the Segment 3 work. (See the East Devon Substation report).
