Docket No. 272 – Development and Management Plan Inspection

Segment 3 Underground Line

Date: January 24, 2008

Location: East Devon Substation to the Housatonic River Crossing

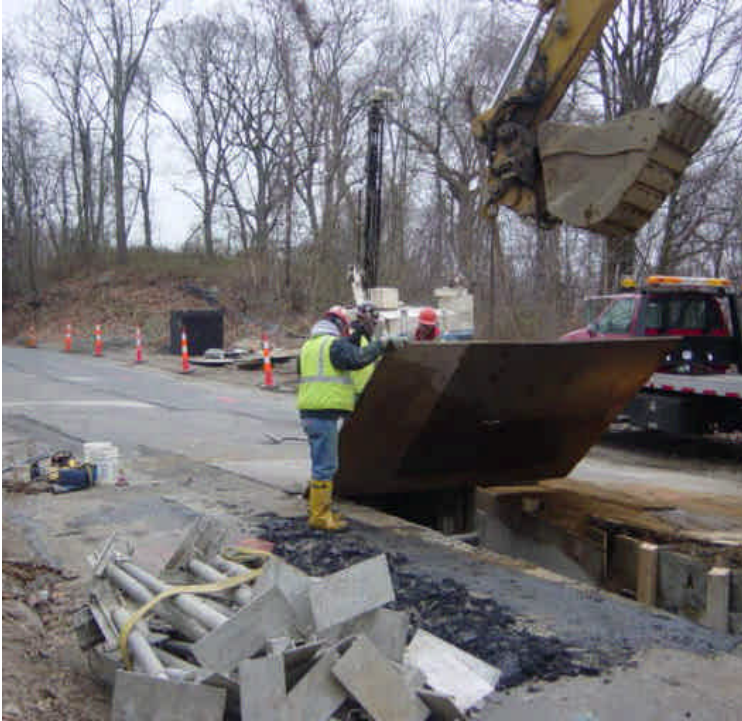
| Areas of Inspection | Observation | Recommended Action | Corrected Action |
|---|--|--|---|
| | Portions of Naugatuck Avenue were closed due to trenching activities at stations #1032-1034. 1/24/08 | None. 1/24/08 | NA |

Trenching continues along Naugatuck Avenue near sta. #1032-1034. Continue to sweep roadway as sediment is generated.

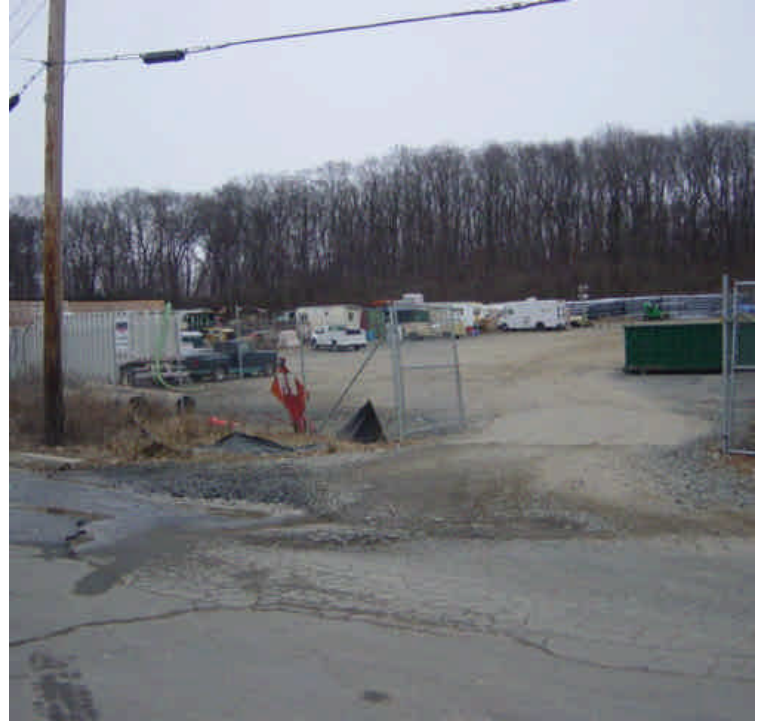
| Areas of Inspection | Observation | Recommended Action | Corrected Action |
|---|--|--|---|
| | Activities have returned to this segment and the Shelland Street lay-down yard is now active. A crushed-stone berm controlling sedimentation remains near the entrance to the yard and tracking was not an issue. 1/24/08 | Continue to monitor area and sweep roadway as necessary. 1/24/08 | NA |

Activity has increased at the Shelland Street laydown yard as work has returned to this segment of the project.

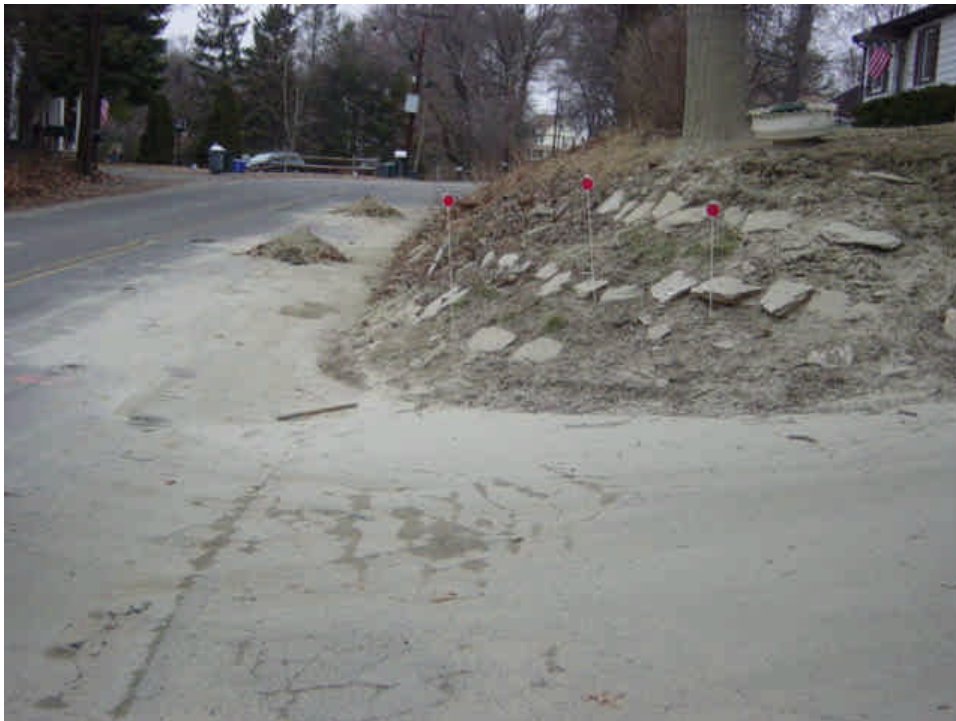
| Areas of Inspection | Observation | Recommended Action | Corrected Action |
|---|---|---|---|
| | was also noted on an adjacent driveway. It was unclear whether the material was project-related. 1/24/08 | | |

Two small piles of fine, dusty material were observed on Naugatuck Avenue near sta. #1038. The material was also observed along the adjacent driveway which appeared to have been wind blown. The source of the material/ dust was unclear and may not be project related.
