Docket No. 272 – Development and Management Plan Inspection

Segment 3 Underground Line

Date: February 7, 2008

Location: East Devon Substation to the Housatonic River Crossing

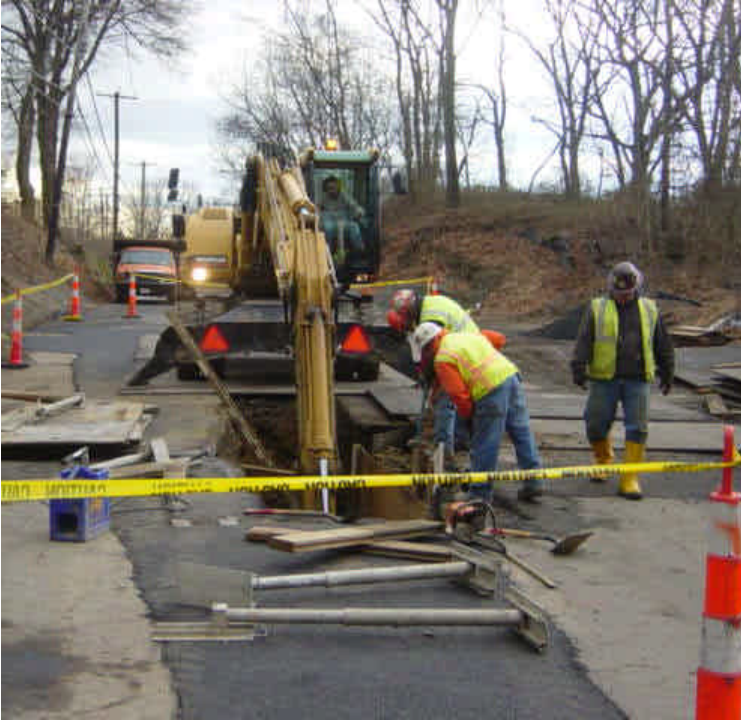
Trenching activities continue along Naugatuck Ave near sta. #1032 to 1033.

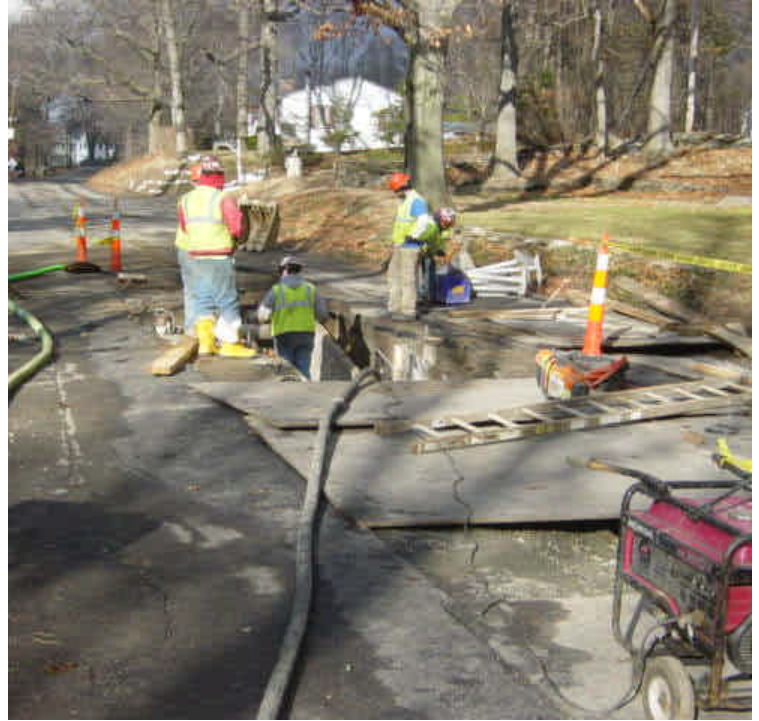
Trenching activities continue along Naugatuck Ave near sta. #1037 to 1038. At the time of the inspection, the trench was being dewatered. Water was filtered, and then discharged appropriately to a nearby sanitary sewer.

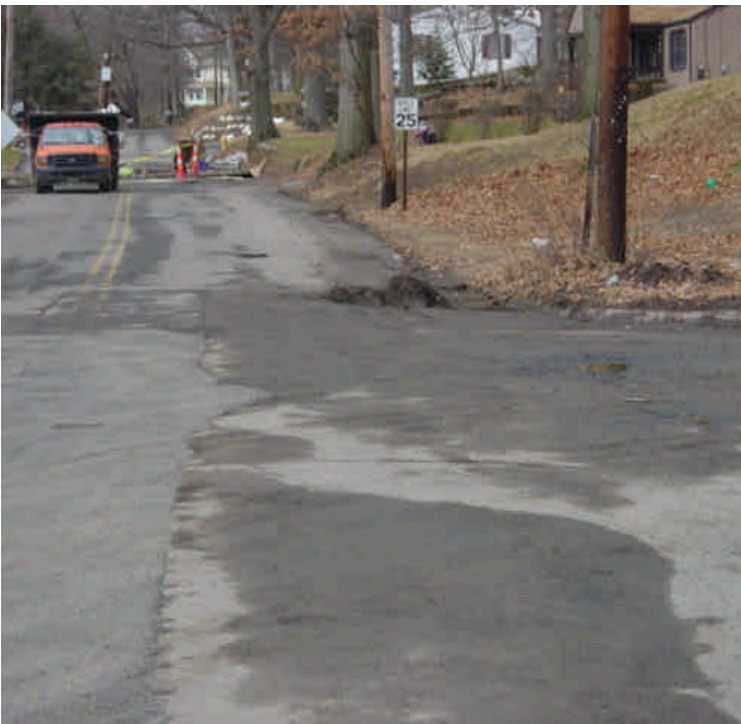
A catch basin near sta. #1034 was plugged with a large amount of sediment and debris, but was not project related. Crews removed some of the sediment to improve drainage.

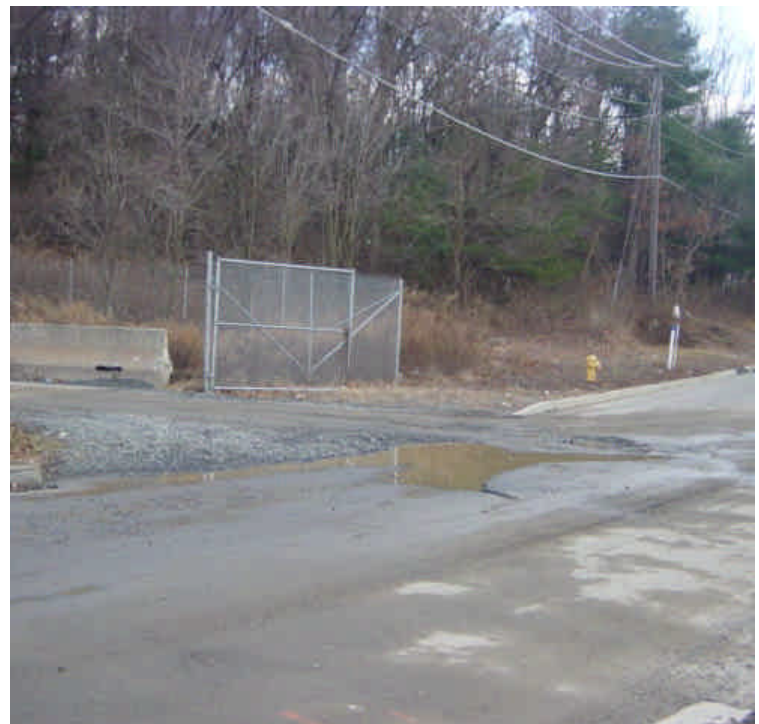
The Shelland Street lay-down yard was muddy and sediment tracking was observed from the entrance of the yard. Stone may need to be refreshed here.
