**Docket No. 272 – Development and Management Plan Inspection**

**Segment 3 Underground Line**

**Date:** February 14, 2008

**Location:** East Devon Substation to the Housatonic River Crossing

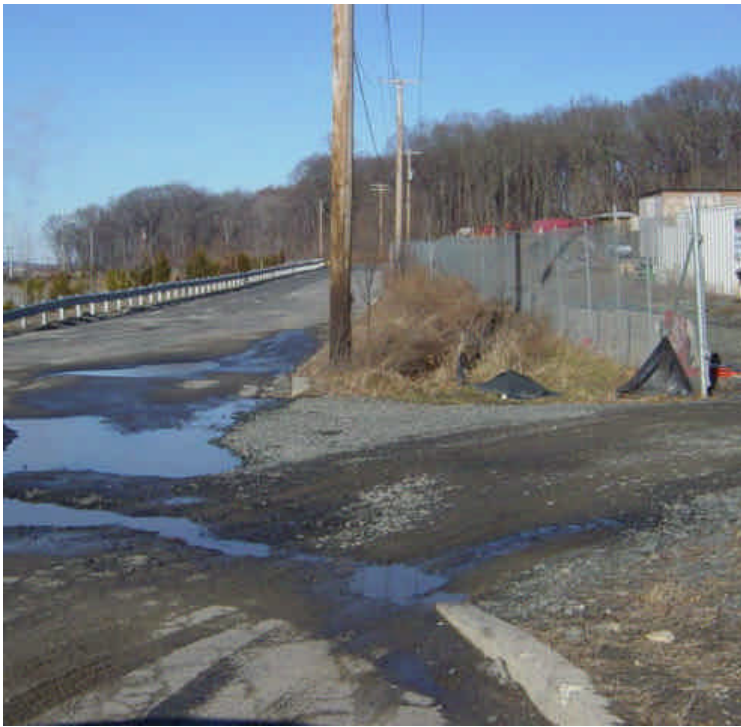
**Construction entrance at the Shelland Street lay-down yard continues to function. A large pothole/ depression has formed near the entrance causing storm runoff to pond in this area.**

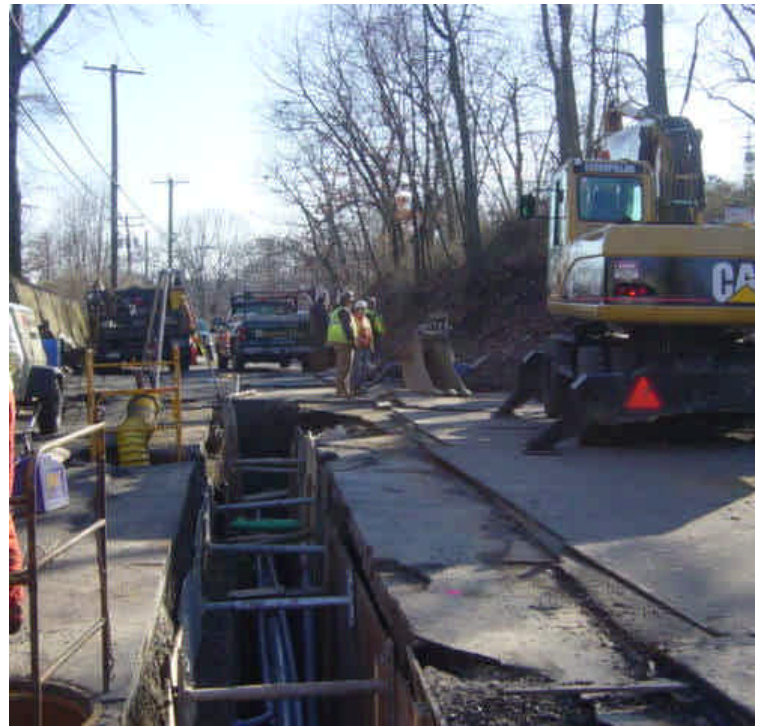
**Trenching activities continue along Naugatuck Ave near sta. #1032 to 1033.**

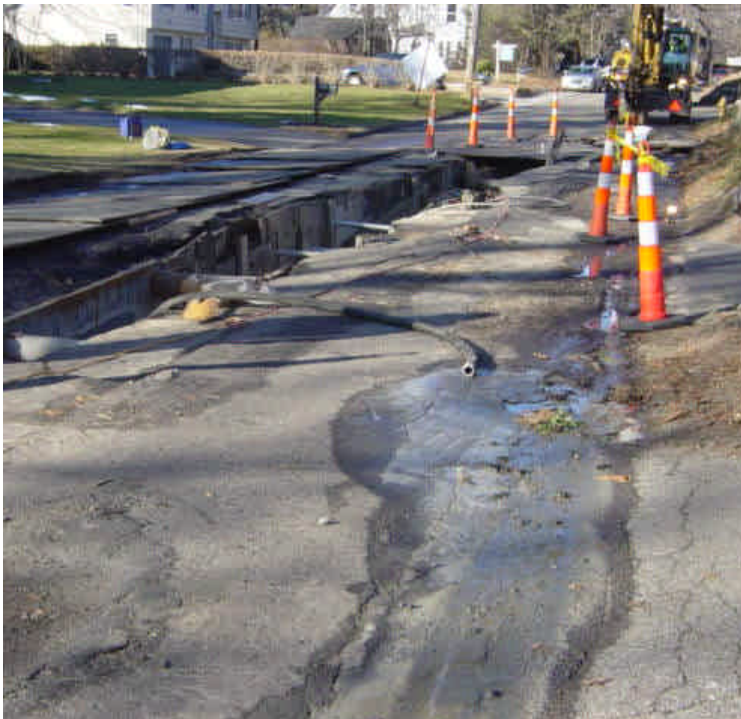
<p><b>Dewatering</b></p>	<p><b>At the time of the inspection the trench near sta. #1038 was being dewatered. The trench was being backfilled and concrete slurry had mixed with the groundwater which was being pumped down the street towards a plugged catch basin near sta. #1034. As a result, runoff was ponding along</b></p>	<p><b>The supervisor was informed of the problem and the crew agreed to vacuum out the catch basin at the end of the day. For future dewatering needs, ensure that it is contained appropriately and filtered as per the D&amp;M plan. Filtration was not observed at this location. 2/14/08</b></p>	<p><b>Needs attention.</b></p> <p><i>Supervisor was notified and catch basin will be vacuumed.</i></p>

**Trenching and backfilling activities continue along Naugatuck Ave near sta. #1037 to 1038. At the time of the inspection the trench was being backfilled. Concrete slurry had mixed with the groundwater which was being pumped down the street towards a plugged catch basin near sta. #1034. The runoff was ponding along the roadway. The supervisor was informed of the problem and the crew agreed to vacuum out the catch basin at the end of the day. Evaluate dewatering methods and ensure they are in compliance.**
