**Docket No. 272 – Development and Management Plan Inspection**

**Segment 3 Underground Line**

**Date:** February 21, 2008

**Location:** East Devon Substation to the Housatonic River Crossing

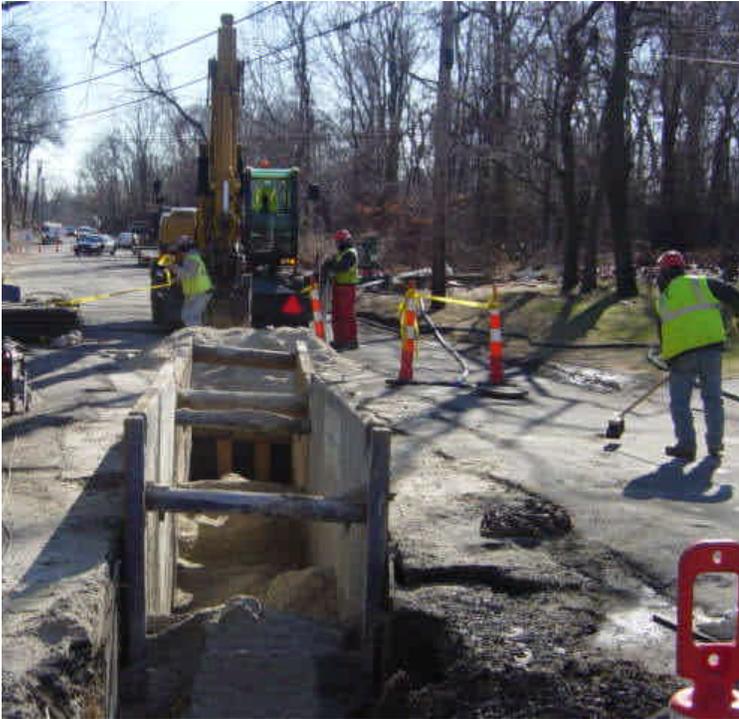
**Trenching and backfilling activities continue along Naugatuck Ave near sta. #1037 to 1038.**

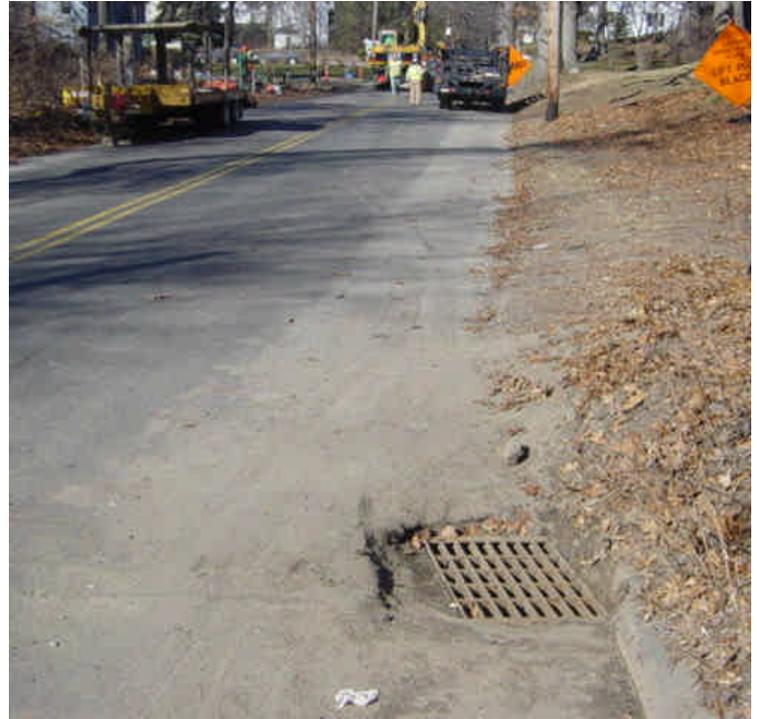
**Groundwater that was accidentally mixed with concrete slurry was discharged to the catch basin near sta. #1034 last week. Debris was removed from the catch basin and the silt sack was no longer in place. Controls need to be replaced due to active work upgradient.**

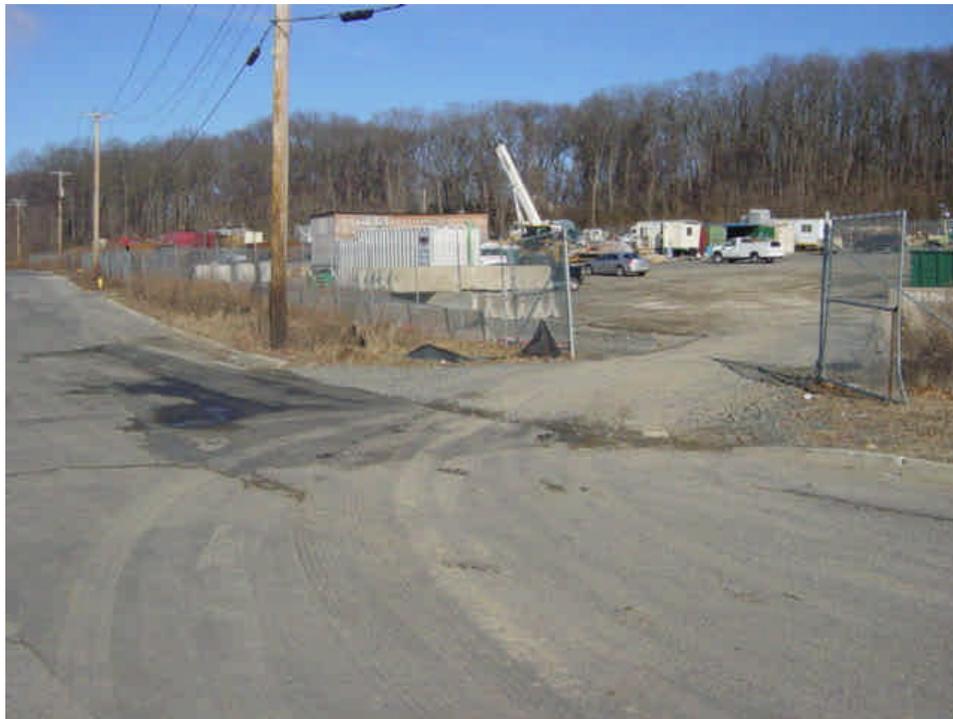
**Construction entrance at the Shelland Street lay-down yard continues to function. A large pothole/ depression near the entrance has been temporary filled/repared with cold-mix. The crushed stone that had accumulated along the shoulder of the road and in the depression in front of the driveway has been removed and was used to refresh the stone entrance.**
