Docket No. 272 – Development and Management Plan Inspection

Segment 3 Underground Line

Date: February 27, 2008

Location: East Devon Substation to the Housatonic River Crossing

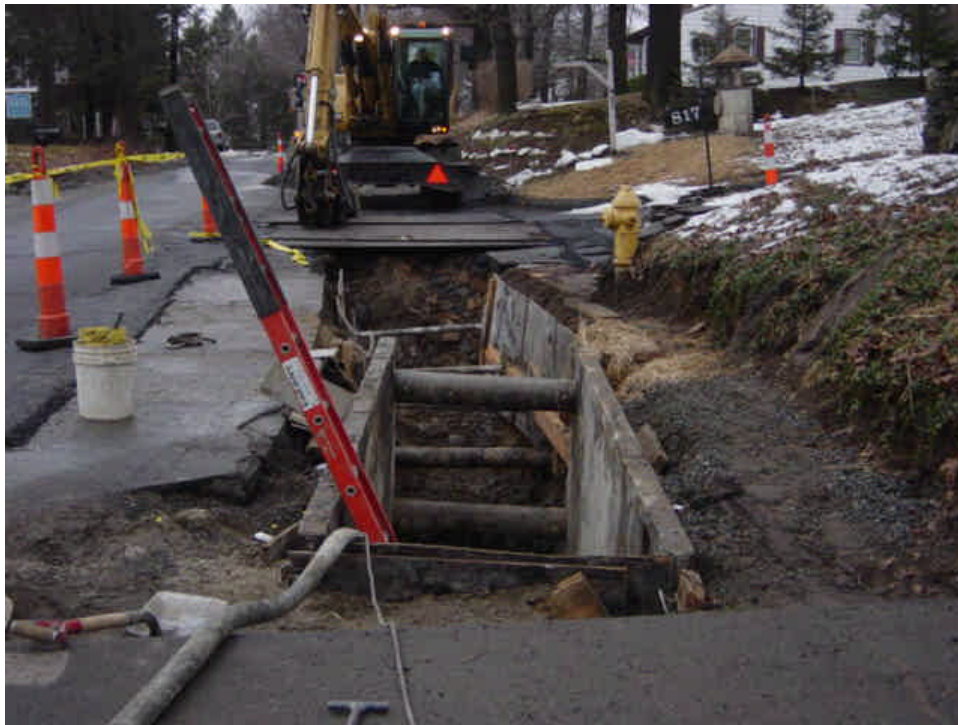
On Naugatuck Avenue, near sta. #1036-1037, trenching and dewatering were in progress. The water was being properly filtered and discharged into the sanitary sewer.

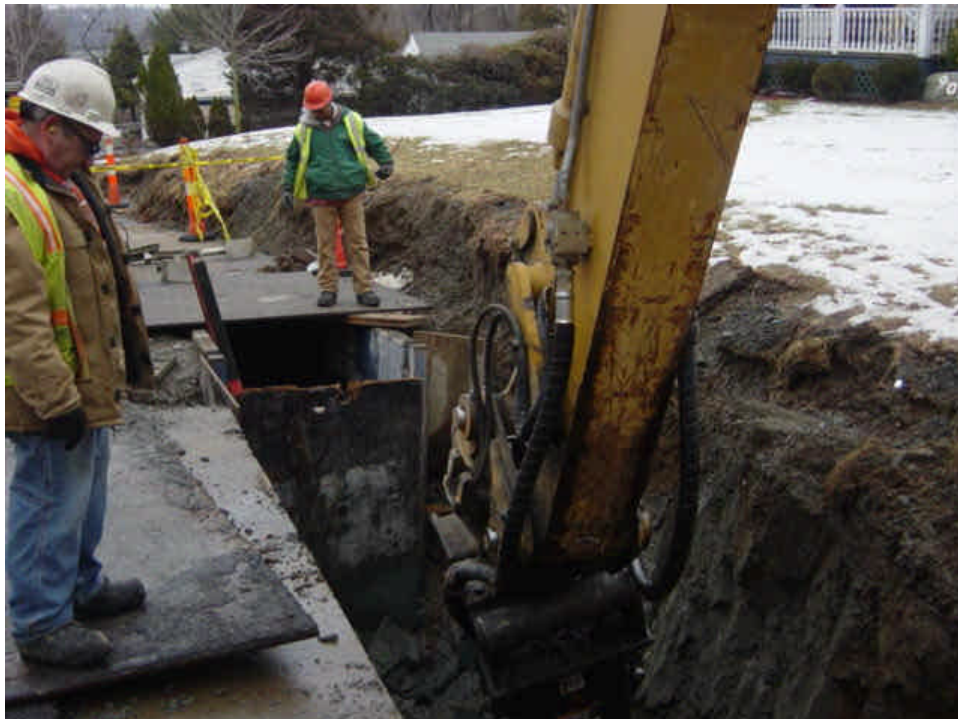
On Naugatuck Avenue, near sta. #1047-1048, the hydraulic jackhammer was being used to break through ledge.
