Docket No. 272 – Development and Management Plan Inspection

Segment 3 Underground Line

Date: March 13, 2008

Location: East Devon Substation to the Housatonic River Crossing

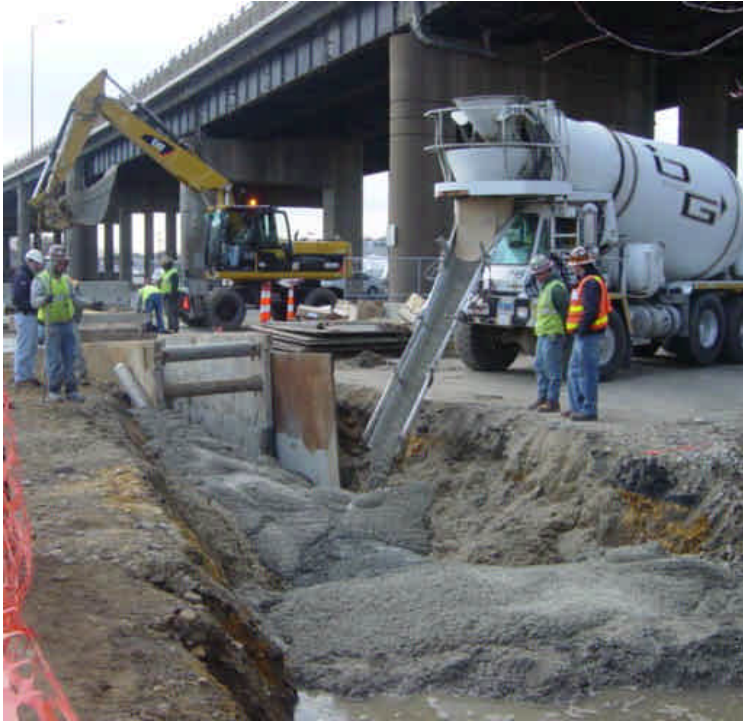
Crews continued vault tie-in work at sta. #999 on the west side of the Housatonic River. (where UI and NU work meets). The drilling pit was partially backfilled. 3/13/08	None. 3/13/08	NA
	An electrical crew was	None. 3/13/08	NA

On the west side of the Housatonic River near sta. #999, vault tie-in work is complete and crews were backfill the drilling pit and trench.

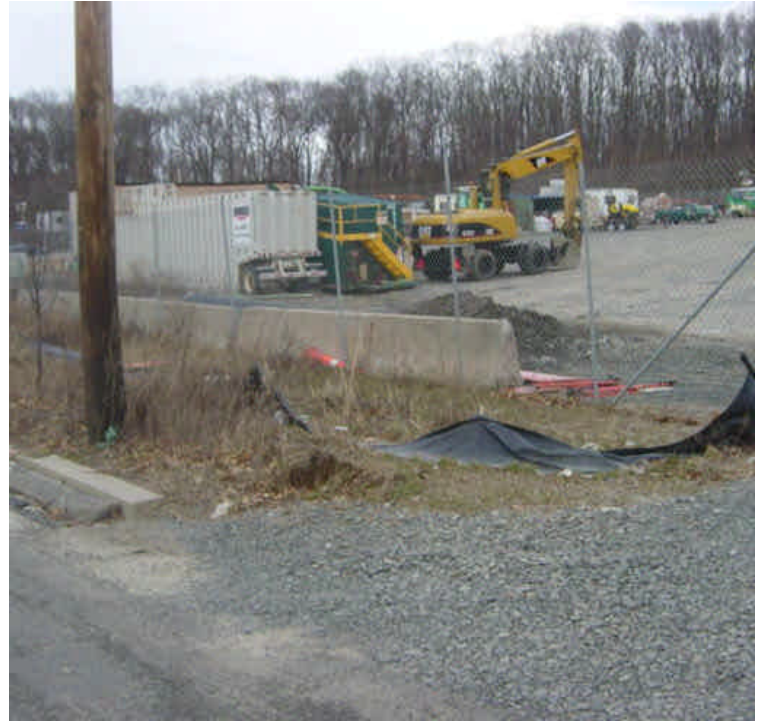
Sediment has accumulated behind the stone berm near the entrance to the Shelland Street lay down yard. A minor amount has migrated beyond the berm. The catch basin remains protected.

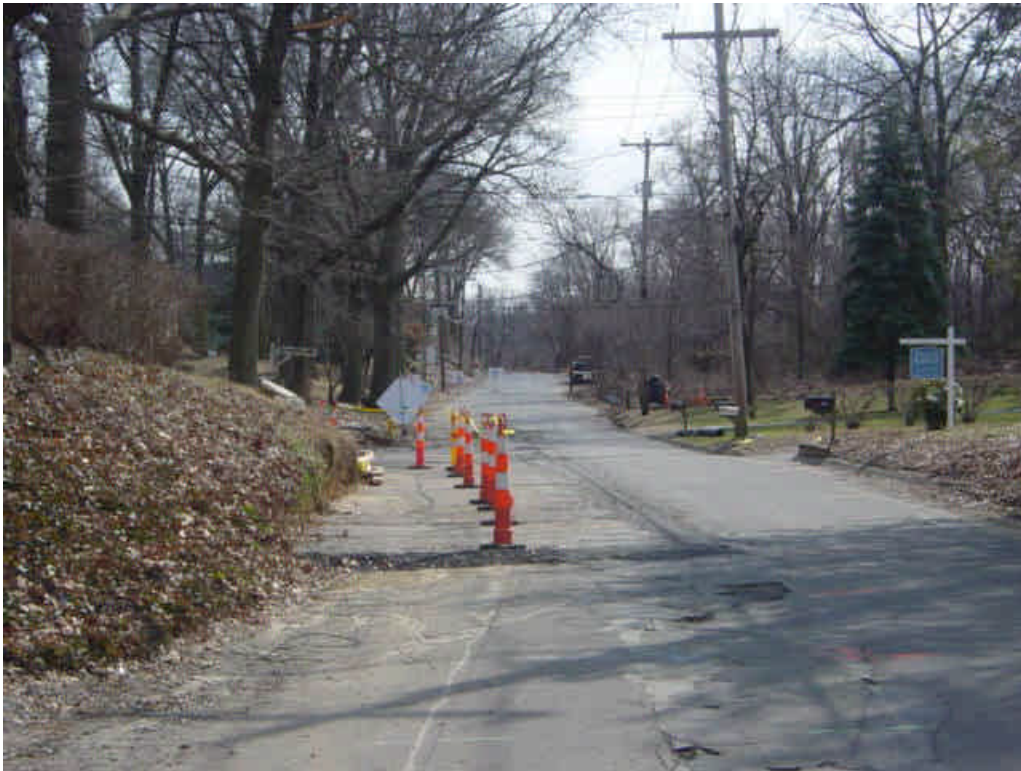
<p>Additional Observations</p>	<p>The city of Milford has recently relocated some water meters in the roadway near sta #1038-1039. 3/13/08</p>	<p>None. 3/13/08</p>	<p>NA</p>

Water meters were recently relocated along Naugatuck Avenue by the City of Milford.
