Docket No. 272 – Development and Management Plan Inspection

Segment 3 Underground Line

Date: April 10, 2008

Location: East Devon Substation to the Housatonic River Crossing

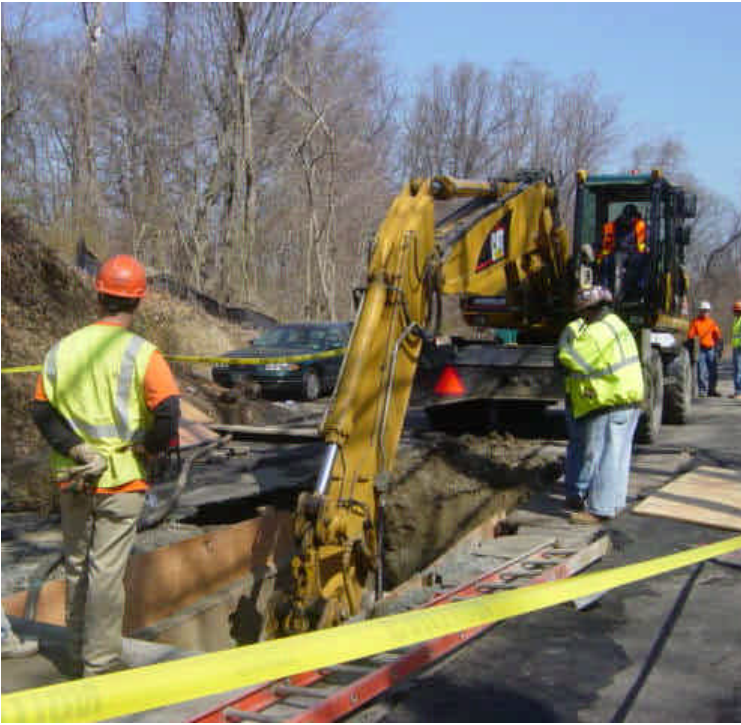
Trenching continues along Naugatuck Avenue near sta. #1031-1032. Ledge was encountered in this area.

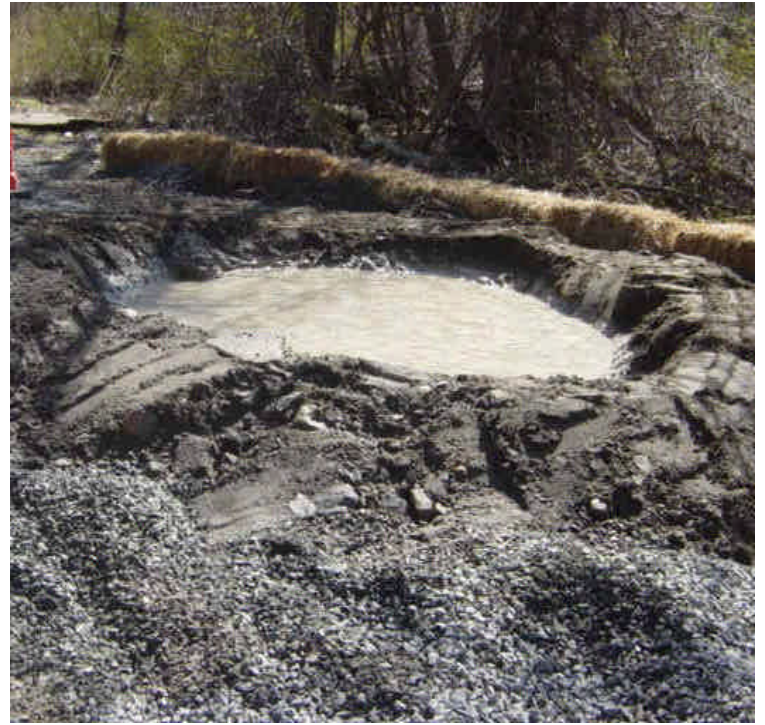
A designated concrete washout area was observed near sta. #1018. Haybales were also placed along the edge of the work zone to provide additional control/protection. Remove concrete material when feasible.

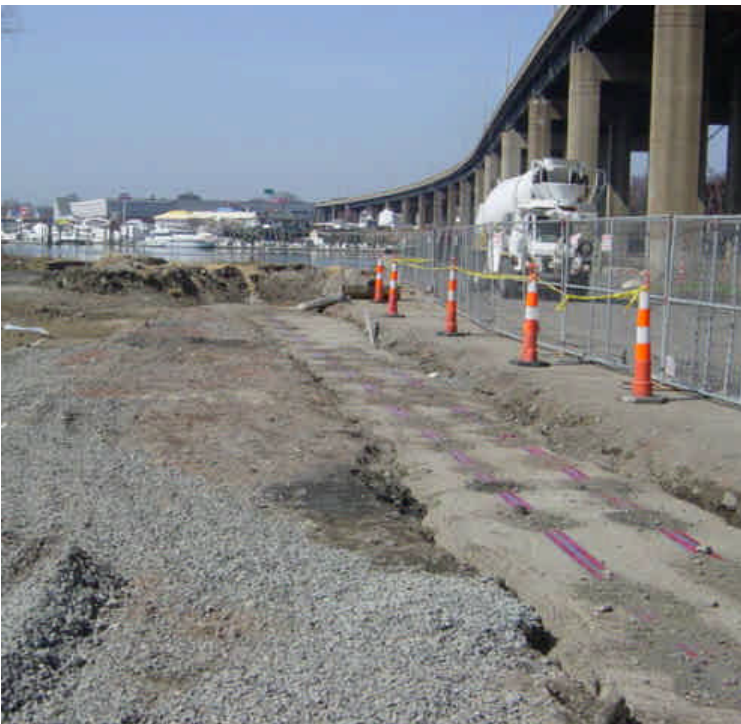
HDD work has been tied-in to the vault near sta. #1015 and the area has been partially backfilled.

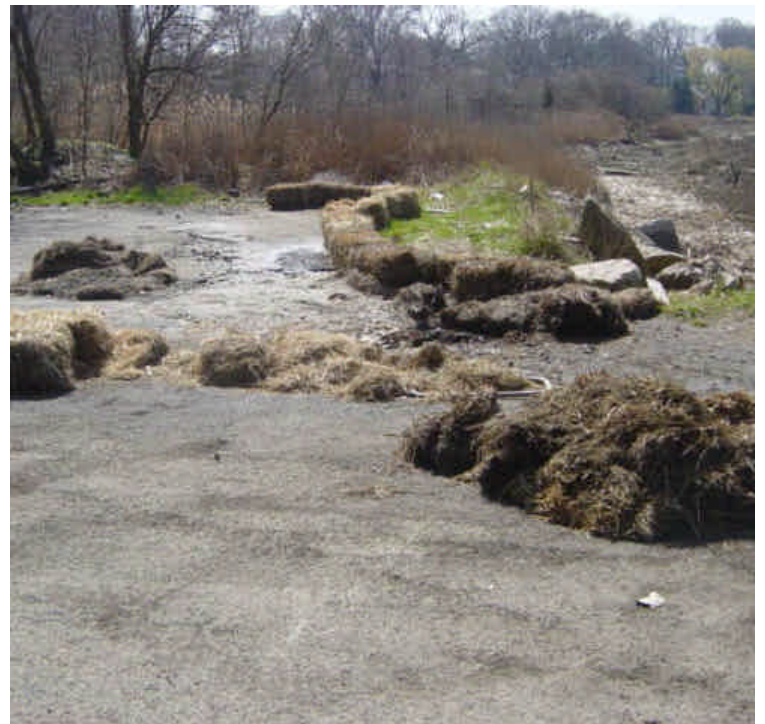
<p>Hay bales remain in place along the bank of the Housatonic River. However, some of the haybales have been moved and are deteriorating. 4/10/08</p>	<p>Continue to monitor the area. Reset and replace deteriorated haybales as necessary. Work to establish original cover (pavement or vegetation) on exposed surfaces. 4/10/08</p>	<p>Needs stabilization and some maintenance.</p>
	<p>The soil on the slope near sta. #1049 (vault #3) which had been exposed (noted 7/5/07) remains temporarily stabilized with hard-pack and barrier controls (since 7/25/07). 4/10/08</p>	<p>Continue to monitor the area for run-off and erosion until it is permanently stabilized. 4/10/08</p>	<p>The slope needs final restoration. (Contractors will be working on a future plan)</p>
	<p>A paved berm remains at the top of the slope near sta. #1080 to proactively divert stormwater to a catch basin (noted 7/19/07). 4/10/08</p>	<p>Continue to monitor to ensure diverted stormwater does not affect neighboring properties. See vegetative clearing section for more details. 4/10/08</p>	<p>Continue to monitor.</p>

Haybales remain in place along the bank of the Housatonic River. Some of the haybales have been moved and are deteriorating. Work to restore any remaining exposed areas with their original cover (e.g. vegetation or pavement).
